Aviation Investigation Final Report

Location:	Reedsville, Wisconsin	Accident Number:	CEN16FA171
Date & Time:	May 4, 2016, 10:02 Local	Registration:	N629JK
Aircraft:	McDonnell Douglas Helicopter 369E	Aircraft Damage:	Substantial
Defining Event:	Loss of engine power (total)	Injuries:	1 Fatal
Flight Conducted Under:	Part 133: Rotorcraft ext. load

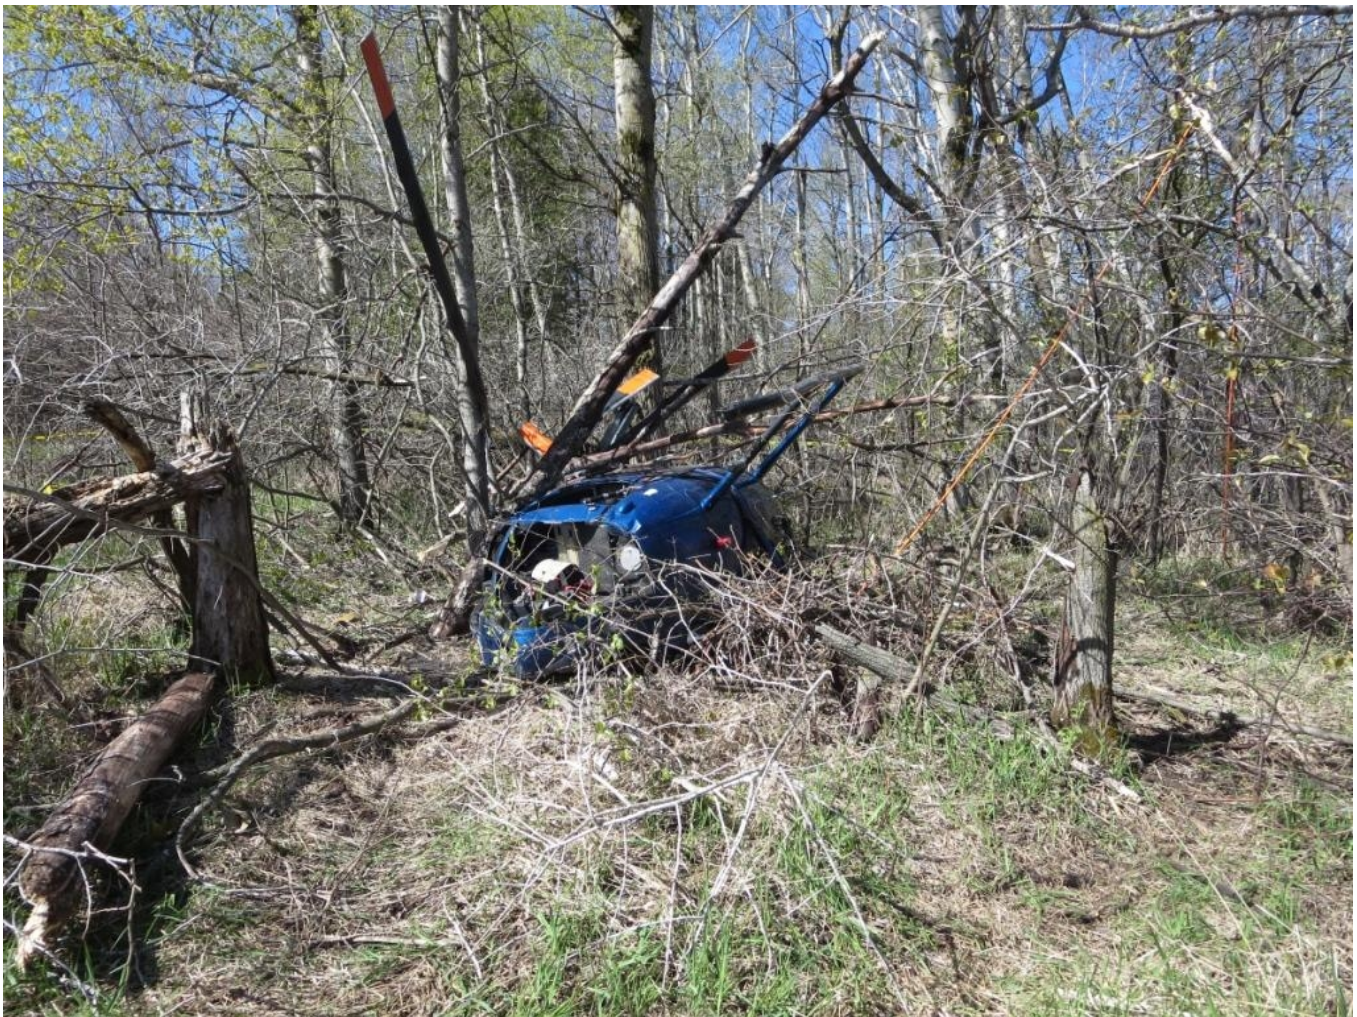
The helicopter came to rest in a wooded area about 125 ft south of tower 9904 (figure 4/5). The surrounding trees were 50 to 75 ft tall, and several of them were broken or showed signs of recent scarring and damage, consistent with the helicopter's impact sequence. All of the major components of the helicopter were found at the accident site. The long line remained attached to the cargo hook and trailed north toward the tower. There was an odor of Jet-A fuel around the main wreckage, and fuel was observed leaking from the helicopter. On-scene documentation was completed, and the wreckage was recovered to a secure examination facility.

Figure 4 – The accident helicopter surrounded by trees

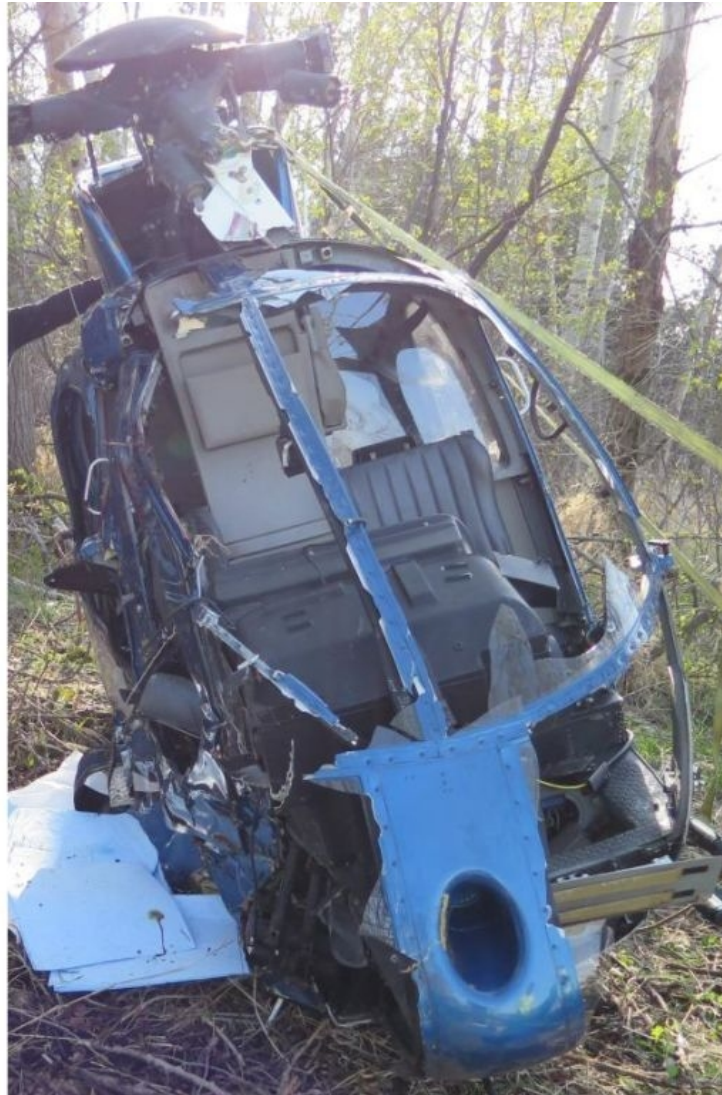
Figure 5 – Front view of accident helicopter damage

All five main rotor blades remained attached to the hub and were cut or removed during the examination. The blades exhibited impact damage with minimal signatures of preimpact rotation.

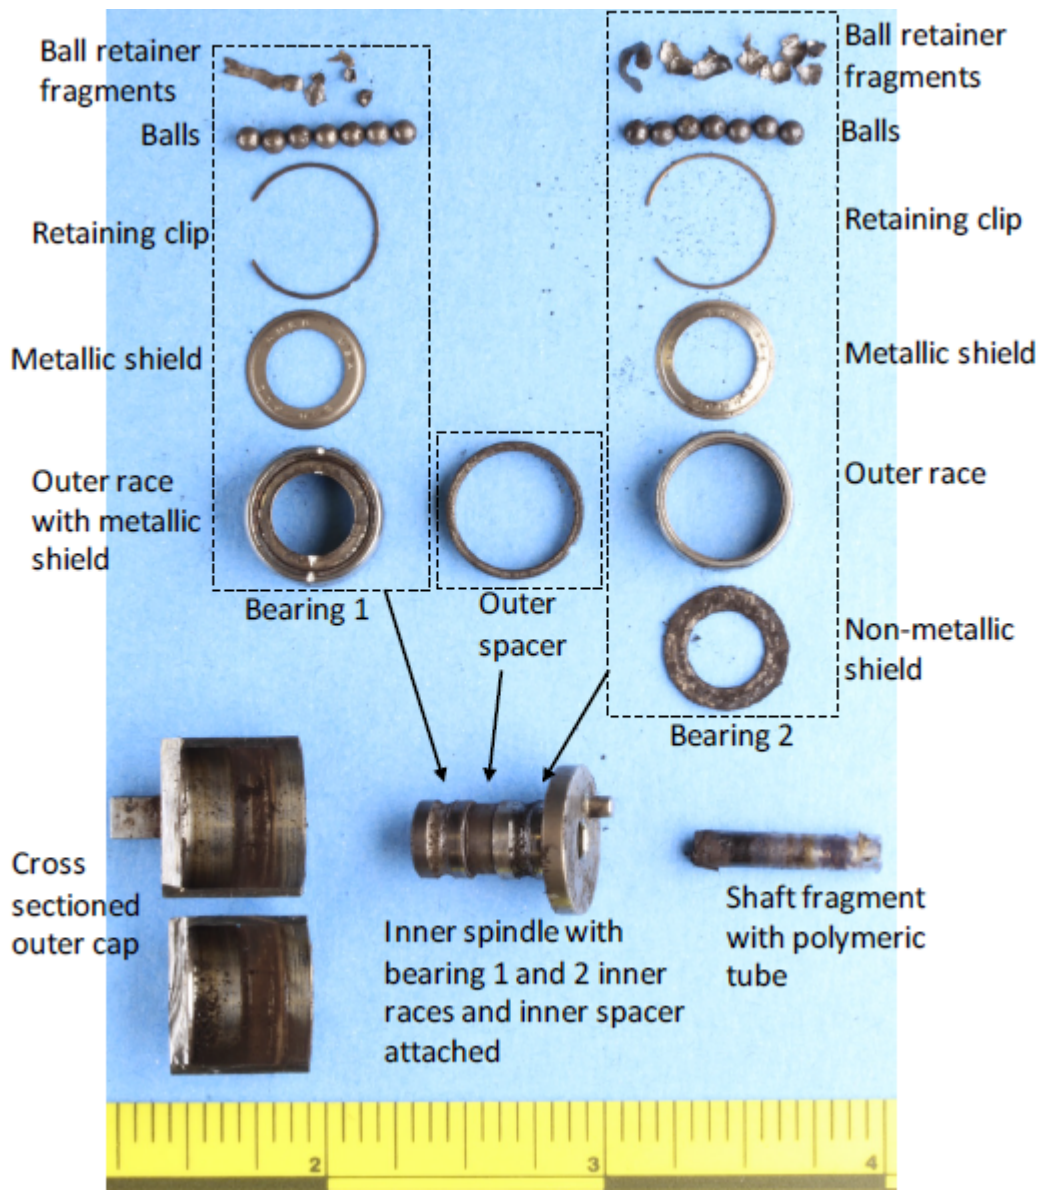
Examination of the PTG revealed that a portion of the drive shaft remained embedded in the spindle of the spool bearing assembly. The fracture surface features of the shaft were consistent with overstress. The internal elements of the spool bearing assembly were seized and would not rotate. The ball bearings and spacers were found coated with voluminous, powdery, black particulate consistent with oxidized metallic wear debris, and no grease was observed. The ball retainers were fragmented, the inner surfaces were found coated with a powdery, black particulate consistent with oxidized metallic wear debris, and no grease was observed. The inner bearing surfaces were rough and frosted, consistent with three-body

abrasive wear. The examination indicated that the fractured PTG drive shaft was the result of a spool bearing that seized due to a lack of lubrication.

The National Transportation Safety Board determines the probable cause(s) of this accident to be: The failure of the power turbine governor's dual-spool bearing due to a lack of lubrication, which resulted in a complete loss of engine power and subsequent impact with terrain.

On September 16, 2016, the NTSB examination of the PTG revealed that a portion of the fractured drive shaft remained embedded in the spindle of the spool bearing assembly. The fracture surface features of the shaft were consistent with overstress. The outer cap of the spool bearing assembly was removed, and the ball bearings and spacers were found coated with voluminous, powdery, black particulate. Much of the powder fell from the assembly upon removal of the cap. No grease was observed. Disassembly of the bearings revealed that the ball retainers were fragmented, the inner surfaces were found coated with a powdery, black particulate, and no grease was observed. The inner bearing surfaces were rough and frosted. Figure 7 shows the disassembled pieces of the spool bearing.

Figure 7 – Disassembled spool bearing with labels

In 2008, a service bulletin (SB) and commercial engine bulletin (CEB) were issued by PTG and engine manufacturers, respectively, that called for replacement of the dual-spool bearing, the type installed in the accident PTG, with a single-spool bearing. The dual-spool bearing had experienced 23 previous failures that had led to either engine oscillations, uncommanded engine acceleration, or a loss of engine power. Although the SB and CEB called for replacement of the accident PTG's dual-spool bearing not later than 750 hours after the PTG was installed new, the accident PTG had accumulated 1,048.7 hours since new when the accident occurred, and the SB and CEB had not been completed. As stated in the operator's Federal Aviation Administration (FAA) approved operations specifications, the operator was required to comply with FAA Airworthiness Directives but was not required to comply with manufacturer's service bulletins. It is likely that had the SB and CEB been completed, the PTG would not have failed and the engine would not have lost power.

Honeywell issued SB GT-73-344, Revision 2, on October 30, 2008, to replace the bearing assembly on PTGs used on Rolls-Royce 250 series engines in order to increase PTG reliability. The SB applied to several PTG models including the AL-AA2 model on the accident engine. Revision 1 was issued March 7, 2008.

Rolls-Royce issued CEB 1402 on April 21, 2008, to increase PTG reliability by incorporating a new bearing assembly. The CEB referenced Honeywell SB GT-73-344 and specified compliance times. The SB and CEB were issued after the accident PTG was installed new, and the SB and CEB were applicable to it. According to the CEB compliance times, the accident PTG's dual-spool bearing should have been replaced with a single-spool bearing no later than 750 hours TT since new.
