# Aviation Investigation Final Report

<b>Location:</b>	Carlsbad, California	<b>Accident Number:</b>	WPR16FA029
<b>Date &amp; Time:</b>	November 18, 2015, 16:23 Local	<b>Registration:</b>	N711BE
<b>Aircraft:</b>	Airbus Helicopters AS350B3E	<b>Aircraft Damage:</b>	Substantial
<b>Defining Event:</b>	Loss of control in flight	<b>Injuries:</b>	2 Fatal
<b>Flight Conducted Under:</b>	Part 91: General aviation - Personal

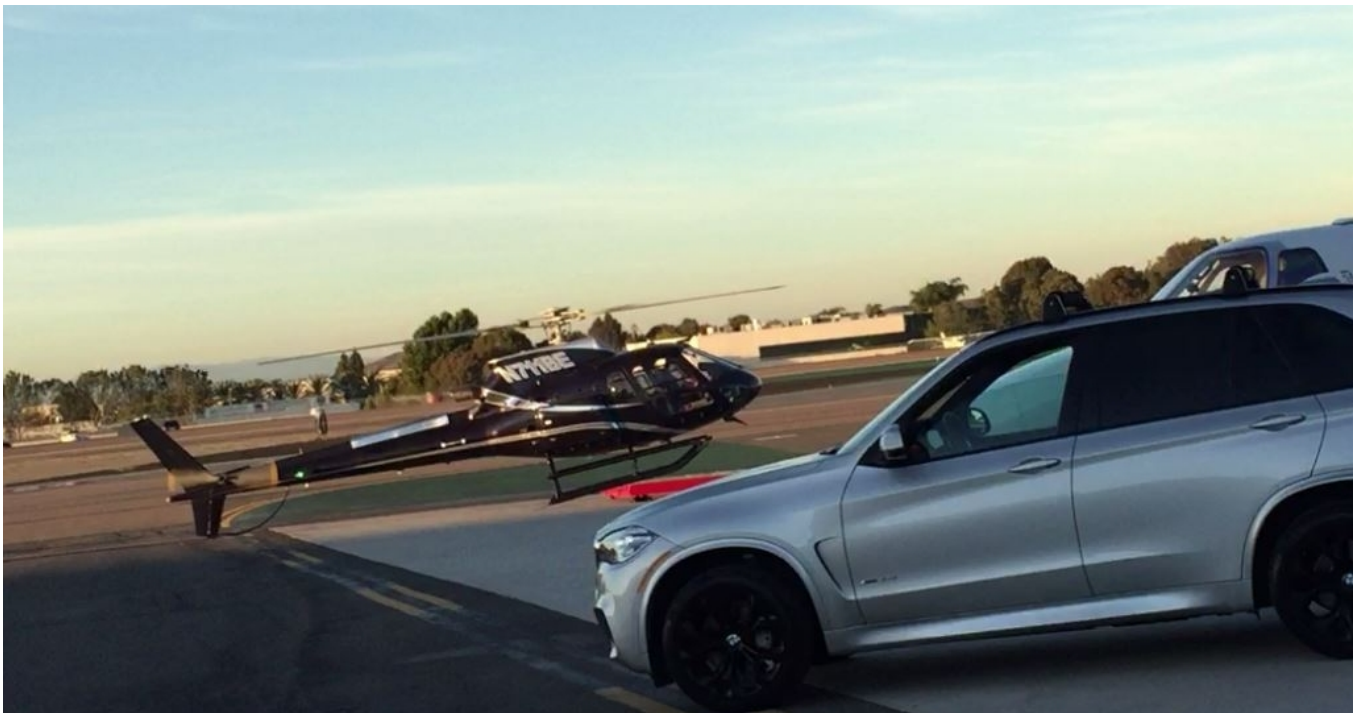
The video revealed that the helicopter hovered over the dolly for about 60 seconds and then landed short, teetering on the aft edge of the dolly (Image 1). The tailskid almost struck the ground, and the helicopter then rapidly pitched forward (Image 2) and then aft again. The tailskid then struck the ground (Image 3), and the helicopter pitched forward, rolled right (Images 4 and 5), and climbed out of view behind the hangar. Security cameras revealed that the helicopter then spun 180° to the left, and the nose pitched up to a 45° attitude. The tail rotor and vertical stabilizer assembly then struck the ground and separated, and the helicopter hit the ground left side low, bounced, and rotated another 360° before landing hard on its belly. Once on the ground, the main rotor blades continued to spin, while the helicopter started spinning on its belly, as the engine continued to operate (Image 6).

Image 1 - Helicopter Landing Short of the Dolly

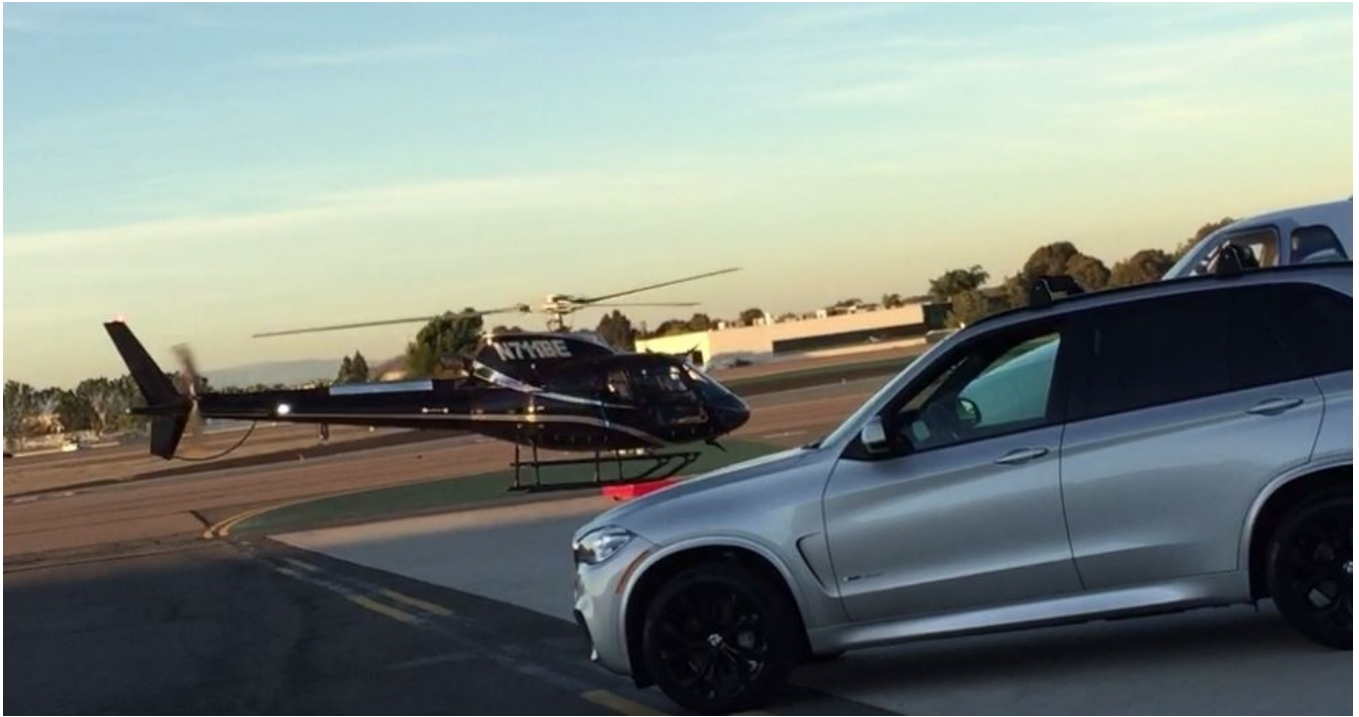
Image 2 - Helicopter Landing Short of the Dolly

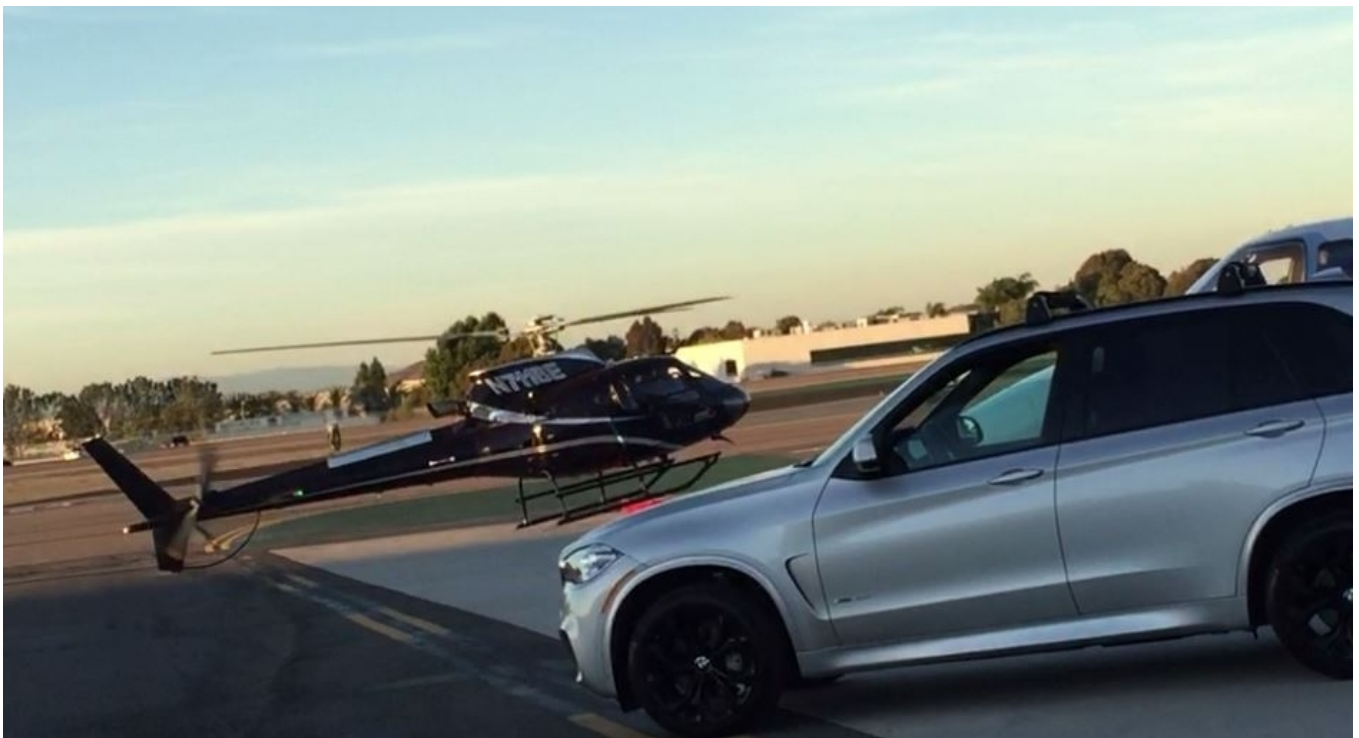
Image 3 - Helicopter Tail Striking the Ground

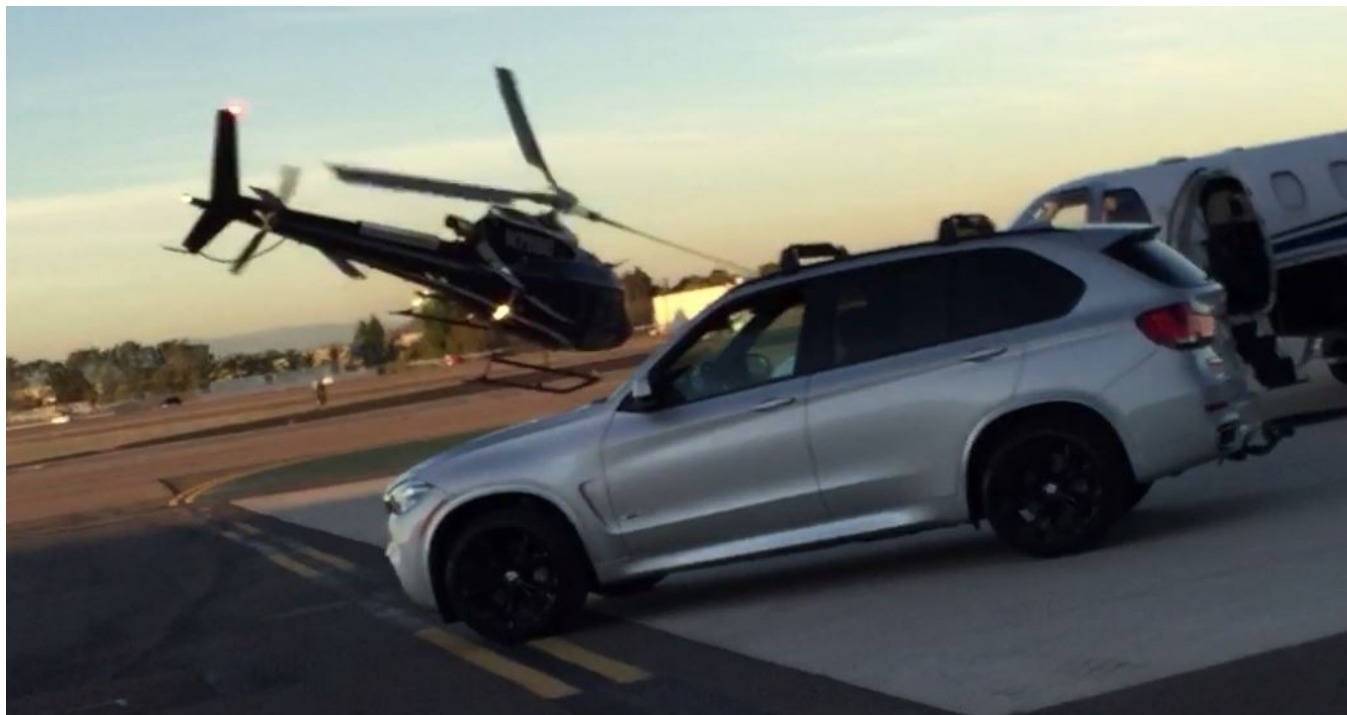
Image 4 - Helicopter Rolling Right over the Dolly

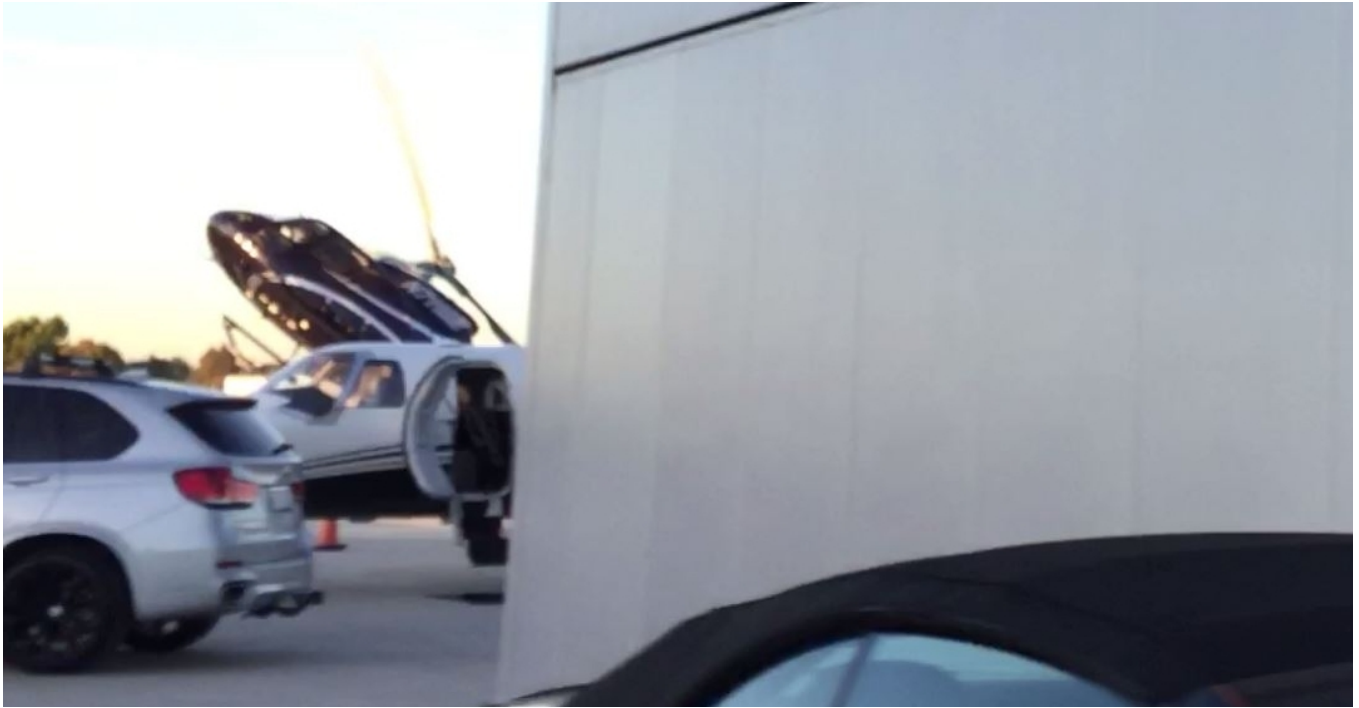
Image 5 - Helicopter Spinning 180 degrees, with Tail Striking the Ground

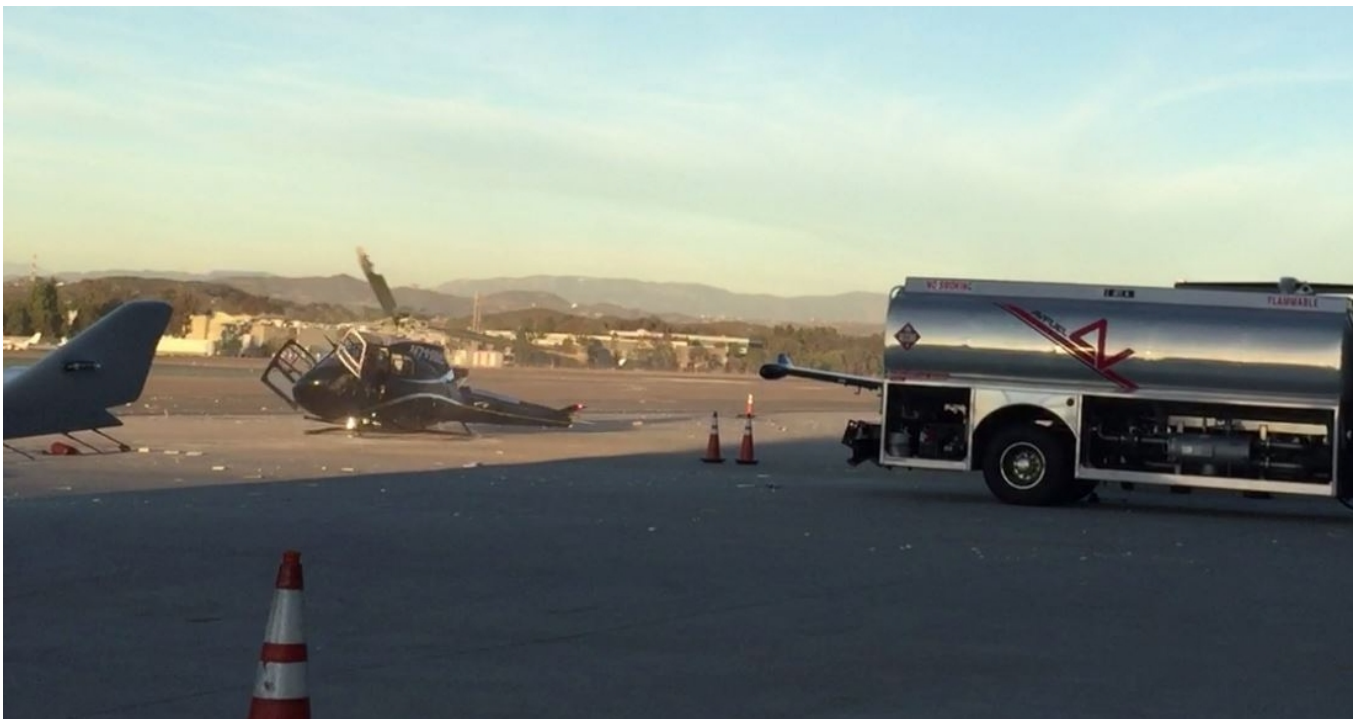
Image 6 - Helicopter Spinning after Ground Collision
