# Aviation Investigation Final Report

<b>Location:</b>	Molokai, Hawaii	<b>Accident Number:</b>	WPR18LA010
<b>Date &amp; Time:</b>	October 16, 2017, 19:18 Local	<b>Registration:</b>	N820DF
<b>Aircraft:</b>	ROBINSON HELICOPTER R44	<b>Aircraft Damage:</b>	Destroyed
<b>Defining Event:</b>	Loss of control in flight	<b>Injuries:</b>	2 Fatal
<b>Flight Conducted Under:</b>	Part 91: General aviation - Instructional

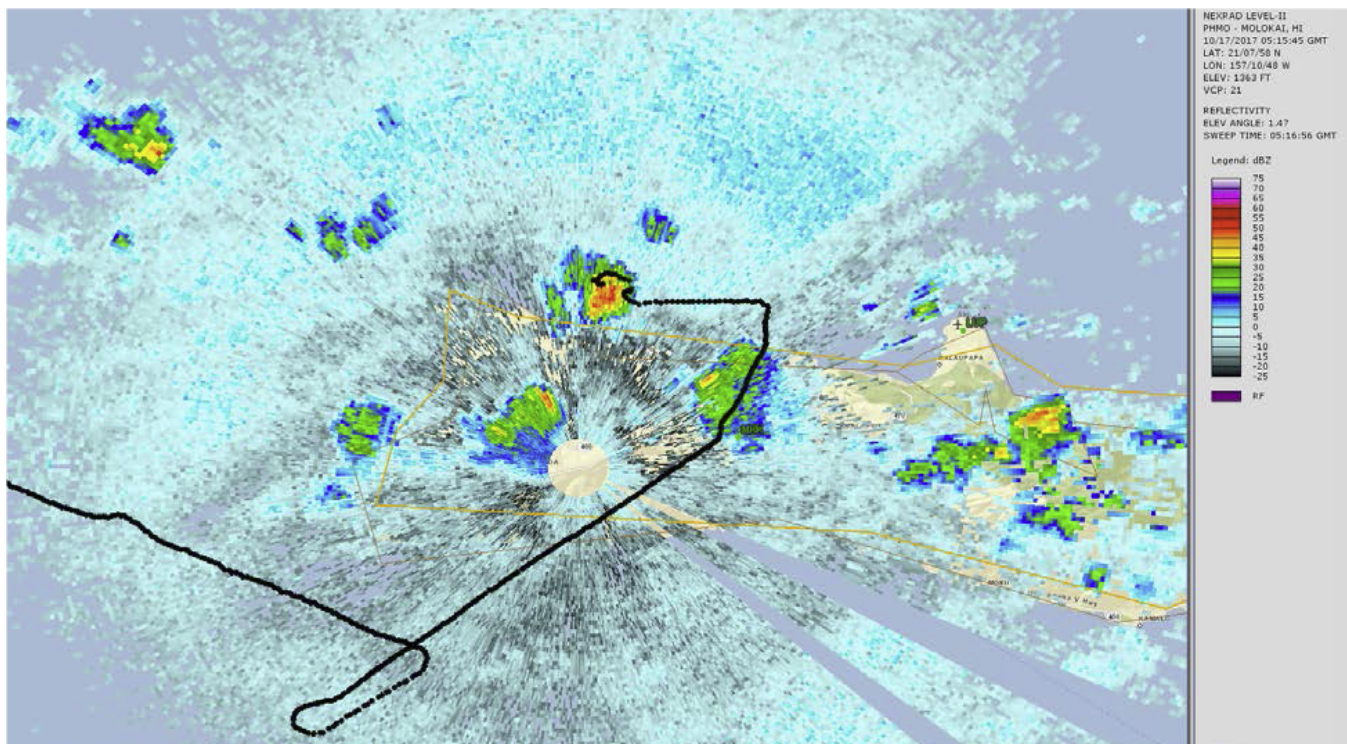
Figure 1: WSR-88D base reflectivity imagery at 1917

The closest National Weather Service (NWS) Weather Surveillance Radar-1988, Doppler (WSR-88D) to the accident site was the Molokai, Hawaii, radar (PHMO), which was located 6 nm south-southwest of the accident site at an elevation of 1,363 ft. The WSR-88D captured base reflectivity imagery at 1917 and 1918 (shown in figures 1 and 2, respectively; the black line shows the helicopter's flight path). The imagery depicts moderate-to-heavy values of reflectivity within the vicinity of the last radar target. Rain showers and convective clouds produce outflow boundaries and gust fronts throughout their life cycle. An outflow boundary or gust front can create an environment favorable for unexpected changes in wind direction and speed. There were no lightning strikes in the vicinity of the last radar target around the time of the accident.
