# Aviation Investigation Final Report

<b>Location:</b>	Granger, Texas	<b>Accident Number:</b>	WPR18FA232
<b>Date &amp; Time:</b>	August 21, 2018, 12:18 Local	<b>Registration:</b>	N530FU
<b>Aircraft:</b>	Hughes 369	<b>Aircraft Damage:</b>	Destroyed
<b>Defining Event:</b>	Loss of visual reference	<b>Injuries:</b>	2 Fatal
<b>Flight Conducted Under:</b>	Part 91: General aviation - Instructional

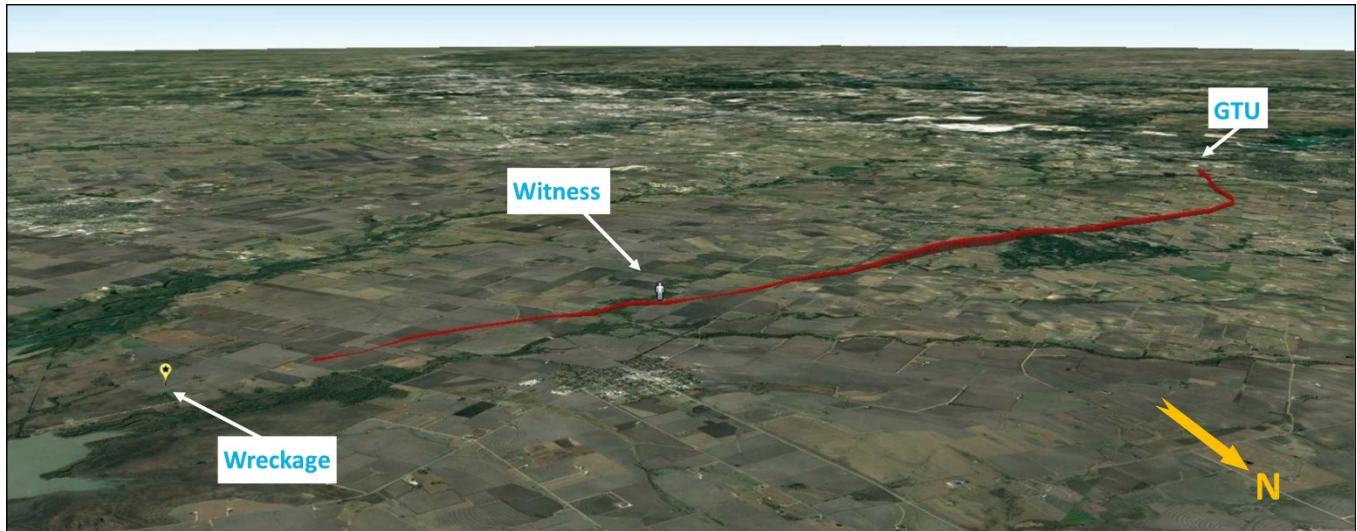
The final stage of the accident was not observed by any witnesses; however radar data from a Federal Aviation Administration (FAA) air route surveillance radar about 30 miles northeast of GTU revealed a target departing the GTU airport environment about 1209 and traveling east while climbing to a mode C transponder-reported altitude of 1,100 ft (about 500 ft above ground level [agl]). About that time, the instructor requested a frequency change with the tower, and 4 minutes after departure (9 miles east of Georgetown), the target began to descend. One minute later, the target had reached an altitude of about 50 ft agl. The target continued traveling east at a groundspeed of about 90 knots and at altitudes that varied between 0 and 120 ft agl over unpopulated areas.

The radar data revealed that, about 1215:26, the target, while at 25 ft agl, had traveled left to right directly in front of the witness's house, coming within 700 ft. The target then began to climb and reached

125 ft agl as it passed beyond the witness' house while proceeding southeast. The last recorded target, which was 1 mile west of the accident site, was captured at 1217:14 at an altitude of 58 ft agl. The helicopter wreckage was located in a cotton field about 4 miles east of the witness' residence, and 1.5 miles west of Granger Lake. (as shown in figure 1).

Figure 1. Radar track (as indicated by red line) and wreckage location. (Background image courtesy of Google Earth).

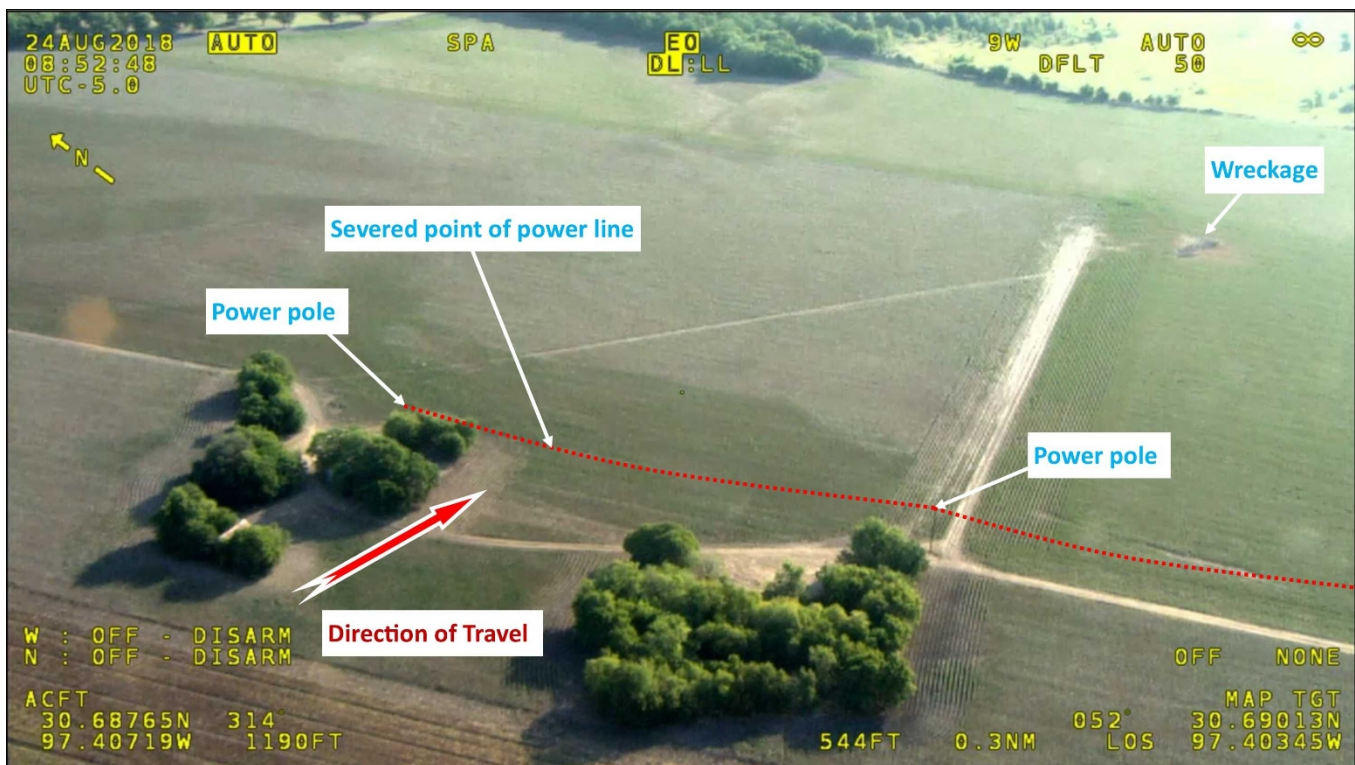
The debris field was bordered to the west by a series of 36-ft-tall power distribution poles, which were oriented north-south and spaced about 450 ft apart. The tops of the poles were spanned by an overhead power line made of steel stranded wire, and an "underbuild" line 4 ft below. The overhead line in the northwest corner of the field, which was about 950 ft from the main wreckage, was severed about midspan (as shown in figure 2), and a red belly-mounted strobe light lens was located 100 ft to the east. The severed point of the line was located in between two stands of trees.

Figure 2. Wreckage and power line locations. (Background image source: Texas Department of Public Safety.)

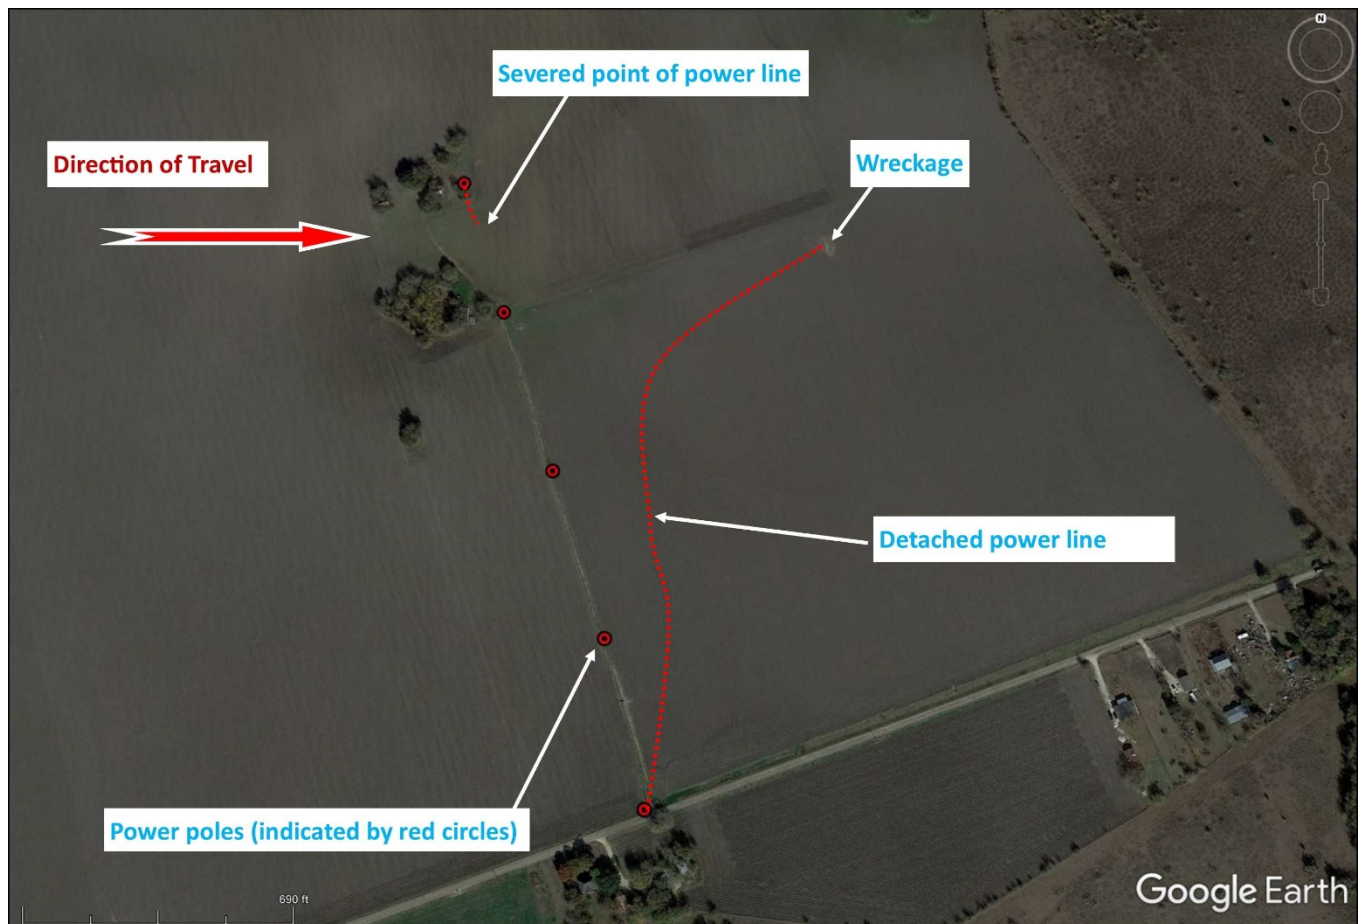
The other end of the overhead line, which was about 1,300 ft in length, had been pulled away from the three poles to the south and was continuous to the main wreckage (as shown in figure 3). The poles

exhibited recent ground disruption at their bases and were bent toward the main wreckage site. When facing east at the altitude and direction of travel of the radar targets, the two poles that held the severed line were obscured by trees.

Figure 3. Detached power line leading to wreckage.

Although the helicopter was painted black with silver lettering, layers of red paint were observed under the paint of various skin and fairing components, indicating that the helicopter was previously painted red. Red-colored transfer marks were observed on the 75-ft-long section of the southern portion of the overhead line that led from the separation point.
