Aviation Investigation Final Report

Location:	Colusa, California	Accident Number:	WPR21FA300
Date & Time:	August 1, 2021, 12:51 Local	Registration:	N7000J
Aircraft:	ROBINSON HELICOPTER CO R66	Aircraft Damage:	Destroyed
Defining Event:	Abrupt maneuver	Injuries:	4 Fatal
Flight Conducted Under:	Part 91: General aviation - Personal

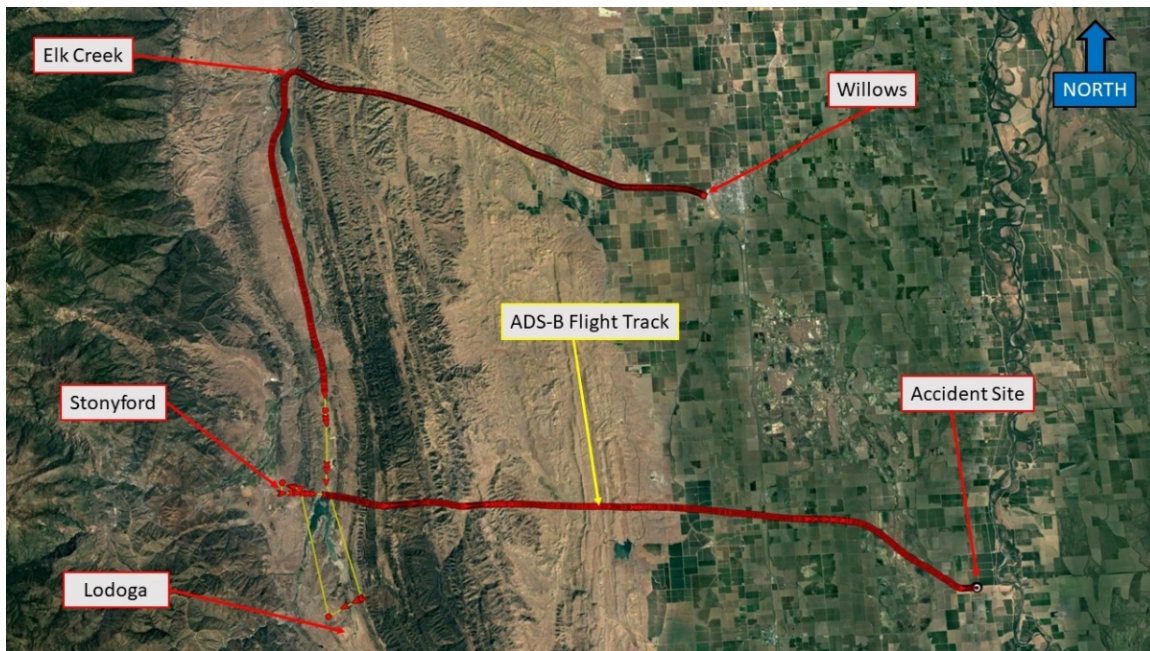
Recorded automatic dependent surveillance-broadcast (ADS-B) data provided by the Federal Aviation Administration (FAA) showed that, about 1207, the helicopter departed Willows, California, and flew toward the foothills that bordered the western edge of the valley. The ADS-B data also showed that the helicopter turned south while over Elk Creek, California, and overflew Lodoga and Stonyford, California, before turning to the east. The helicopter continued an easterly heading for about 12 minutes and then turned to a southeasterly heading. The helicopter remained on a southeasterly heading for about 2 minutes and then initiated a left turn to an easterly heading when the helicopter was about 0.7 miles west of the accident site, as shown in figure 1. The last recorded data point showed that the helicopter was about 392 ft west of the accident site. The ADS-B data contained no altitude data for the entire flight.

Figure 1. ADS-B flight track for the accident flight.

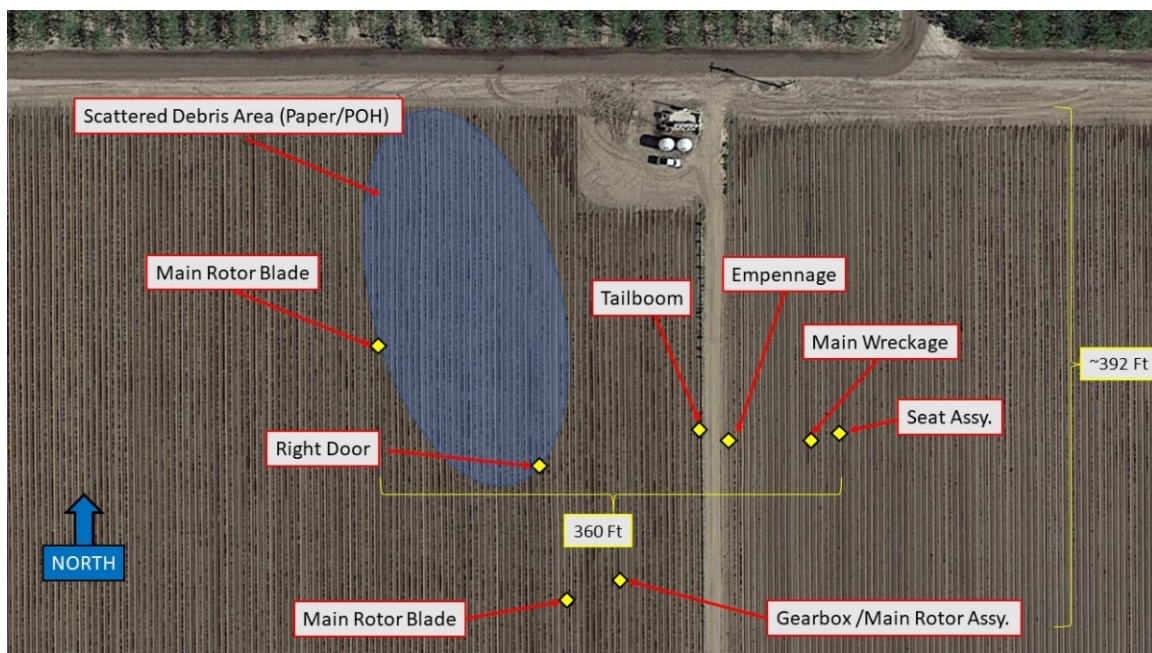
Examination of the accident site revealed that the helicopter impacted a tomato field. Wreckage debris was scattered among an area that measured 360 ft by 392 ft, as depicted in figure 2.

Figure 2. Wreckage diagram of debris area.

A portion of the main rotor blade was located on the western edge of the debris area. The right door was located about 161 ft southeast of the main rotor blade portion. About 112 ft south of the right door, the outboard portion of one blade was found. A ground impression that was about 16 ft long, 8 inches wide, and in a “U” shape was located about 8 ft east of the outboard section of the main rotor blade. The main rotor gearbox and main rotor assembly were located about 5 ft east of the ground impression.

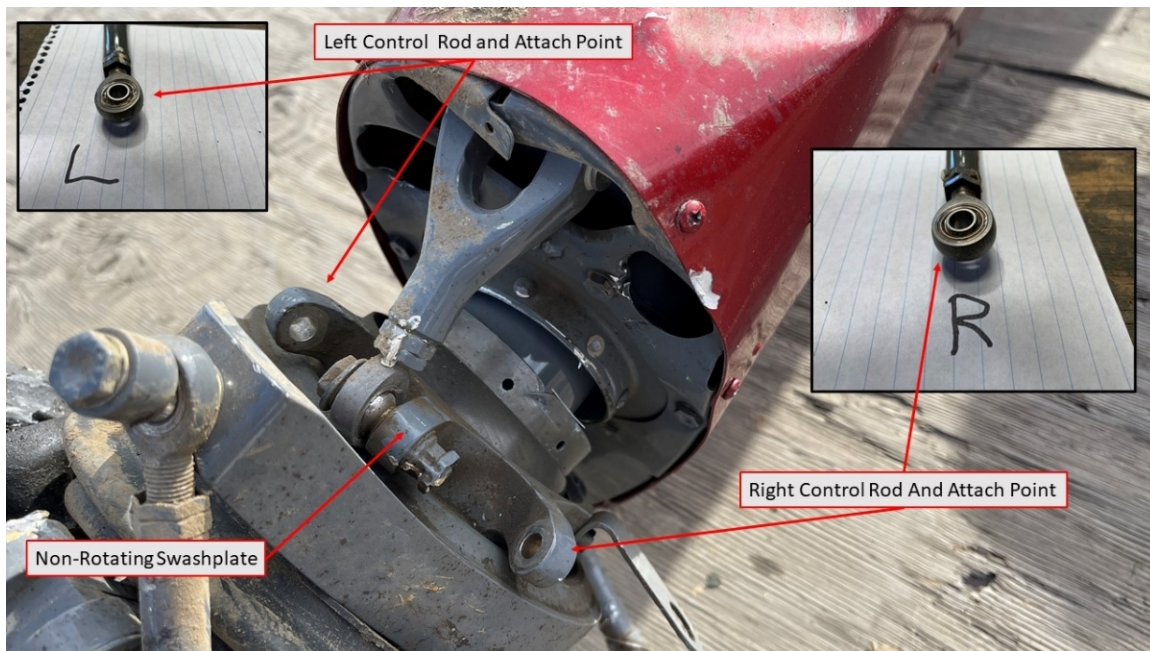
Cyclic and collective control continuity was established, but multiple separations consistent with overload were observed throughout the systems. The forward left and right control tube attachment hardware at the nonrotating swashplate was not located at the accident site or within the recovered wreckage. All three control tubes from the servo to the swashplate remained intact with some slight bends and scratches, as shown in figure 3.

Figure 3. Nonrotating swashplate area and both upper areas of the left and right control tubes.

The forward left and right control attachment lugs on the swashplate were cleaned and examined. No substantial thread imprints were observed on the bores of the attachment holes on the lugs. Remnants shaved from the attachment bolt were located on the lower forward half of the lug at the left side of the hole, and the area between the bolt remnants was rubbed.

The lower portion of the lug with the attachment bolt remnants was examined using a scanning electron microscope. The lower portion of the bolt remnant exhibited dimple features consistent with ductile overstress fracture.

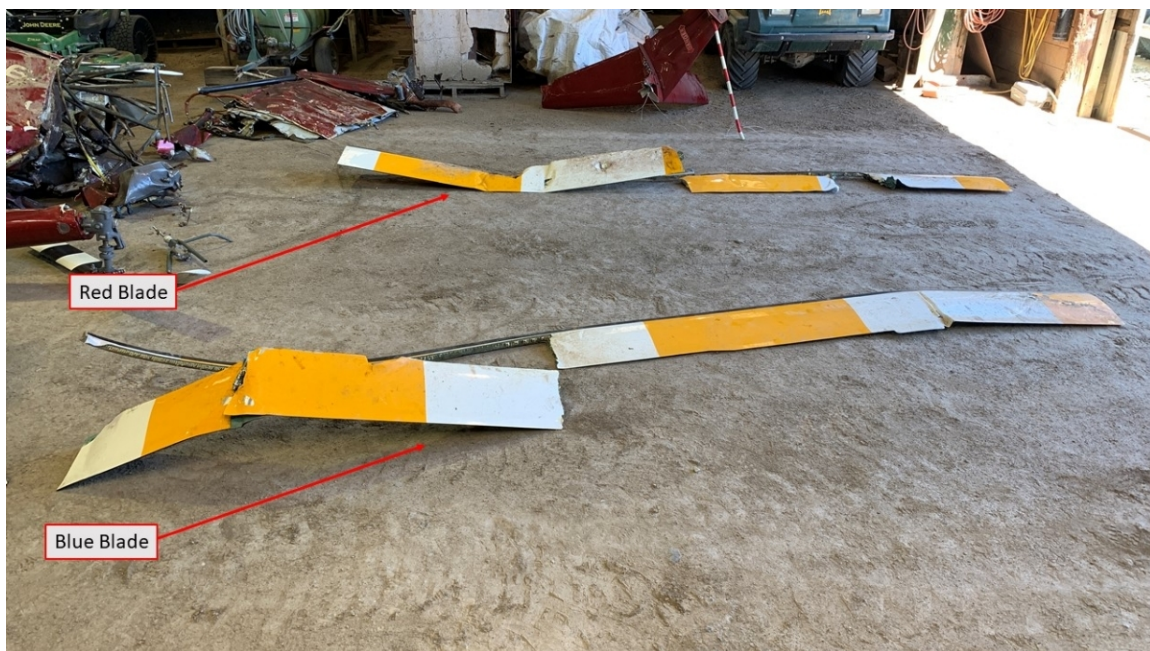
The tail rotor controls were separated in multiple areas. All areas of separation were consistent with impact damage and/or overload separation. The main rotor blades exhibited varying degrees of damage and were fractured in various areas, as shown in figure 4.

Figure 4. Red and blue main rotor blades.

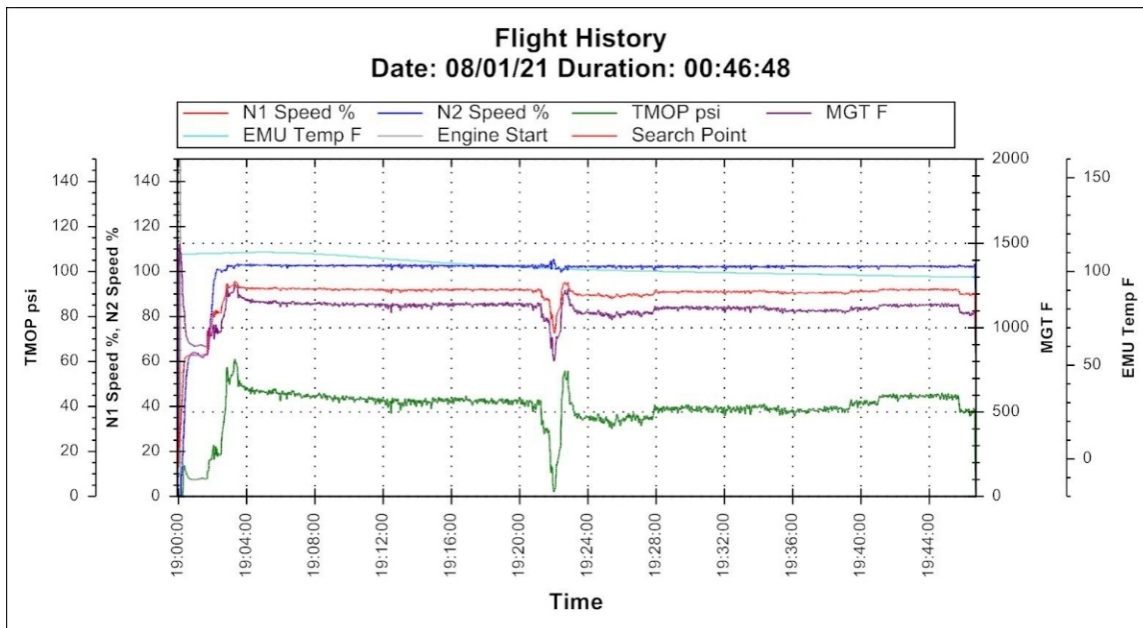
The turbine module was disassembled for examination. The gas generator turbine turned freely by hand. The power turbine remained locked in position due to impact damage. The second, third, and fourth stage turbine air foils were intact and undamaged. The engine monitoring unit was located within the wreckage, and all stored data were downloaded. The data showed that the engine was operating at the time of the accident, which can be seen in figure 5.

Figure 5. Downloaded engine data for the accident flight.

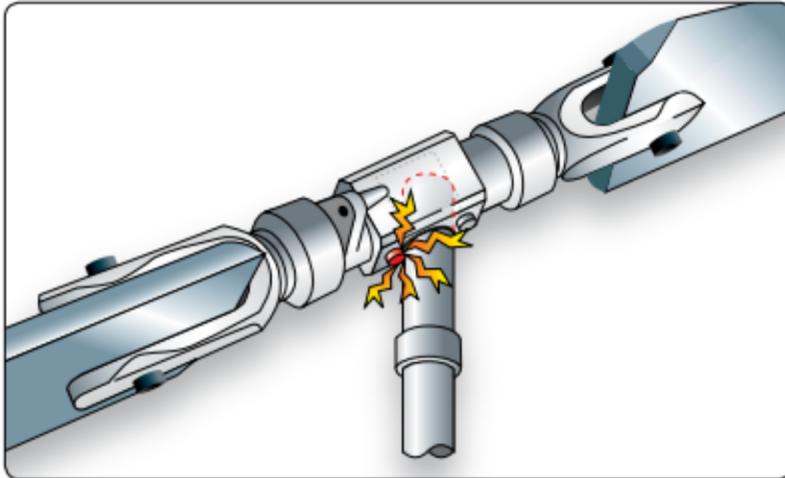
Abrupt forward cyclic input or pushover in a two-bladed helicopter can be dangerous and must be avoided, particularly at higher speeds. During a pushover from moderate or high airspeed, as the helicopter noses over, it enters a low-G condition. Thrust is reduced, and the pilot has lost control of fuselage attitude but may not immediately realize it. Tail rotor thrust or other aerodynamic factors will often induce a roll. The pilot still has control of the rotor disk, and may instinctively try to correct the roll, but the fuselage does not respond due to the lack of thrust. If the fuselage is rolling right, and the pilot puts in left cyclic to correct, the combination of fuselage angle to the right and rotor disk angle to the left becomes quite large and may exceed the clearances built into the rotor hub. This results in the hub contacting the rotor mast, which is known as mast bumping...and the energy and inertia in the rotor system can sever the mast or allow rotor blades to strike the tail or other portions of the helicopter.

The handbook included an illustration that depicted the hub contacting the rotor mast, as a result of improper corrective action in a low-G condition (figure 6).

Figure 6. Result of improper corrective action in a low-G condition
