*Example property
London*

Part owner's damp report

12 April 2022

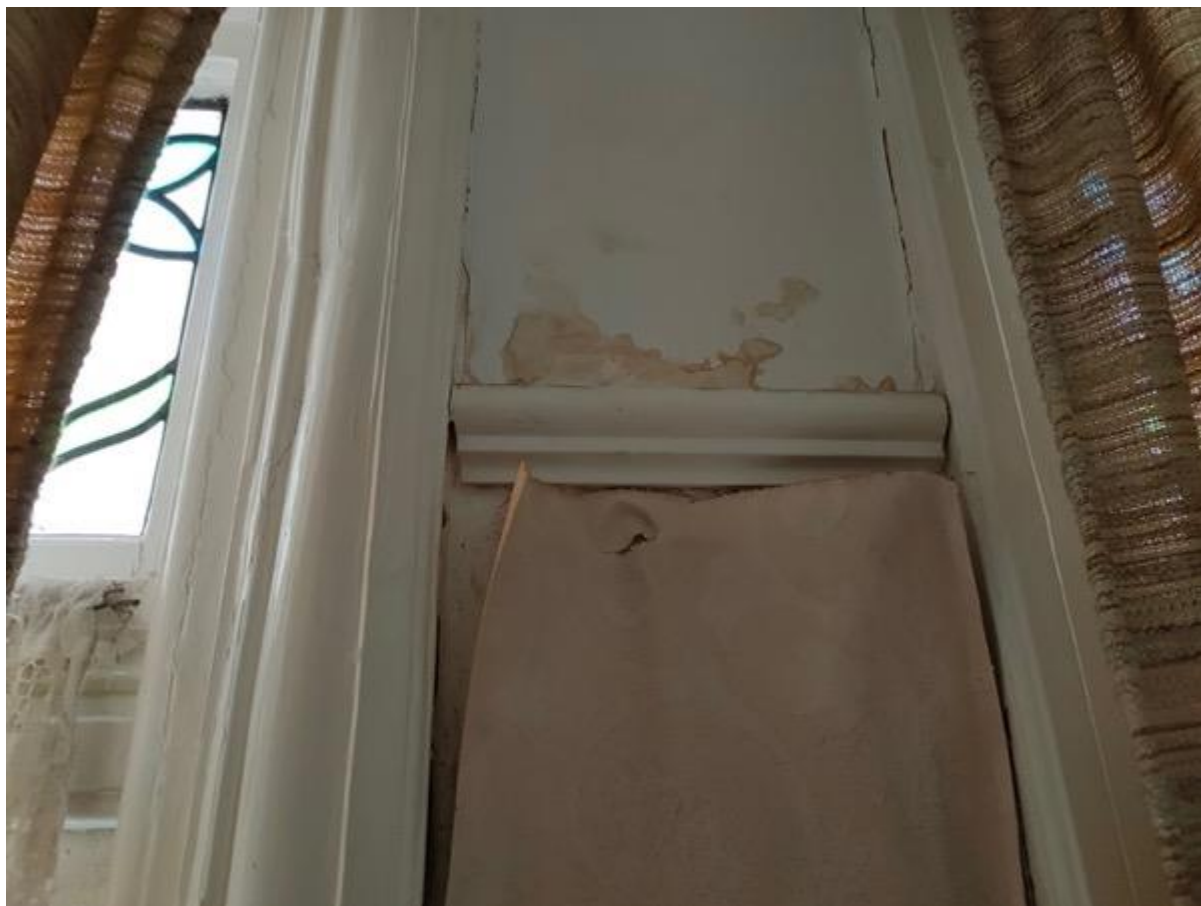
There are many damp issues around the house. There is a brown stain on the right-hand rear reception wall. The brown discolouration like a teabag stain is a sign of water flowing through building material. In this case it is caused by rainwater and referred to as penetrating damp.

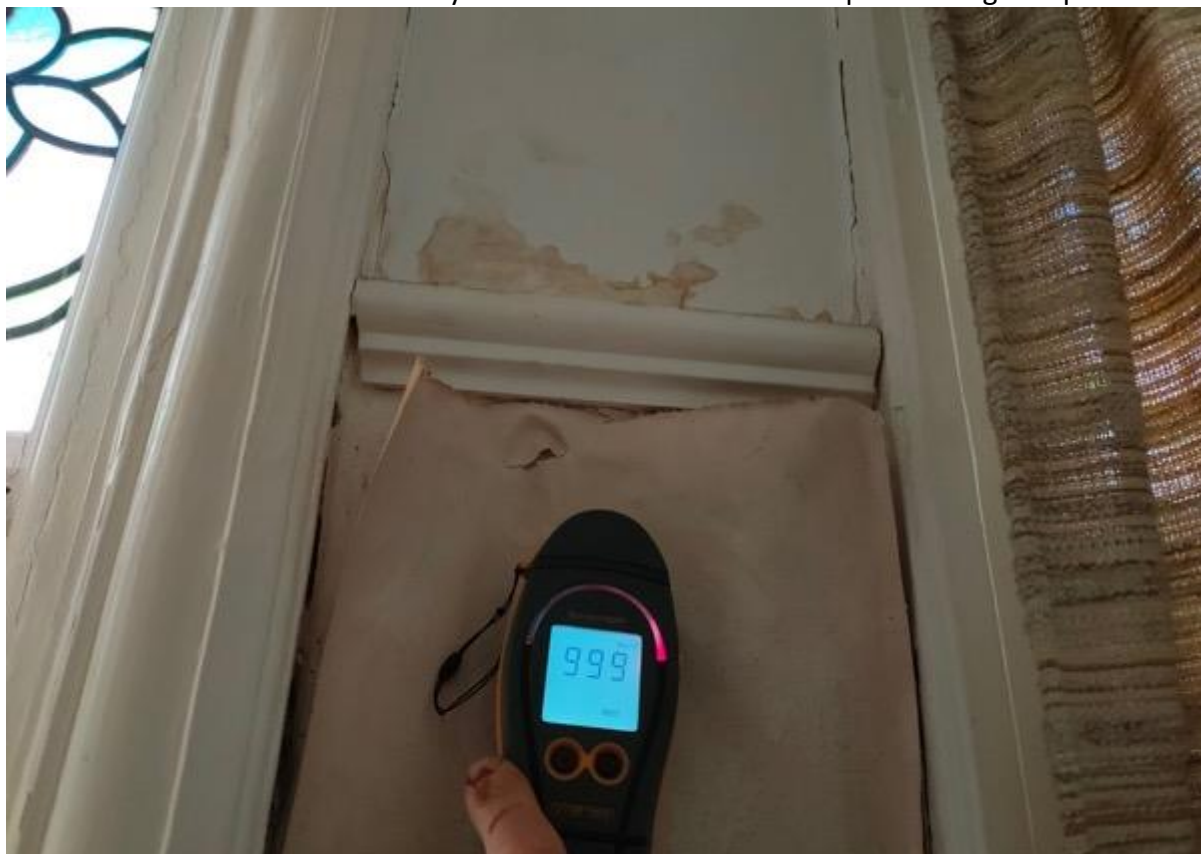
The wall was damp, as determined by a Protimeter radio frequency damp meter.

The damp meter's measurement limit is 999REL, below 300REL is consider dry. 999REL indicates water absorbed at depth. High readings illustrate the extent and profile of dampness, and are used to help pinpoint the source of moisture [surveyor.tips/profile](https://www.surveyor.tips/profile).

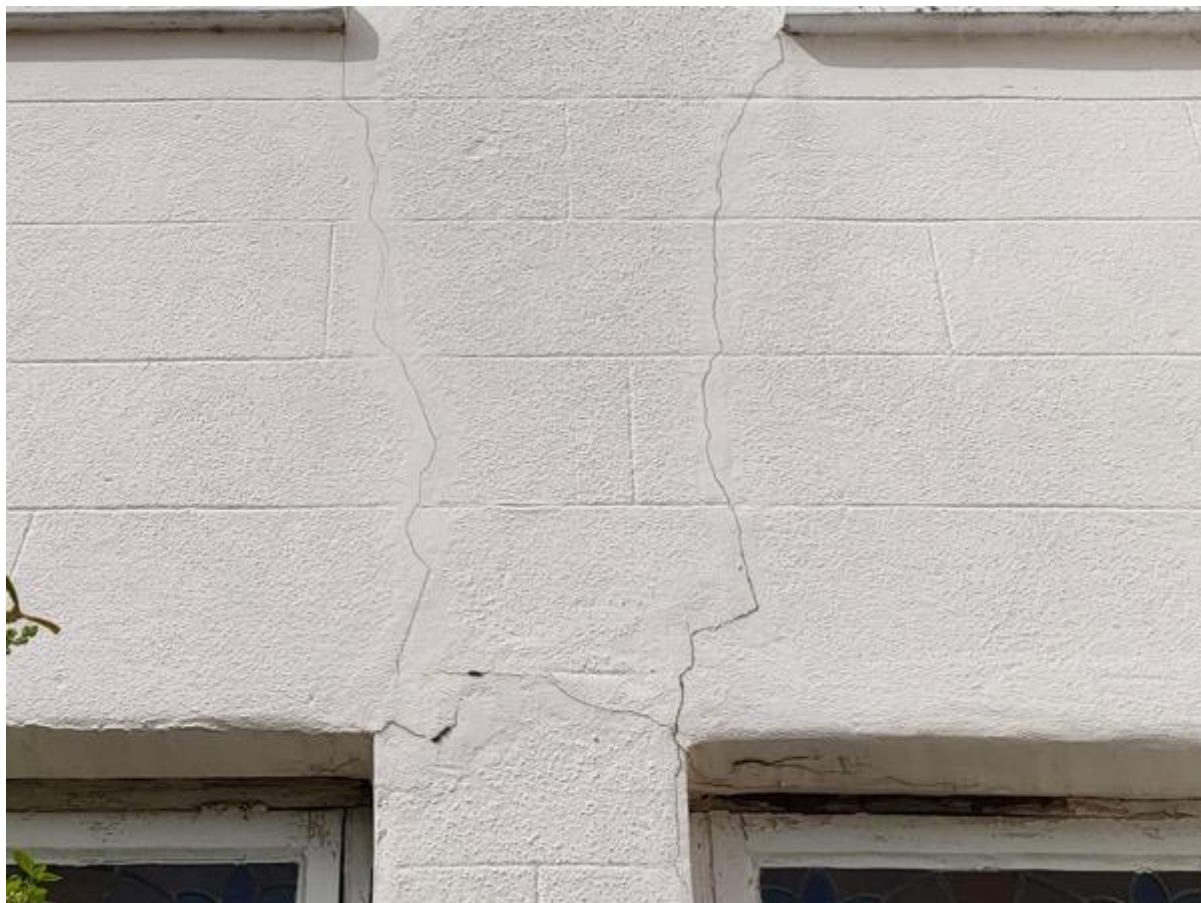
Outside there are render cracks. Cracks suck in water like capillaries.

Render expands in the sun and contracts at night. This often causes cracking. Water flows down an impermeable surface. All else being equal, a horizontal crack will draw in more water than a vertical crack. Water cannot evaporate out through the render so penetrates inside. Sometimes the crack merely dampens the outside brick causing heat loss, increasing risk of condensation. However, clearly water is penetrating through this wall.

Remedial actions necessary to keep the property dry and mould free	
Instruct a general builder to rake out and fill render cracks and repaint flaking or cracked masonry paint - an external acrylic caulk for small gaps, similar material to the original render for larger gaps (>3mm). The paint should be as impermeable as any coating between it and an absorbent wall it i.e. impermeable if painted on render or impermeable paint. Normal Sandtex or Dulux exterior paint is semi-permeable. Zinsser market an impermeable satin finish: "Zinsser Perma-White Exterior".	£1,000
It is likely that water has been entering into the sub-floor from the blocked front drain. The gully is damaged and needs repair to stop water bypassing the drain. There is a good chance of drain damage under the house (as I had at my property). Consider instructing a CCTV drains survey (~£400). TIP: monitor sub-floor humidity with a hygrometer probe under the damp wall (which I left in place during the survey). A probe can be pushed through cracks in floorboards or by discretely drilling out a hole. The sub-floor relative humidity will fluctuate. If it remains above 85%RH, then consider increasing sub-floor ventilation by unblocking current airbricks and possibly enlarging or adding another (to the front and or rear). If high humidity continuous, consider installing a mechanical, inline sub-floor extractor fan, or two such as the MORI WMF Weatherproof Multi- Functional Sub-Floor Ventilation by HomeVent (a division of Elta), £420 for two plus about £300 installation costs. There is a possibility that the DPC has been bridged by builders rubble in the sub-floor void, in front of the hearth and surrounding the chimney breast, remove any oversite and check for rot in the sub-floor void.	£400

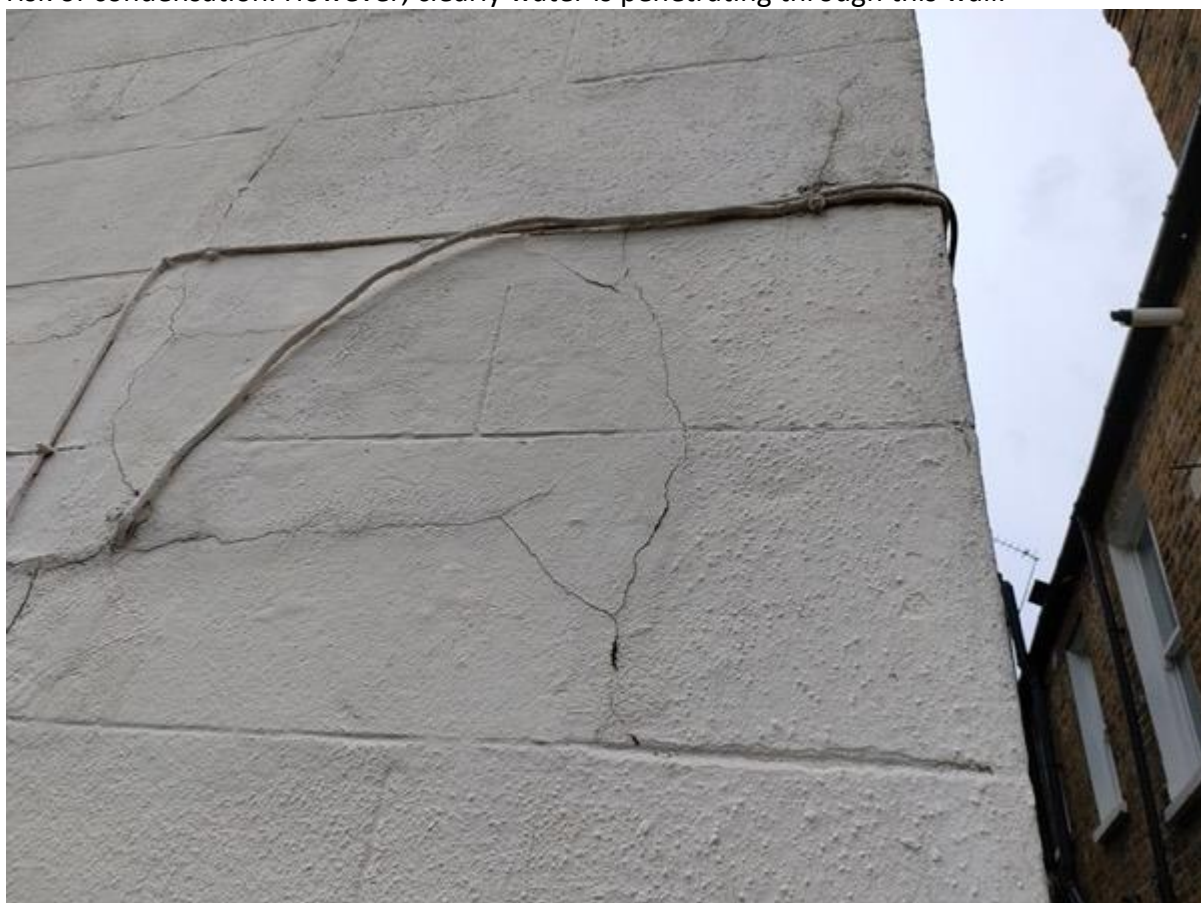
Render cracks are visible on the left-hand rear reception wall.

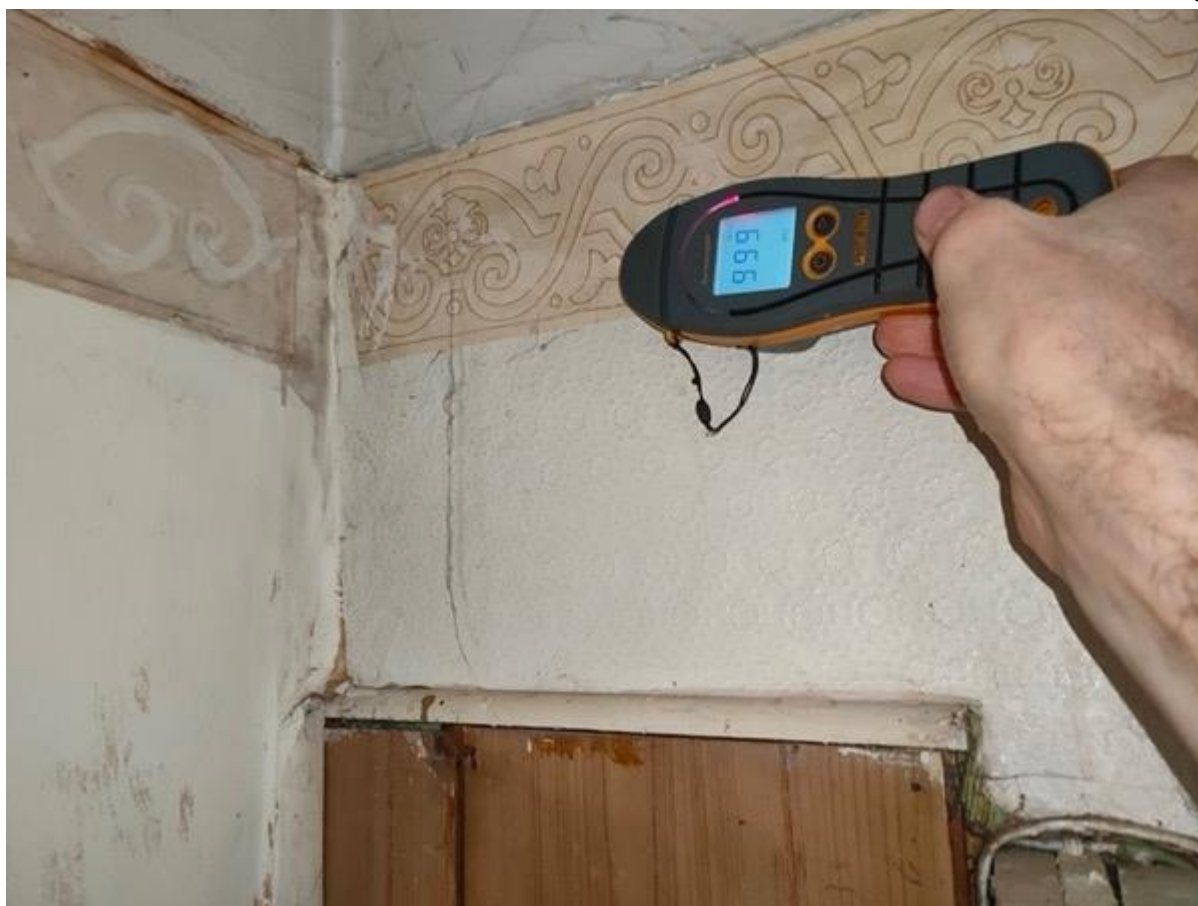
The wall immediately inside at ceiling level is damp with brown stains from penetrating damp.

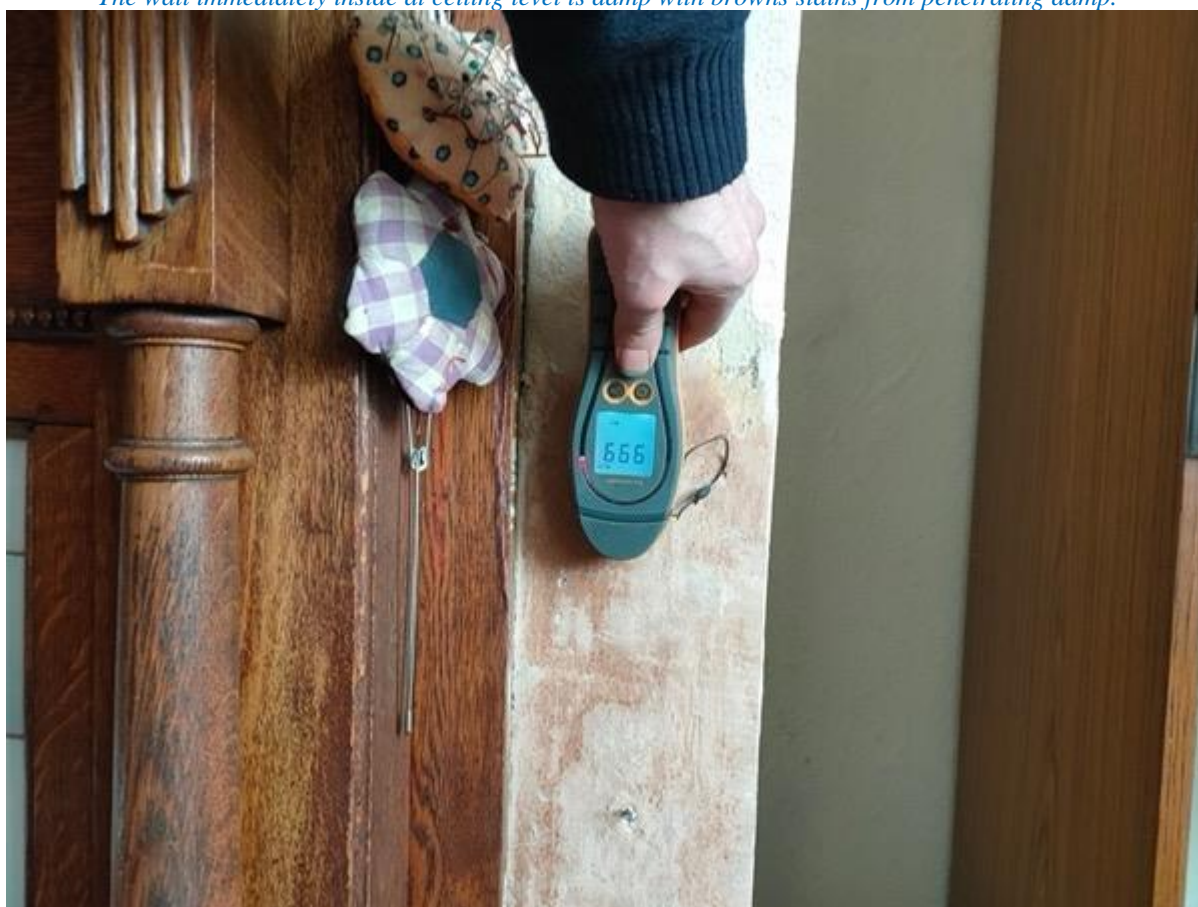
The chimney breast is damp up to about 1 metre above ground level.

It is possible that the damp in the chimney breast is connected to the render cracks. However, chimney breasts that are not used for fires, are at increased risk of dampness, as there tends to be increased heat loss from the flue and the hearth is supported by bricks, increasing the surface area able to absorb water vapour from the sub-floor void. There may also be some oversight causing the DPC to be bridged in the sub-floor void.

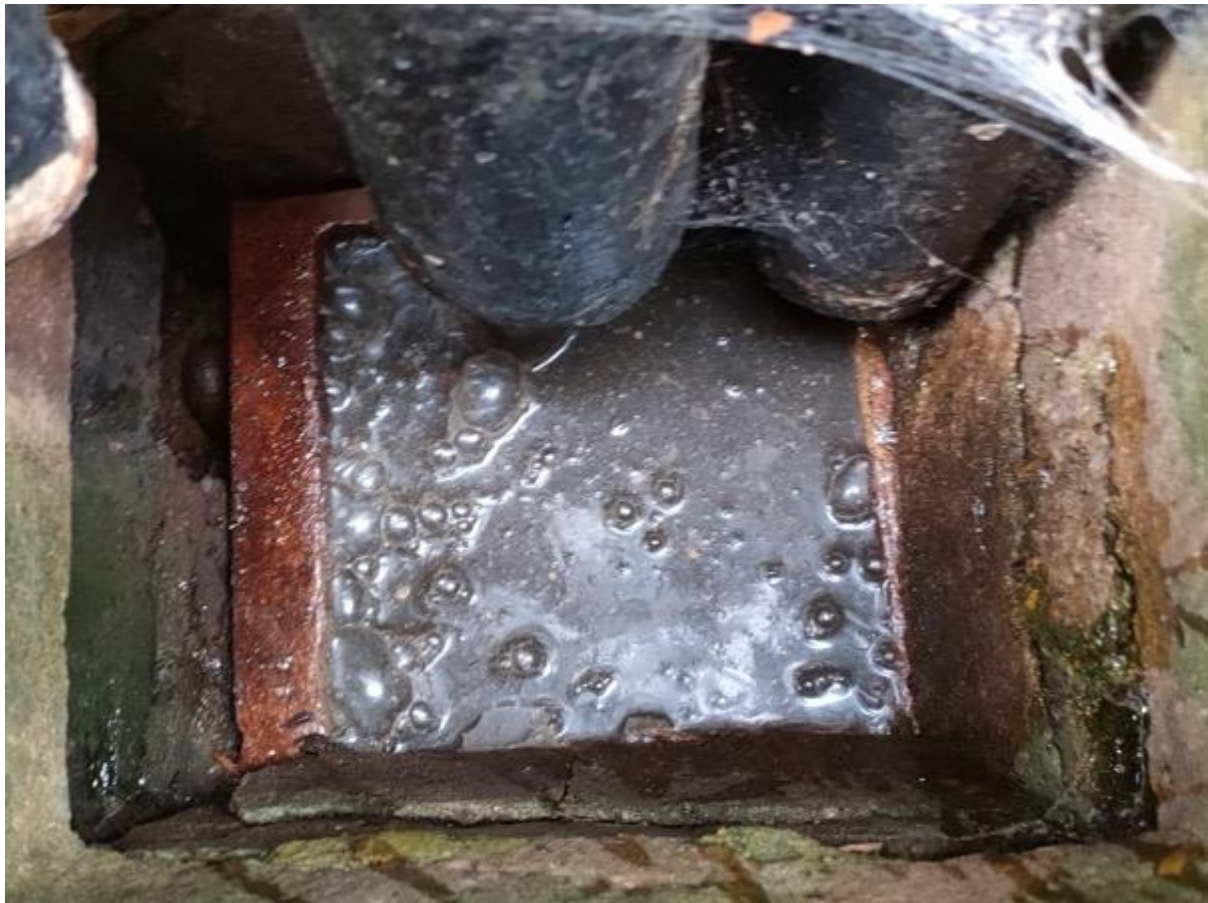
The kitchen drain was blocked. The gulley is cracked allowing the overflow to pour into the sub-floor void.
I would have a CCTV drain survey of all waste and rainwater drains.

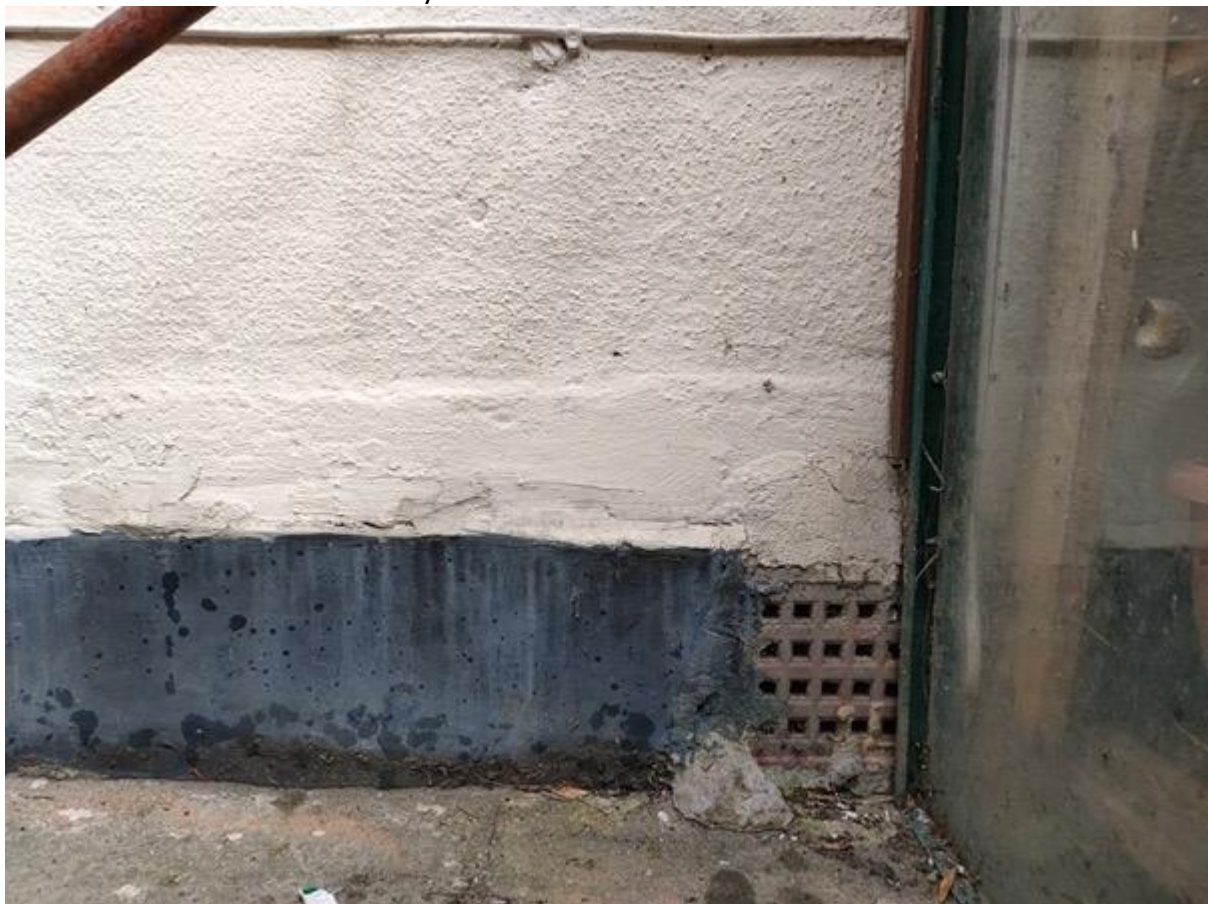
The back addition needs its own sub-floor ventilation in case moisture enters the sub-floor void.
The only airbrick to the back addition has been partially blocked, it should be opened up. Considering the kitchen has been out of use for a year, it is likely only limited water has entered the sub-floor void in that time. That it has dried and that the damp is mainly residual moisture.

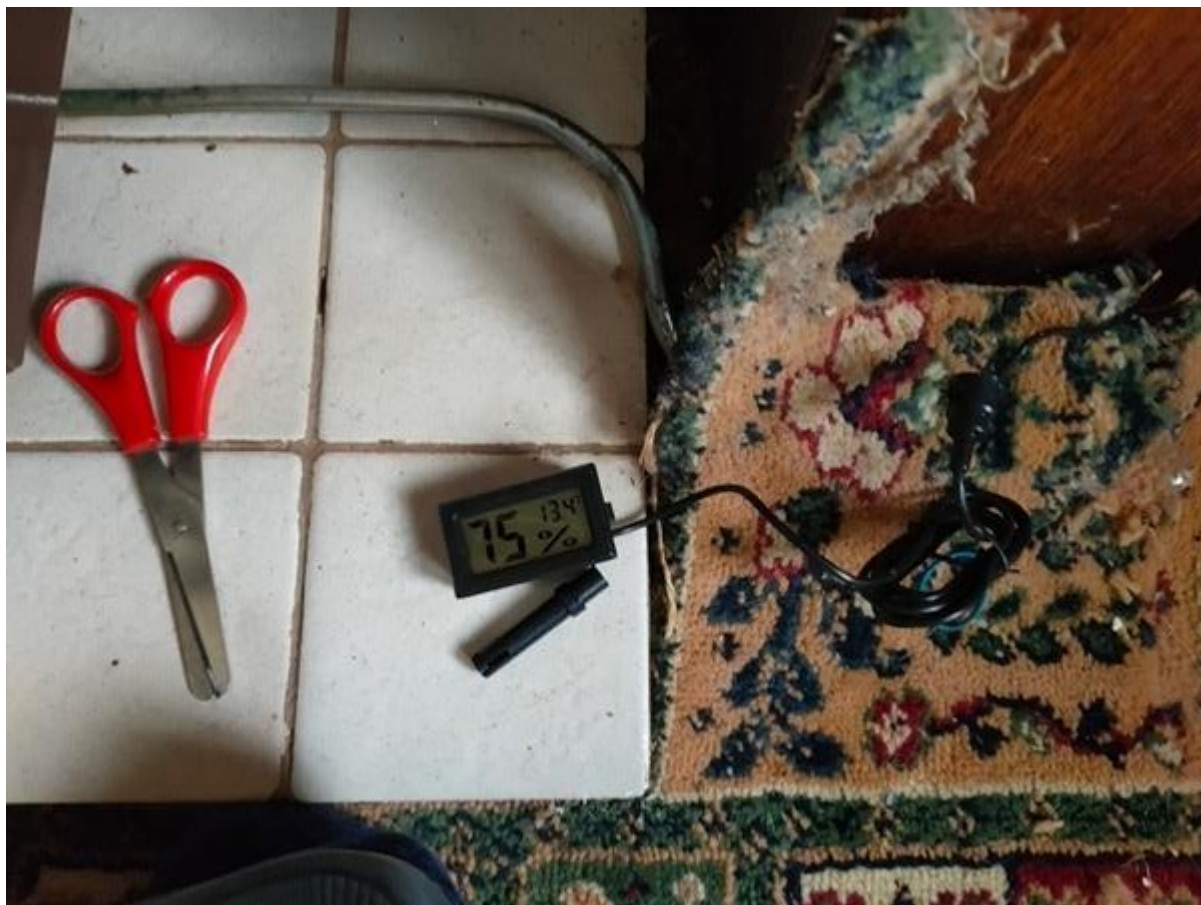
I pushed a hygrometer between floorboards. I am not sure it is sufficiently in the void to measure humidity.

The relative humidity in the sub-floor void should be below 75%RH. It can fluctuate when it is cold or raining outside. I suspect that moisture has entered the sub-floor void and that the limited sub-floor ventilation has resulted in condensation forming on the DPC, this can result in rising damp like symptoms. It can also result in rot, which given rot elsewhere, increases risk of rot in the sub-floor void. You should inspect under the timber floor.

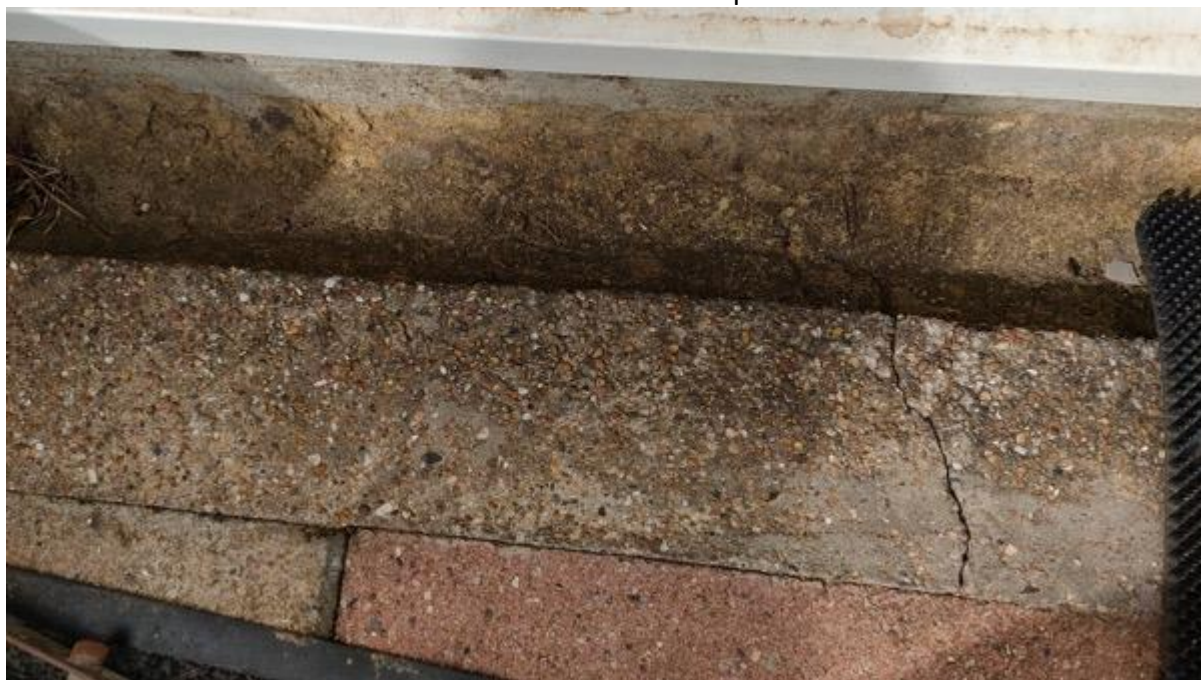
The rear doors have been replaced with double glazing. A sub-floor vent has been blocked. There is a crack.

The left-hand rear reception has double glazing and insufficient neighbouring kitchen. Double glazing reduces airflow from timber windows and the dehumidifying “benefit” of single glazing. While the house has been unoccupied for a year, the penetrating damp from render cracks, heat loss from cold walls and minimal ventilation would almost certainly have compounded dampness through condensation. This is likely to be added to from ingress into the poorly ventilated sub-floor from the blocked drain.

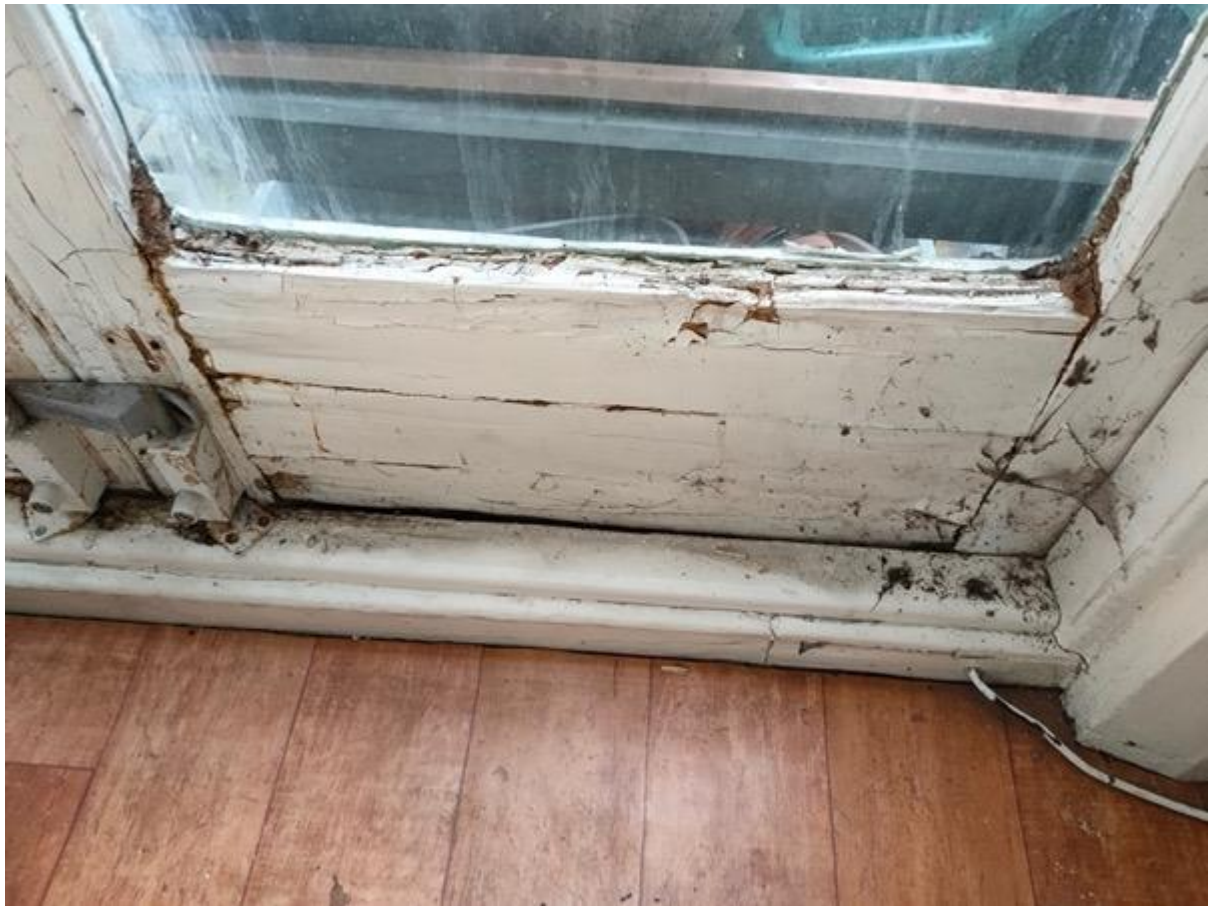
A common problem with single glazed windows is condensation dribbling onto timber causing rot.

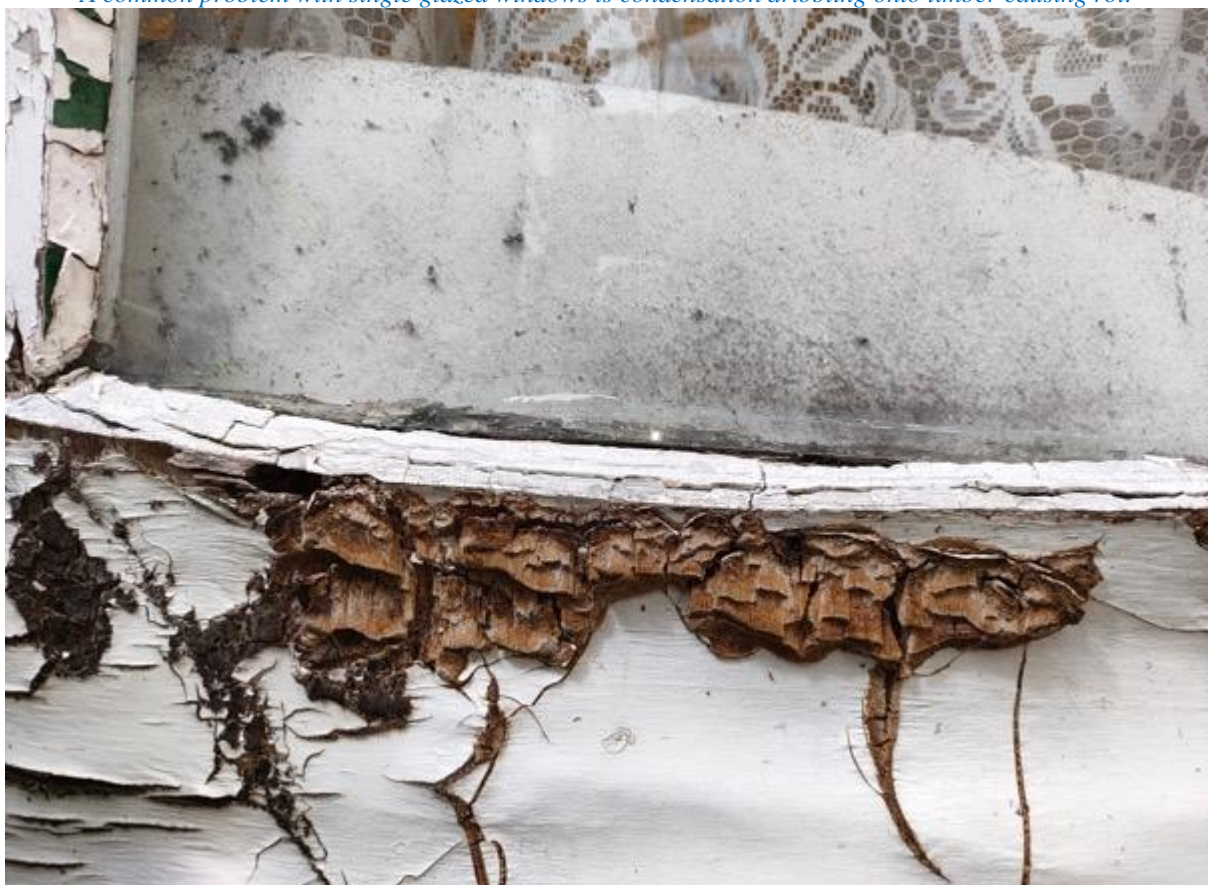
The fruiting body of window rot is exceptionally rare, especially such as large example.

The fruiting body looks like *Phellinus contiguus* or window rot. Window rot is very common in old properties. It is difficult to know if timber started rotting inside or outside. Window rot is normally isolated to timber windows and door frames. It is good practice to check for rot in nearby timber including the sub-floor void. Look for cracked timber.

Replace the rotten reception doors, ensuring that all rot is removed, check in the sub-floor below the door.	£1,000
TIP: speed wall drying further. Depending on external temperature, either keep windows open, or close windows, put heat on if required to around 16°C and considering using a dehumidifier - see below.	£50
TIP: monitor dampness with simple damp meter, logging at the same time and position every week.	£10
TIP: monitor relative humidity and temperature against wall or ceiling, to see effects of improvements, such as ORIA Wireless Thermometer Hygrometer (20m (2 Packs)) - see surveyor.tips/datalogger - already in place	£20
TIP: cook with tops on pots and pans to reduce production of vapour from cooking by 80%.	
TIP: keep at least a small amount of heat late at night, when it is cold outside. Reduce clutter around external walls vulnerable to condensation to increase airflow.	
TIP: dry clothes outside or in vented room with door closed (which could a bathroom with the extractor running).

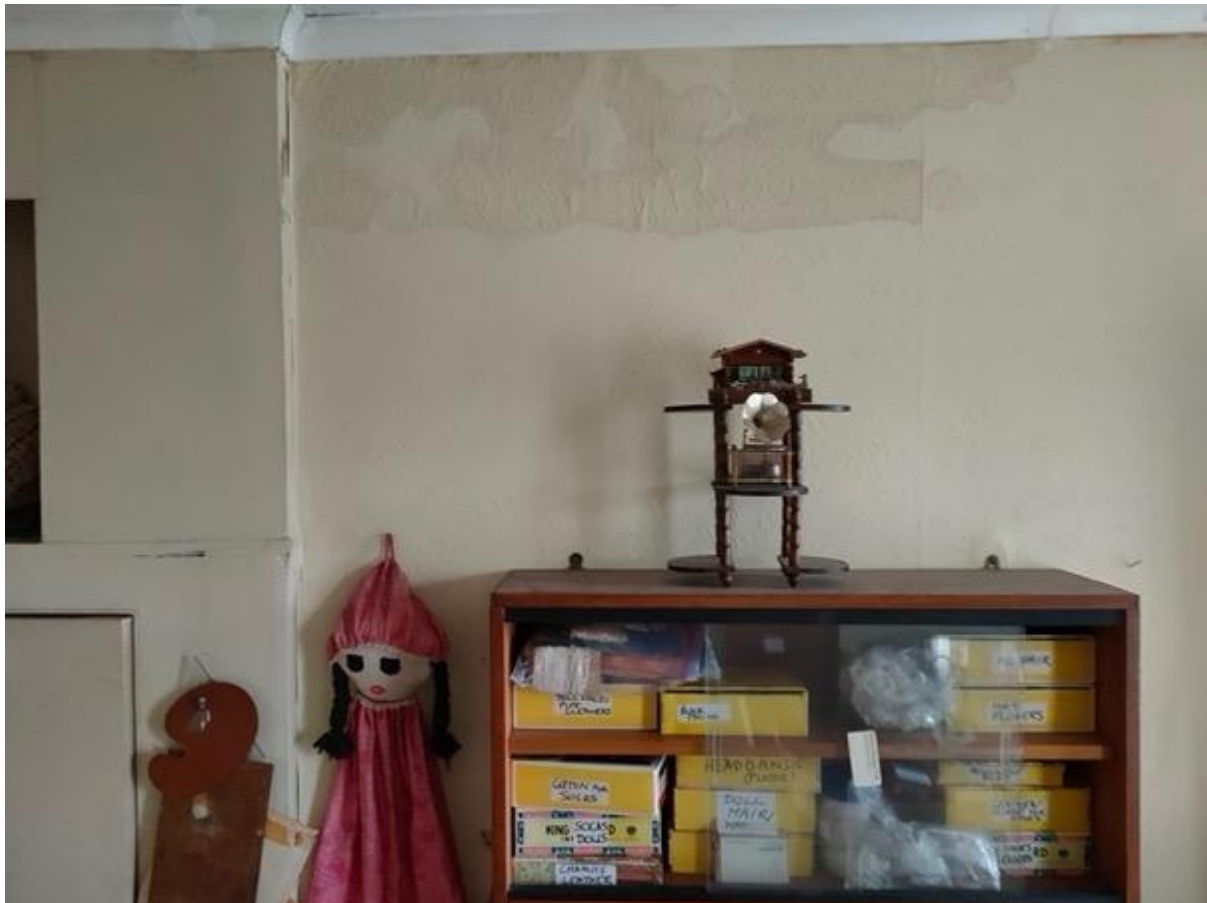
Dampness was first seen on the back addition first floor chimney, after a recent, heaving winter storm.
The wall has remained damp since the storm, despite no further heavy storms.
A wall takes around 1 month per 25mm to dry. So, the fact that it is still damp does not mean there is an ongoing source of damp. However, there is a risk of hygroscopic salts being released by water, see later.

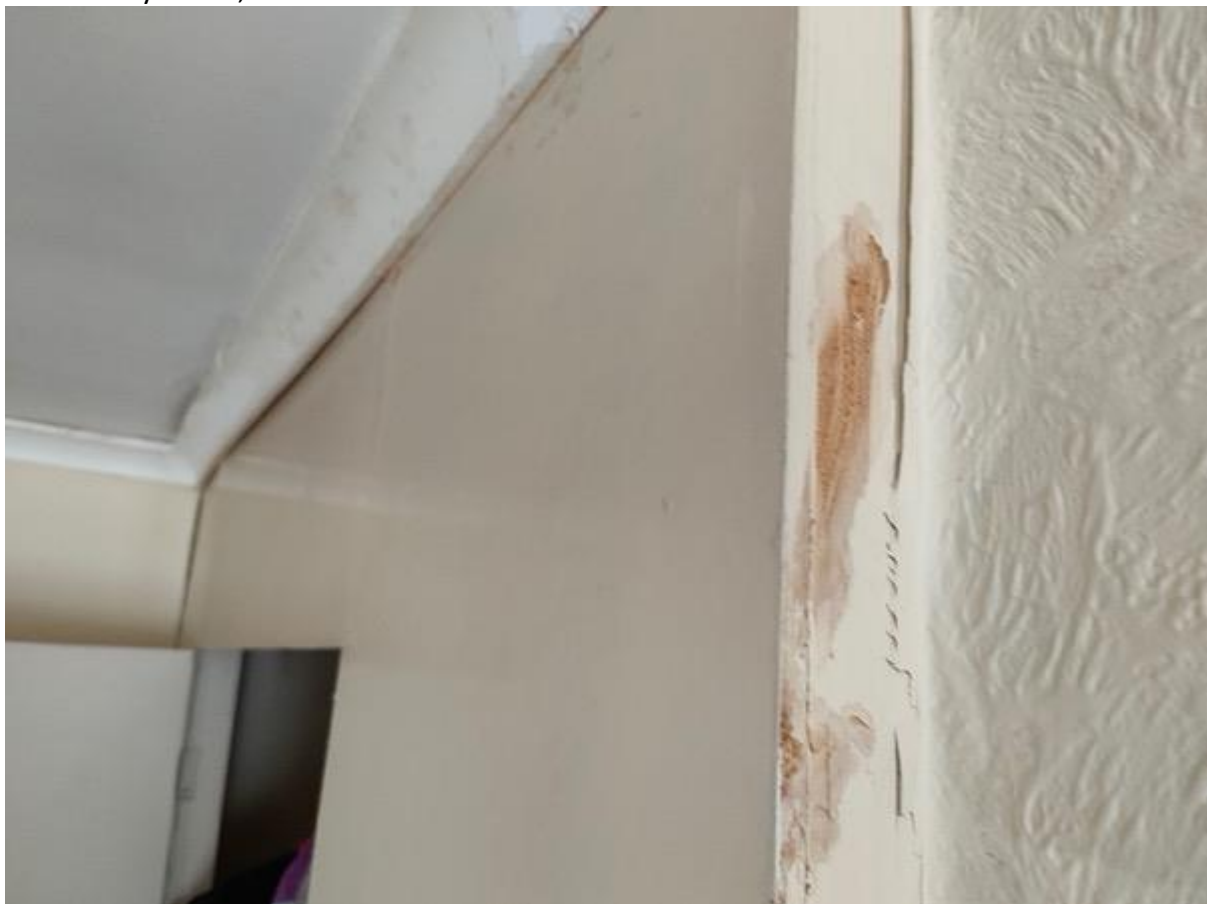
There are brown stains suggesting water has passed through building material.

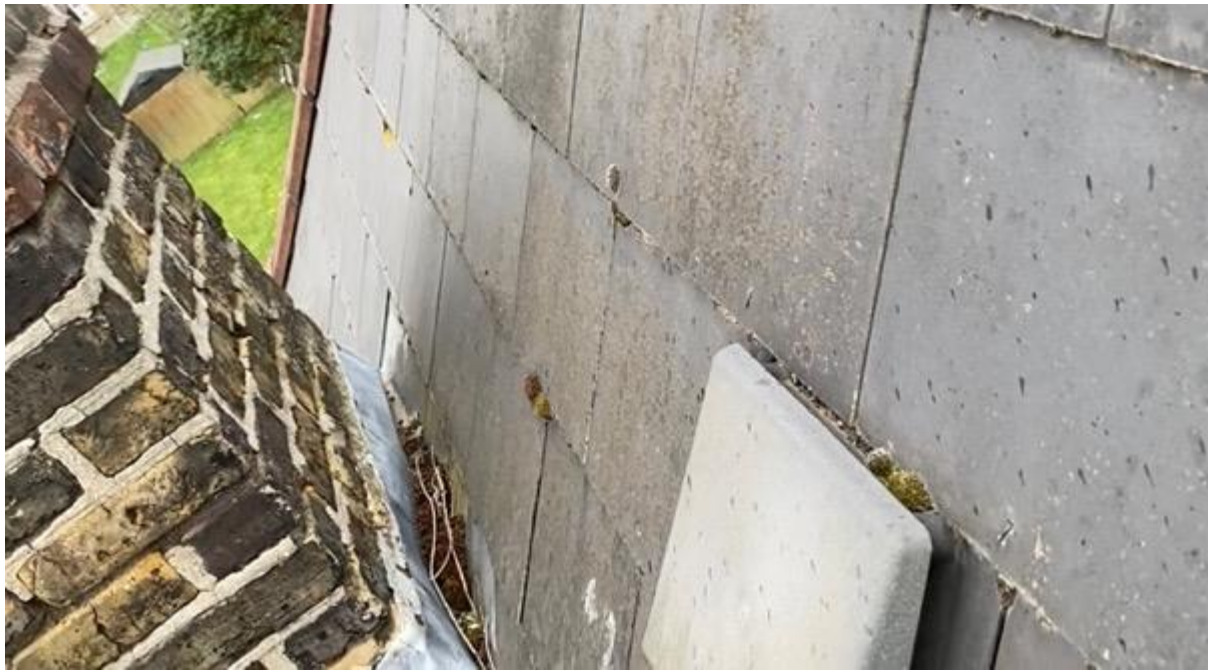
The flashing above looks short, about 1 brick up the chimney stack. Moss suggests water is pooling.

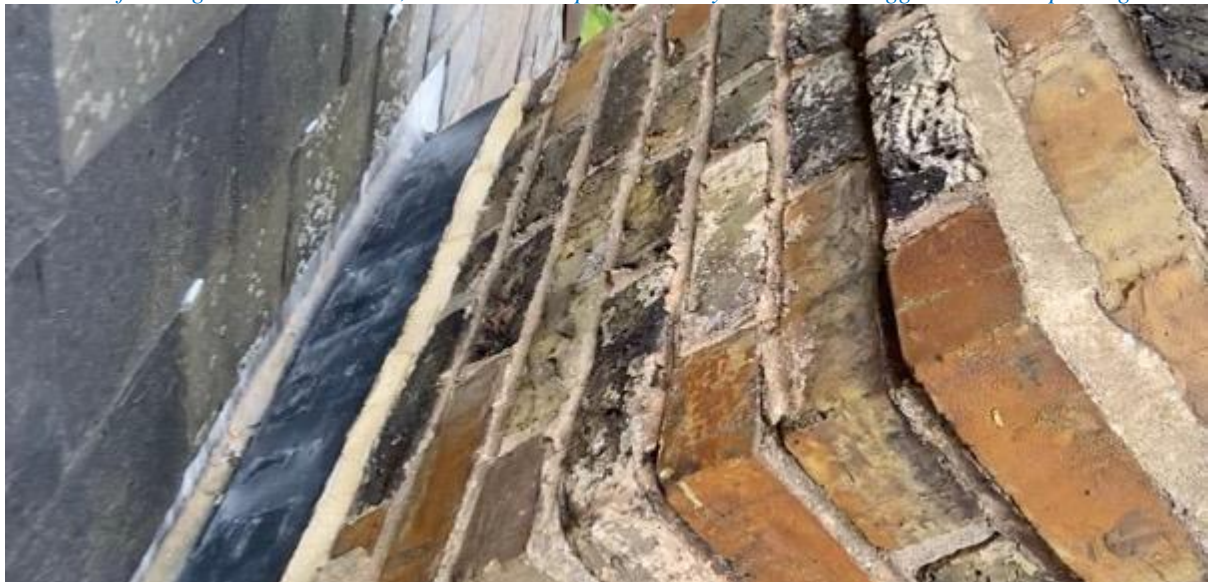
Looking at the neighbours equivalent flashing, it is higher about 2 bricks, with no signs of moss.

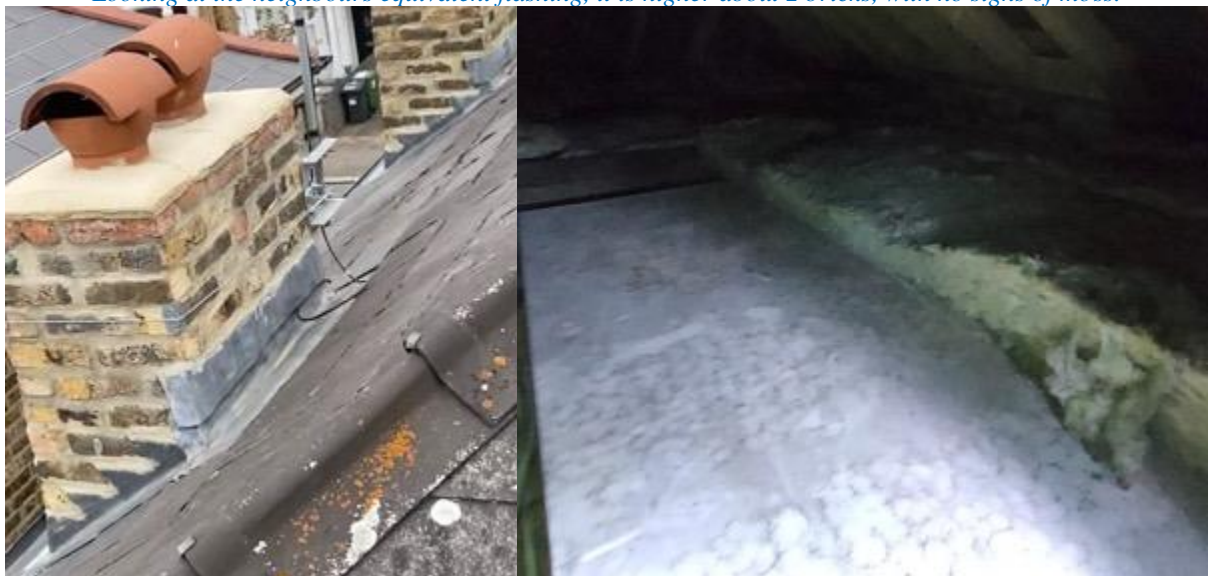
At my next survey, there was improved flashing, flaunching and cowls, but damp continued via condensation. The cause of dampness at this property was more evident, because marks were left by condensation dripping off the heavy bitumen sarking material onto a white piece of timber. And there was no ventilation. Many clients come to me after spending thousands on replacing roofs, or other forms of damp proofing only to find the root cause is condensation.

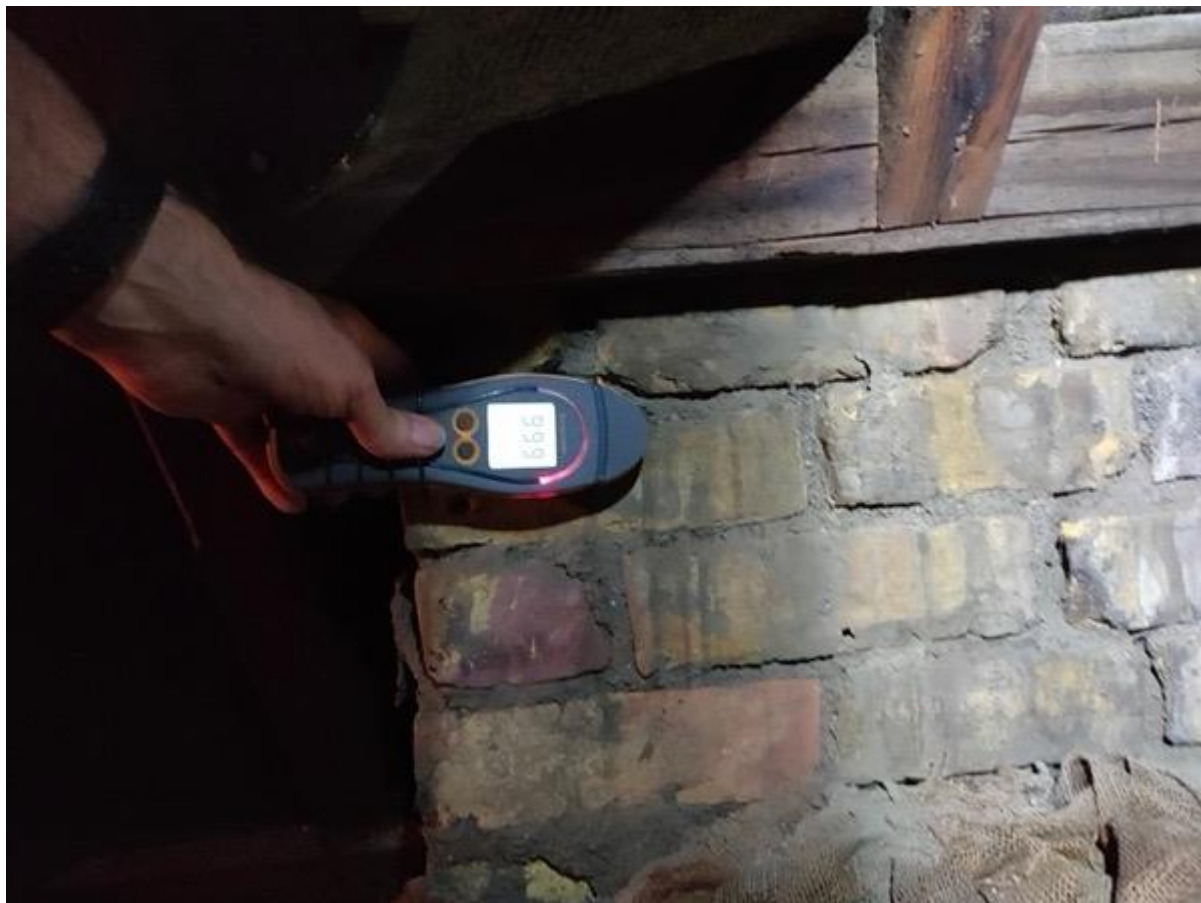
The chimney breast immediately above your back addition is damp.

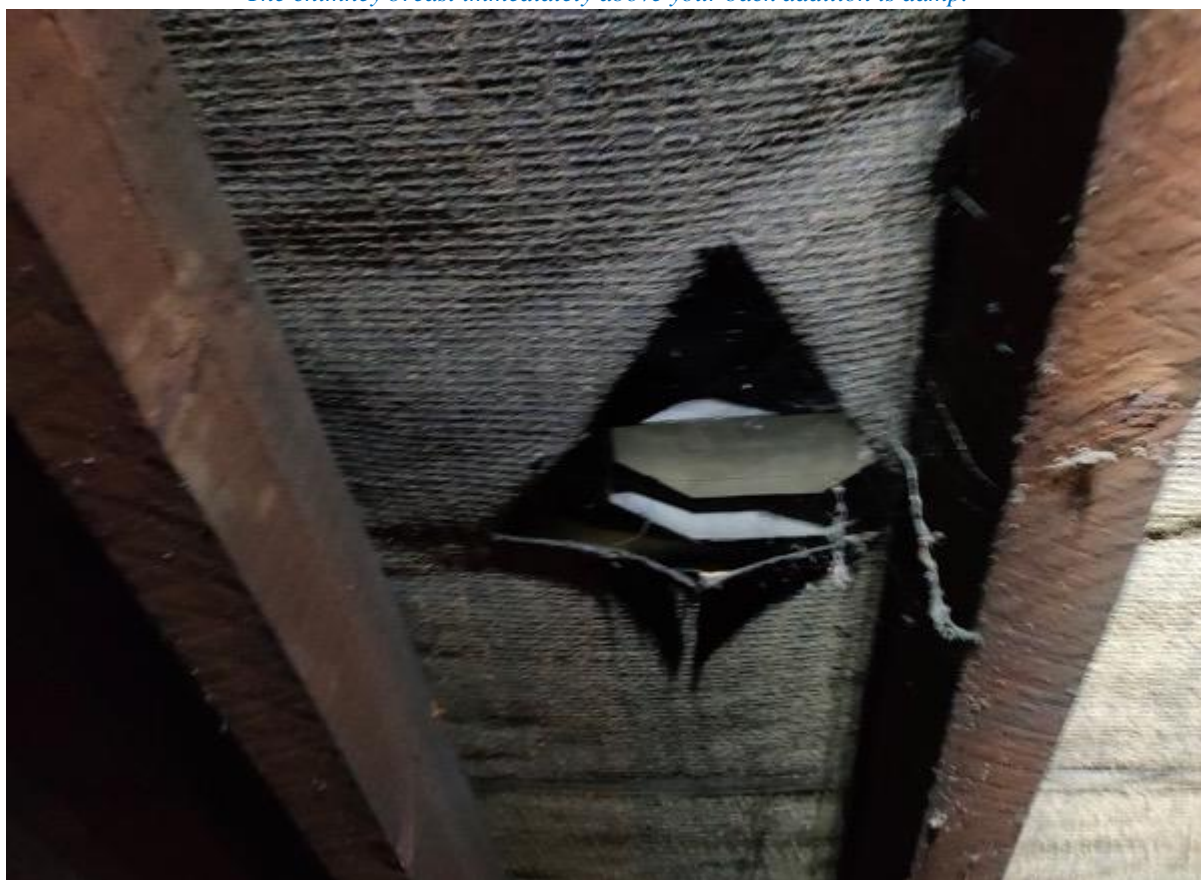
The roof has heavy 1960's style bitumen based sarking material, to reduce the risk rain bypassing cracked tiles. Sarking material reduces airflow, they are at risk of condensation forming. Ventilation reduces the risk but is the ventilation working effectively. There is a water tank in the loft increasing the risk of condensation on the sarking material. Although water appeared on the wall soon after a storm, it does not necessarily mean that the roof leaked. The colour and profile of damp is the same as caused by interstitial condensation (condensation within building material).

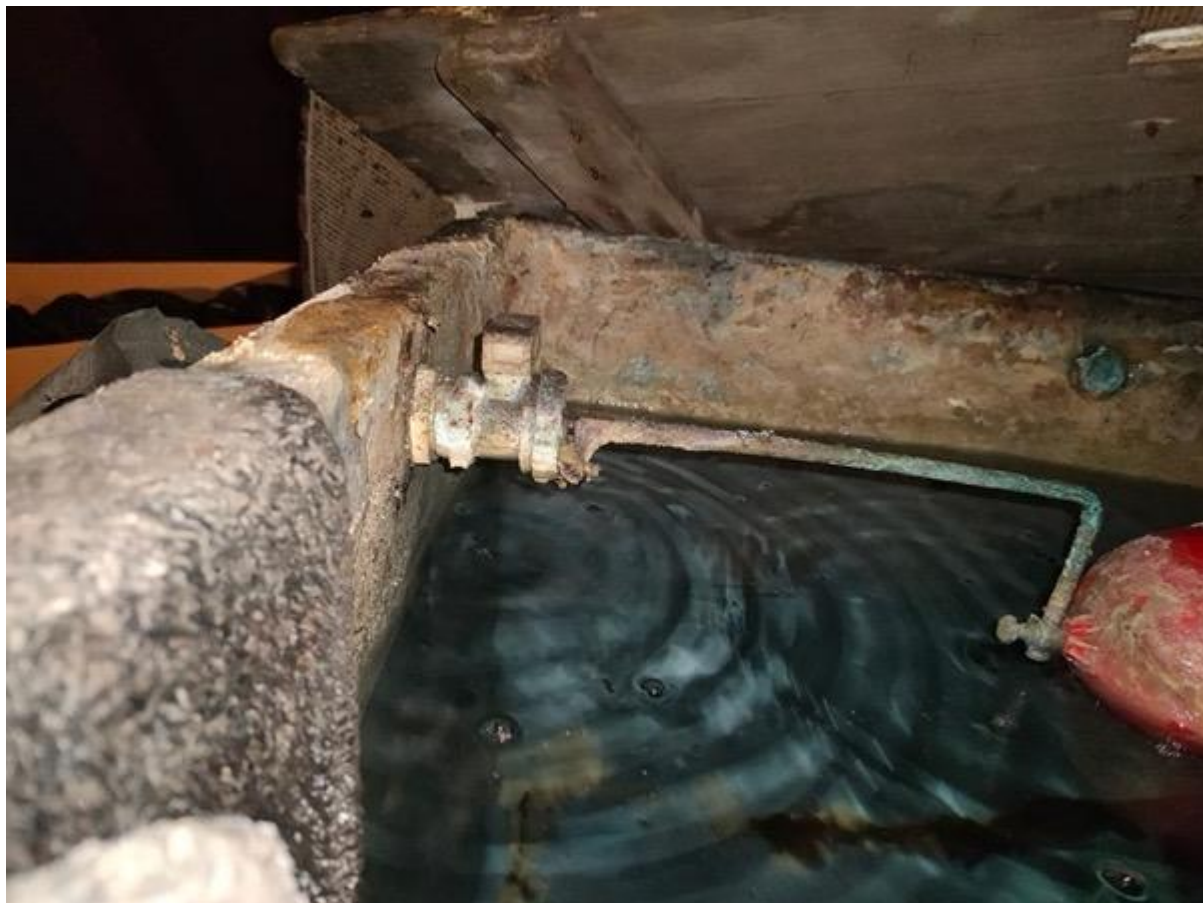
The stopcock on the water tank in the loft was defective, causing continuous flow of water.

It is rare to find properties in London with water tanks still. They are a relic of less reliable mainswater in the past. The issues with tanks are: 1) condensation in the loft, 2) potential leak such as through the overflow pipe (although I saw no evidence) 3) legionnaires disease. I would connect all water directly to the mains, remove the water tank and old header tank for the heating system, from the property.

I would decommission and remove the water tanks and increase loft insulation £1,000 considerably, making sure that it is even and pushed deep into the eaves.	£1,000
While it is possible that the lead flashing is causing ingress, it is just as likely that the water in the upstairs chimney breast results from interstitial condensation, so if you are doing some roof work and or have scaffolding consider replacing the lead flashing around the rear chimney stack and add cowls. If not then removing the tank will reduce the risk of interstitial condensation. Check the vents in the loft (they appeared to be OK), by monitoring the humidity in the loft, such as with data loggers (mainly a winter issue).	£500
Optimal actions – estimate of optional costs	£4,675
