*Example property
London*

Part owner's damp report

12 April 2022

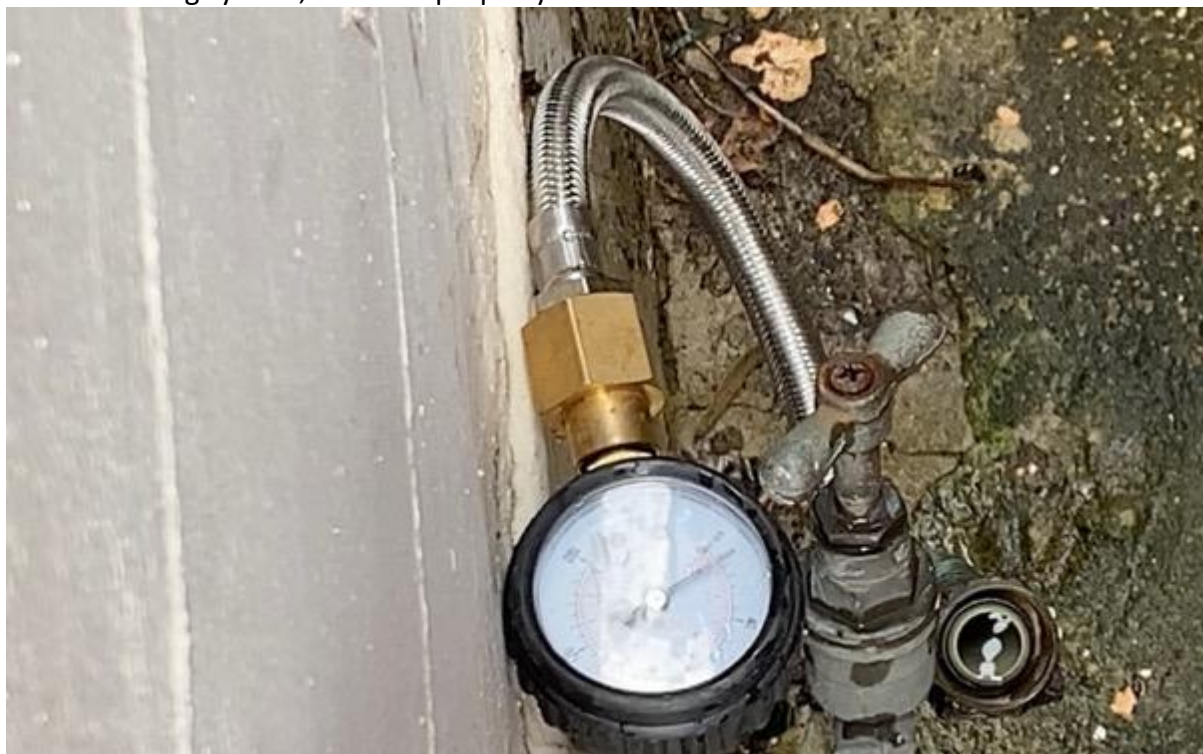
There was a loss of mainswater pressure. This was most likely to have been caused by the defective stopcock.

I could not get the stopcock on the tank in the loft to stop and therefore was unable to test for a mainswater leak. However, I think it is unlikely that you have mains leak as well as all the other issues.

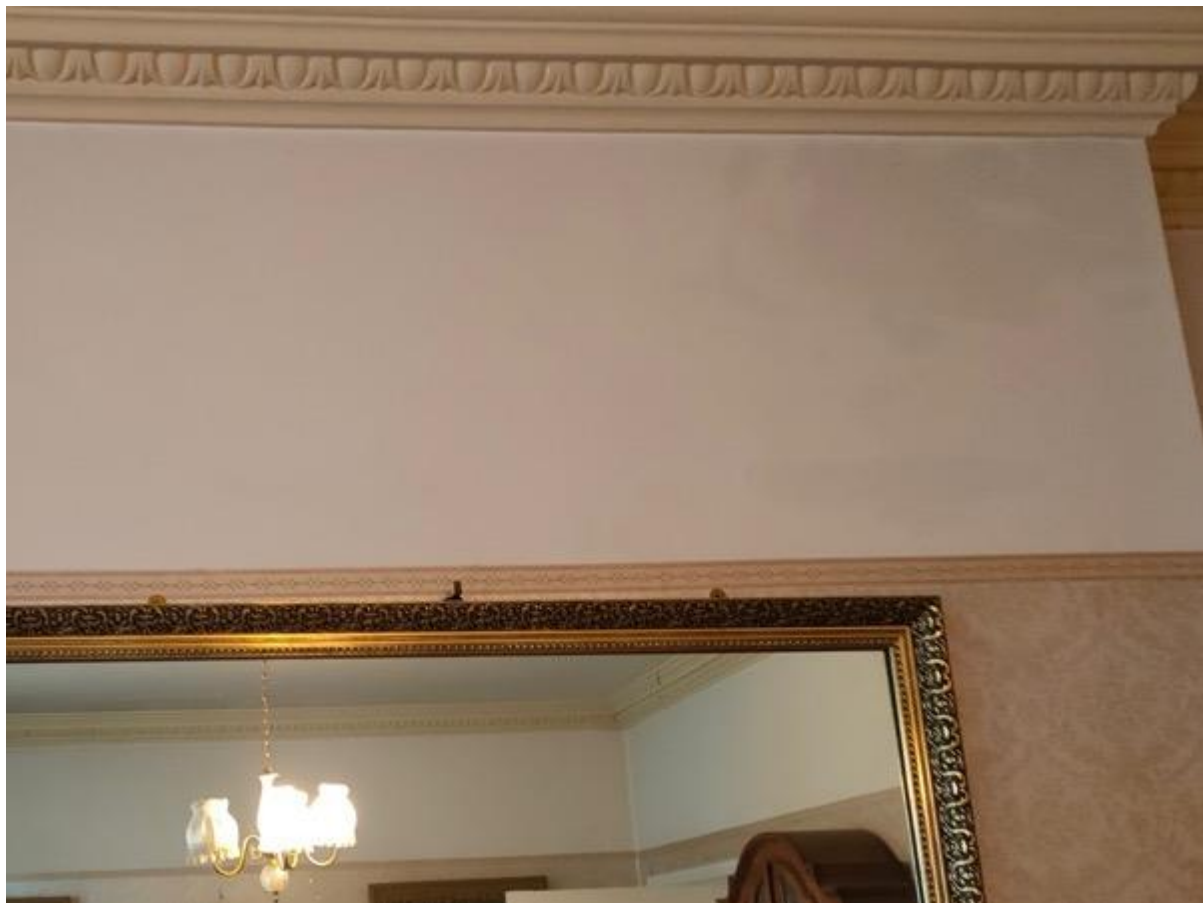
There is a darkened, but colourless patch on the left-hand side front chimney breast.

The patch did not look damp, but I suspect that internal soot, such as from candles or smoke or has been trapped by damp from hygroscopic salts, marginally more than elsewhere.

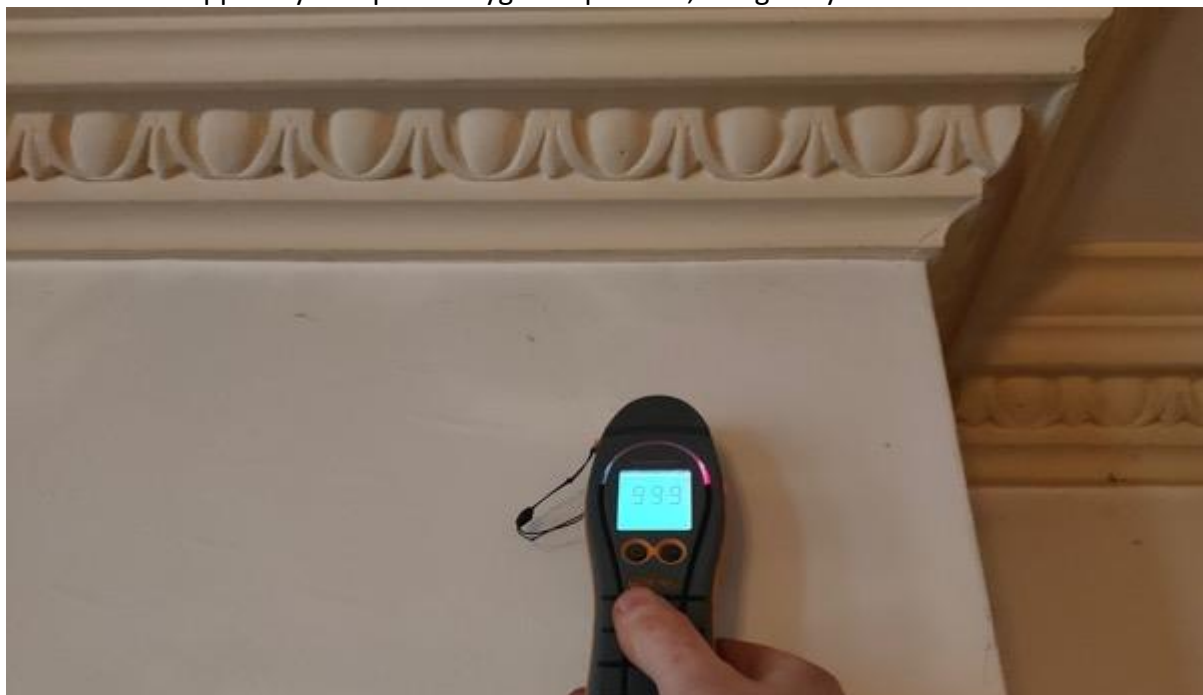
The wall is damp deep within it.

The combination of colour profile and location suggests that you have hygroscopic salts embedded in the chimney breast. Hygroscopic salts hold moisture in dynamic equilibrium, i.e. there is no flow of water. They cannot cause rot, mould, woodworm or other damage. Calcium nitrate is the most common form of hygroscopic salt in residential properties. They are often found on chimney breasts and cause deliquescence, a form of condensation, at normal levels of relative humidity, above about 50%RH, see surveyor.tips/hygroscopic. The simplest, cheapest, best solution is an oil-based primer-sealer such as two coats of Zinsser Cover Stain BIN, applied as a spray or paint with an overlap area of at least 300mm.

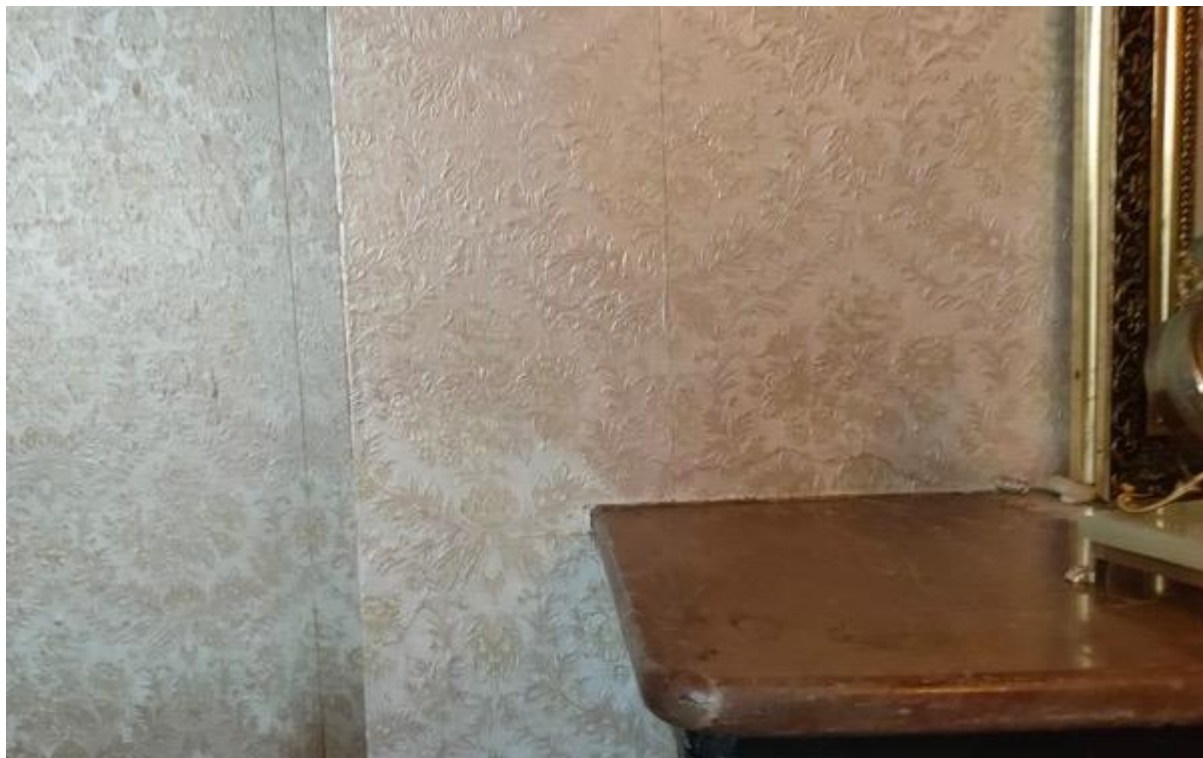
These salts are often associated with colour difference such as in the wallpaper to the left of the chimney breast.

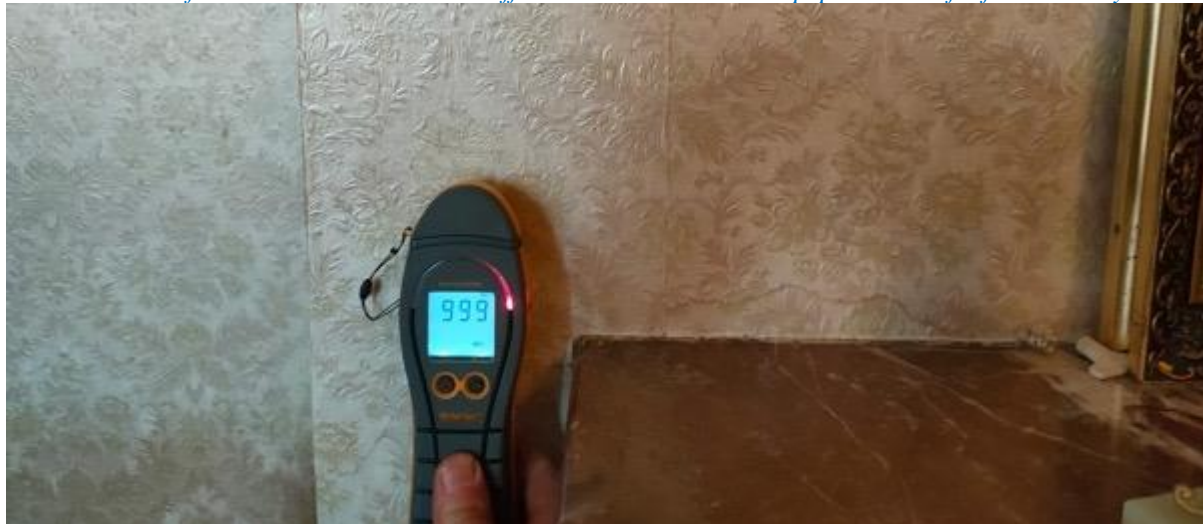
Often furniture causes the wall to evaporate unevenly. The wall is damp above the chimney breast, yet ...

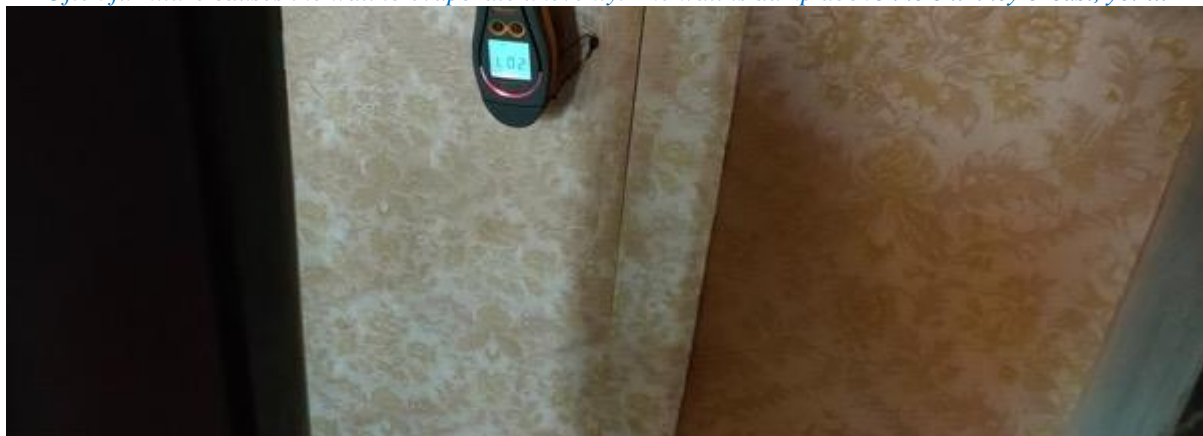
... dry below it. Indeed, the base of all walls were largely dry, which they would not be if there was rising damp. Rising damp comes from groundwater, the water under the water table. As water passes through soil it picks up hygroscopic salts. The existence of hygroscopic salts on walls is the primary justification for the chemical damp proofing industry costing UK homeowners about £½ Billion p.a. However, hygroscopic salts also come from wood and coal (and equine urine). The movement of hygroscopic salts in walls has never been studied scientifically, according to the PCA, nor has rising damp been independently studied or replicated in the laboratory. The “risk” increases with increased damp and chimney removal.

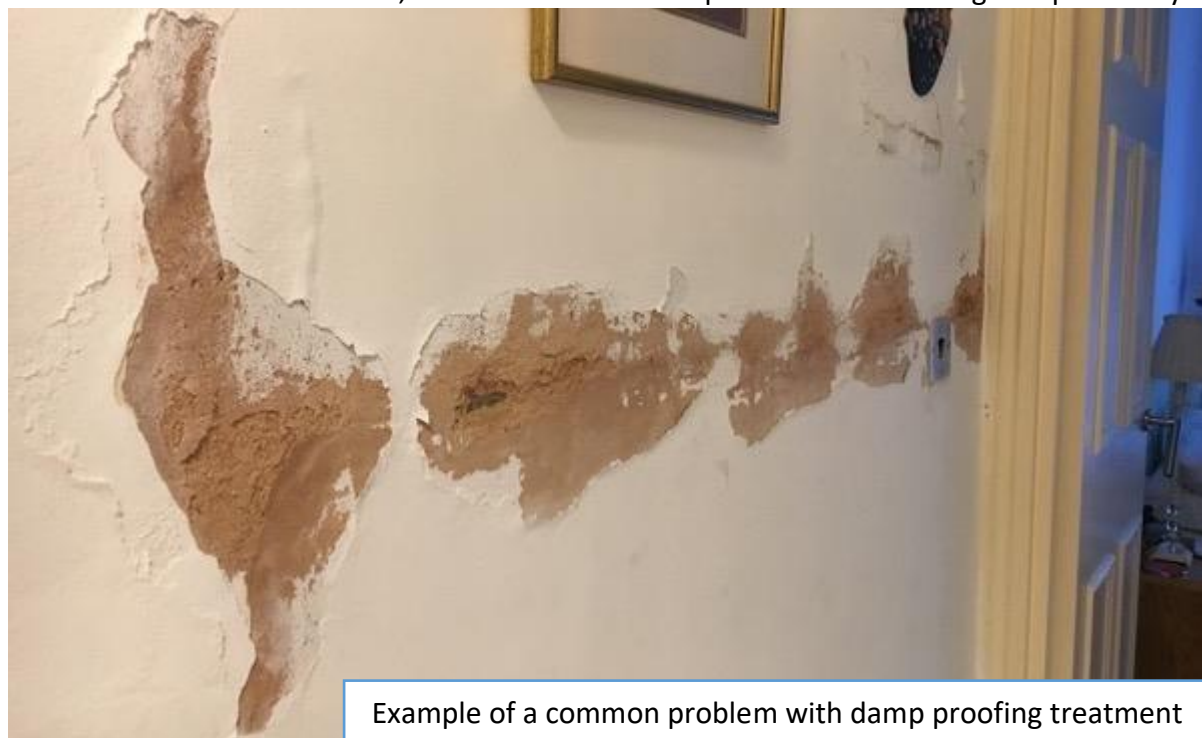
Example of a common problem with damp proofing treatment

Replacing absorbent plaster with impermeable "slurry" will itself need replacement unless the cause is solved. If as is commonly the case, condensation is the root cause, excess humidity can become trapped at the interface between the original permeable plaster and impermeable slurry. The damage here results from 2 damp proofing treatments from London's "leading" chemical damp proofer. The work was not covered under guarantee, instead an additional £16,000 was quoted to repair it. The root cause was an easily repaired bathroom extractor.

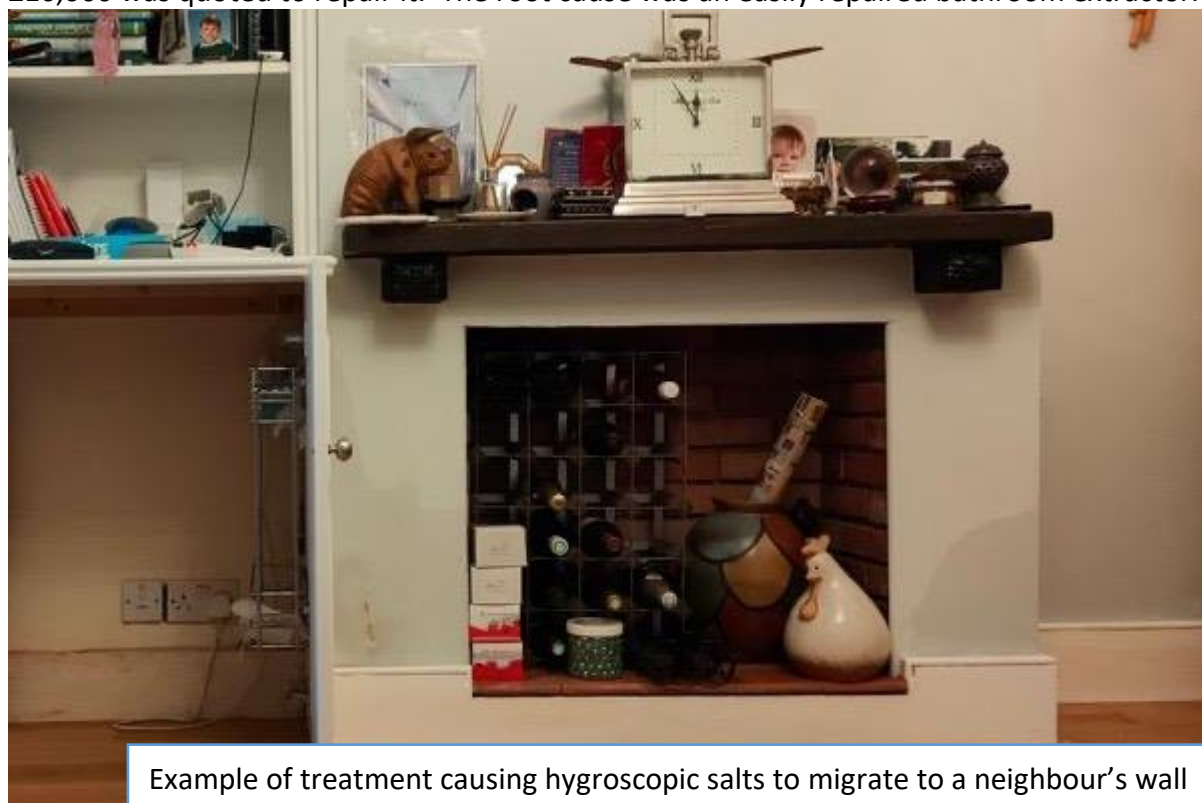
Example of treatment causing hygroscopic salts to migrate to a neighbour's wall

Hygroscopic salts are visibly along this party wall. The wall was dry until the neighbour had damp proofing. Damp proofing treatment falls under the Party Wall etc. Act 1996. Agreements need to be entered into with neighbours. Is it worth the risk of damaging walls, when there is no likelihood or convincing evidence of rising damp?

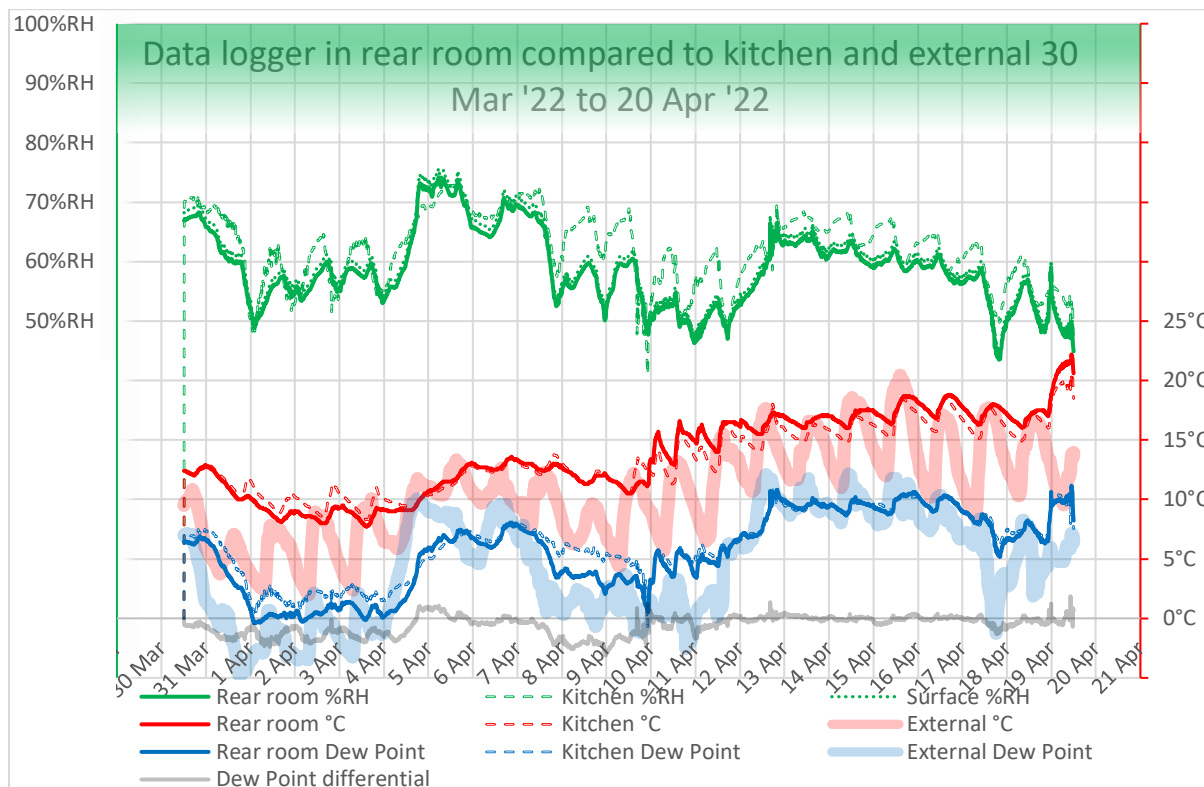
This graph comes from the data from your data loggers.

1. During the period under investigation the surface relative humidity on the damp wall (green dotted line at the top of the graph) is never above the mould point (85%RH), when mould is at risk and at or close to the dew point when condensation starts.

4. The grey line in the graph is called the dew point differential. The line shows that no vapour is being generated.
5. The external data is useful for understanding heat loss on a poorly insulated wall and potential for reducing vapour when replacing humid internal air with external air. Comparing internal to external dew points, shows very little vapour is generated in, or passing into the house (it has been dry, but residual damp should also show).
