USB332x Family Silicon Errata and Data Sheet Clarification

This document describes known anomalies for all functional revisions of the USB332x device.

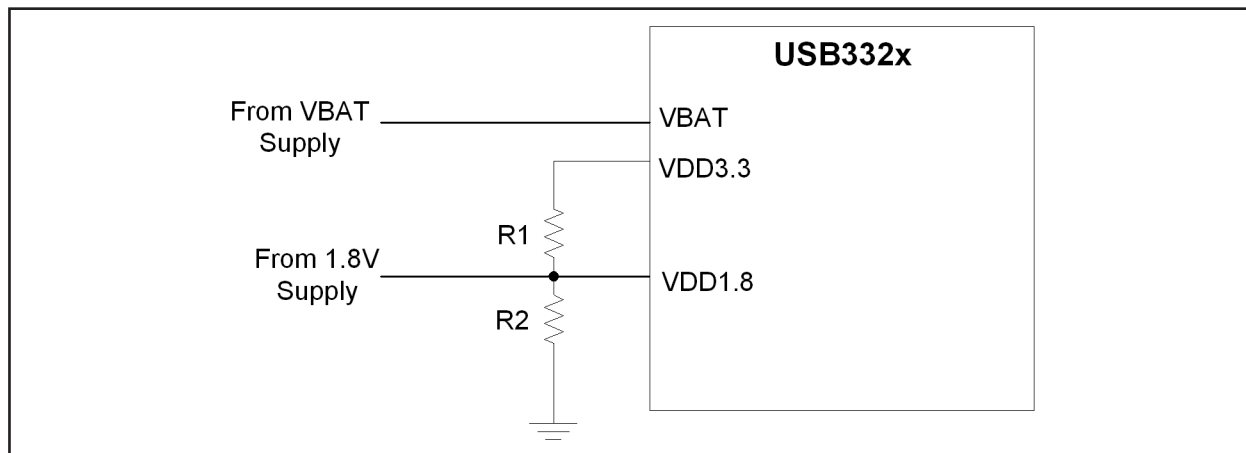
FIGURE 1: RESISTOR DIVIDER CIRCUIT

The VBAT (VDD3.3) pin may draw up to 1.3mA of current from the VBAT source when all of the following conditions apply:

1. The VDD1.8 supply is removed.
2. The VBAT supply is ON.

In this mode the VBAT (VDD3.3) pin should draw $\leq 25 \mu\text{A}$.

Removing supply voltage from both VBAT and VDD1.8 produces a leakage current of 0 μ A. If the customer elects to leave VBAT on while VDD1.8V is off, the USB332x may exhibit increased current draw (>25 μ A) from the VBAT (VDD3.3) supply when in Suspend Mode. USB functionality is not affected

- Leave the VDD1.8 supply ON whenever voltage is applied to VBAT. Standby current will be $\leq 25 \mu$ A.
- Supply voltage on VBAT from a PMIC and switch it off whenever VDD1.8 is switched off. Standby current will be 0 μ A.
- Add a LDO regulator with enable between VBAT and the battery which can be switched off whenever VDD1.8 is switched off. Standby current will be 0 μ A.
- Add a resistor divider between VDD3.3 and VDD1.8 supplies, as shown in [Figure 1](#):

R1 = 210 k Ω 1%

R2 = 309 k Ω 1%

Note: If there are other devices attached to the 1.8V on the customer platform, those device impedances need to be taken into account.

Standby current will be $\leq 30 \mu$ A.
