KSZ9897R Silicon Errata and Data Sheet Clarification

This document describes known silicon errata for functional revisions A1 of the KSZ9897R. The silicon errata discussed in this document are for silicon revisions as listed in [Table 1](#). The silicon revision can be determined by the device's top marking. A summary of KSZ9897R silicon errata is provided in [Table 2](#).

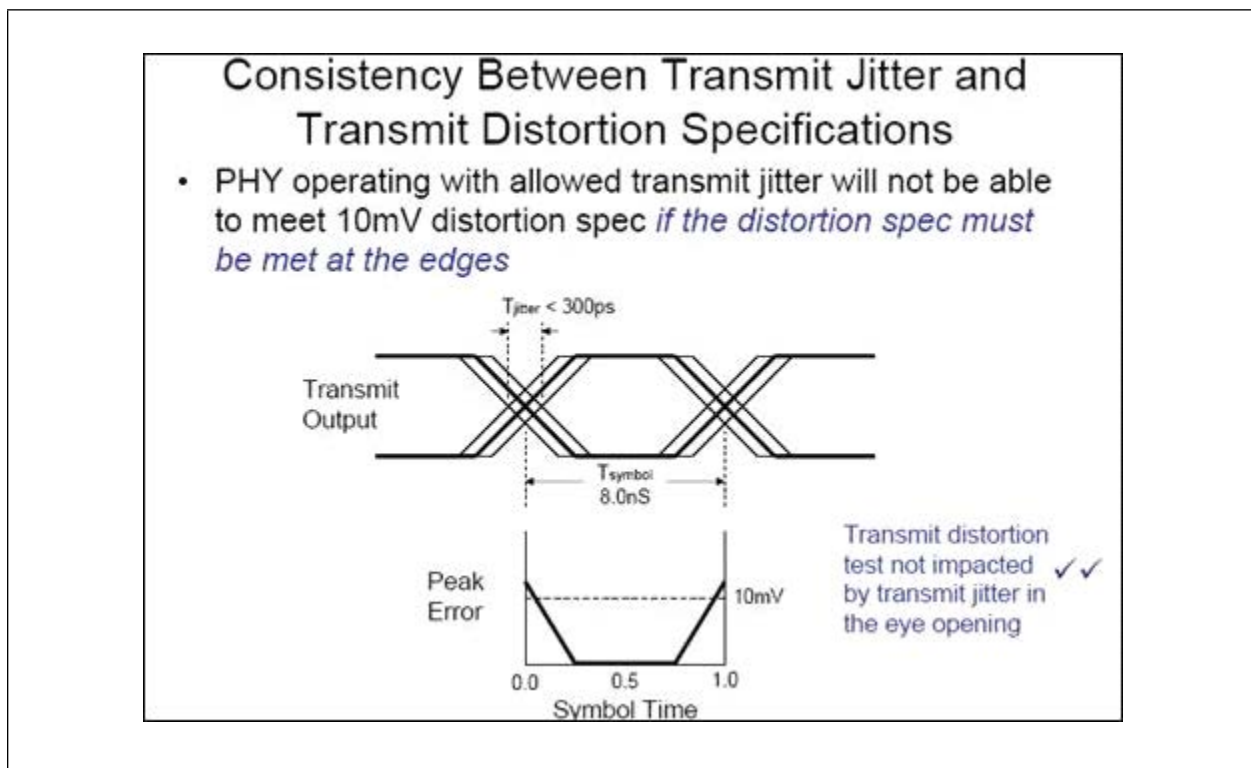
FIGURE 1: IEEE DOCUMENT PAGE 6

The device's 1000BASE-T Transmitter Distortion is approximately 40mV, versus the <10mV indicated in the IEEE specification.

IEEE testing calls for <10mV peak transmitter distortion for at least 60% of the UI within the eye opening. However, this measurement might not be valid, as the transmit distortion test is sensitive to transmit jitter. Refer to the explanation below, taken from the aforementioned IEEE document.

- On page 6, a contradiction between Transmit Jitter and Transmit Distortion requirements:
