HARDWARE PATCH for Zemmix Neo, SX-1, SM-X and related machines (update 2020.04.06)

2020.08.19 Hardware Patch for OCM machines “aka BUSDIR_n patch”

2020.10.16 Hardware patch for Zemmix Neo BR machines (aka +5V line stability fix)

2022.04.19 Hardware Patch for SM-X, SX-2 and related machines (aka PS/2 keyboard compatibility fix)

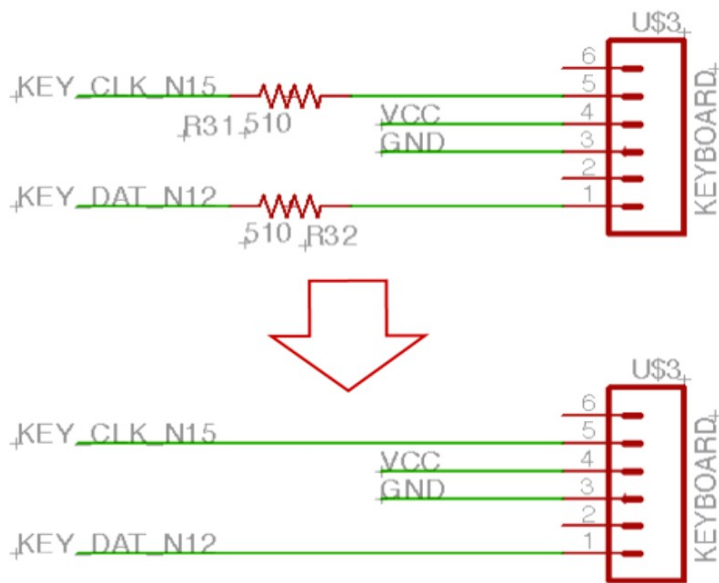
This is an optional fix. If your keyboard is NOT working properly you can apply this hardware patch or purchase another keyboard.

How to do it: short-circuit R31 and R32 like in this photo.
