# **RAPPORTO DI NON CONFORMITA' A FORNITORE** **SUPPLIER NON CONFORMITY REPORT**

RNC Supplier	001/25	Date	14/01/2025

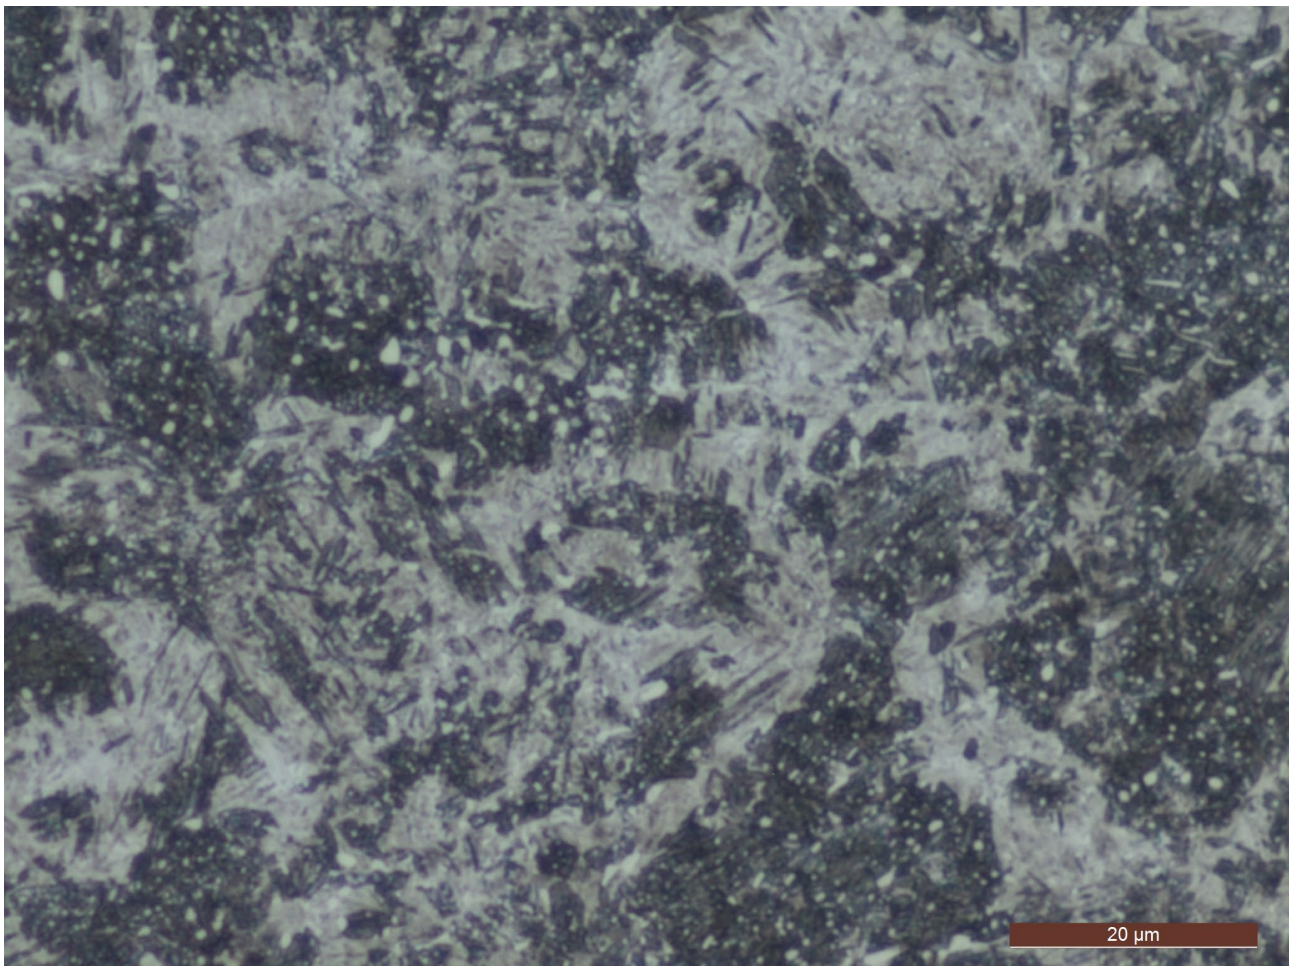
The cause, from our analysis, results that is the incorrect heat treatment execution. In the metallographic laboratory, we found, by analyzing a roller with low hardness, the presence of untransformed structures (dark spots with carbide concentrations, see attached picture).

The microstructure in these dark spots consists of Bainite and very fine Pearlite. This structure indicates insufficient temperature or time during austenitization phase before quenching.

Picture 1: Microstructure found with the analysis in our metallographic laboratory.
