Annual Maintenance Contract Report

Electrical Preventive Maintenance Service Report

LOCATION: OTP

AMC NO: AMC/2026/0001

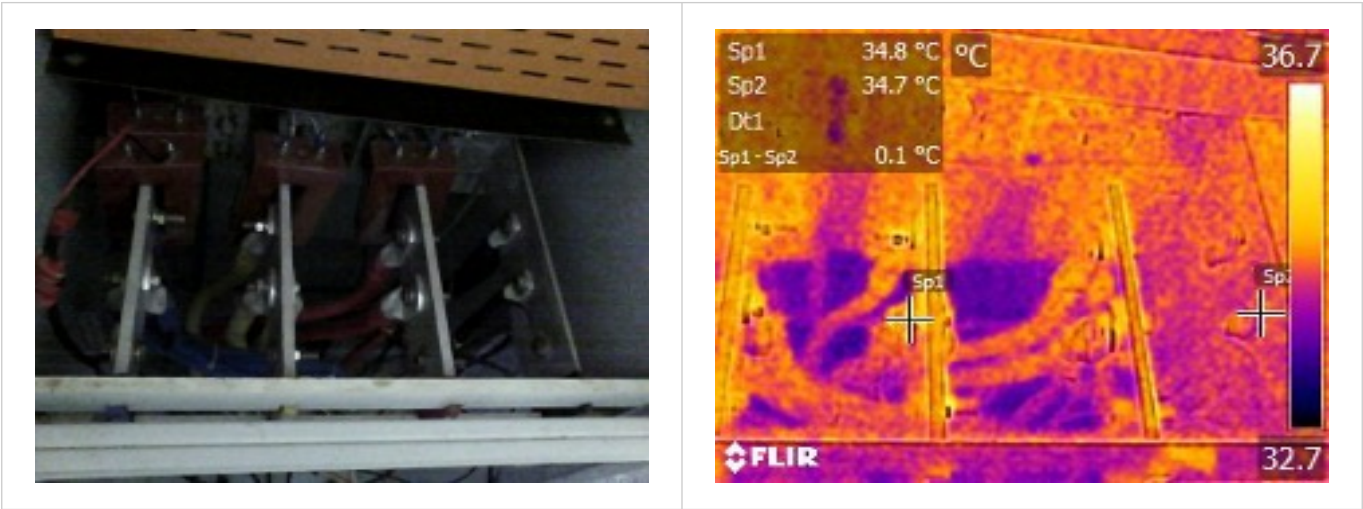
INSPECTION ITEM 1: hjhjbhbj - bkbkbk

LOCATION	bjhvhvjhv
PANEL	hjhjbhbj
FEEDER	bkbkbk
MAX TEMPERATURE	33.0°C
MIN TEMPERATURE	34.0°C
DELTA-T (ΔT)	-1.0°C
RISK CATEGORY	normal

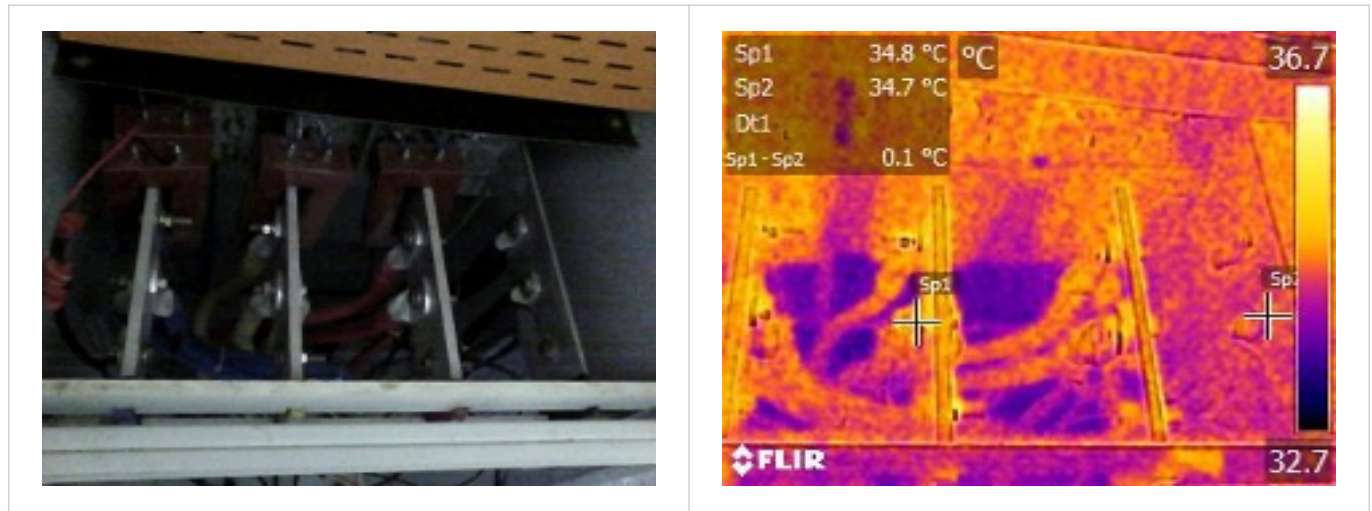
INSPECTION ITEM 2: bkkkbkjbj - jbkjbjbjk

LOCATION	kbeyfi
PANEL	bkkkbkjbj
FEEDER	jbkbjbjk
MAX TEMPERATURE	30.0°C
MIN TEMPERATURE	32.0°C
DELTA-T (ΔT)	-2.0°C
RISK CATEGORY	normal

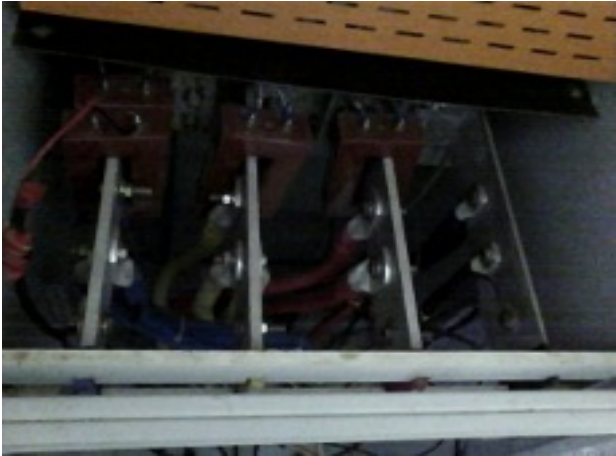
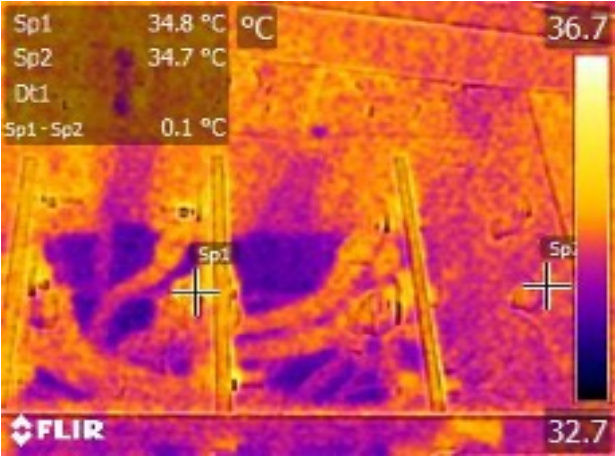
INSPECTION ITEM 3: bbkjbkj - bjkbkjb

LOCATION	iybvi
PANEL	bbkjbkj
FEEDER	bjkbkjb
MAX TEMPERATURE	40.0°C
MIN TEMPERATURE	29.0°C
DELTA-T (ΔT)	11.0°C
RISK CATEGORY	check_monitor

ANALYSED BY	
COMMENTS	vhvkj
SIGNATURE
