POST-THERMOGRAPHY INSPECTION REPORT

Client: Saama Technologies

Location: OTP

Report No: POST-TIR/2026/0001

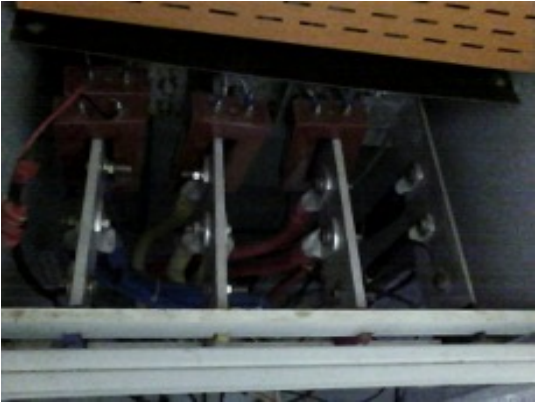
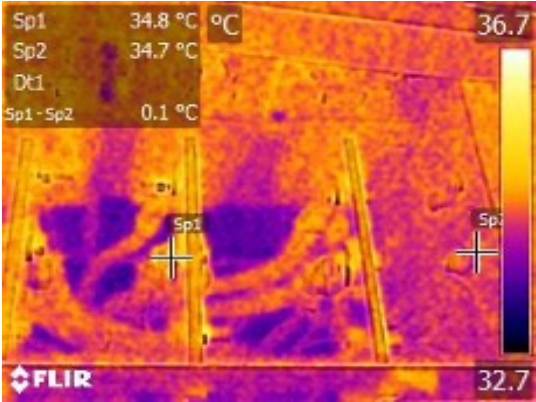
Location	iybvi
Panel	bbkjbkj
Feeder	bjkbkjb

Maximum Temperature (Ar 1): 40.0°C
Minimum Temperature (Ar 2): 29.0°C
Delta Value (ΔT): 11.0°C

Assessment: Based on the thermal analysis, this feeder has been assessed.
The Risk Category is Check & Monitor.
Recommended Action: Possible deficiency; warrants investigation
