MC3: INTERNALLY-DESIGNED EQUIPMENT/JIGS/PRODUCTS

DFL7000s Chiller Unit Water Turbidity Sensor

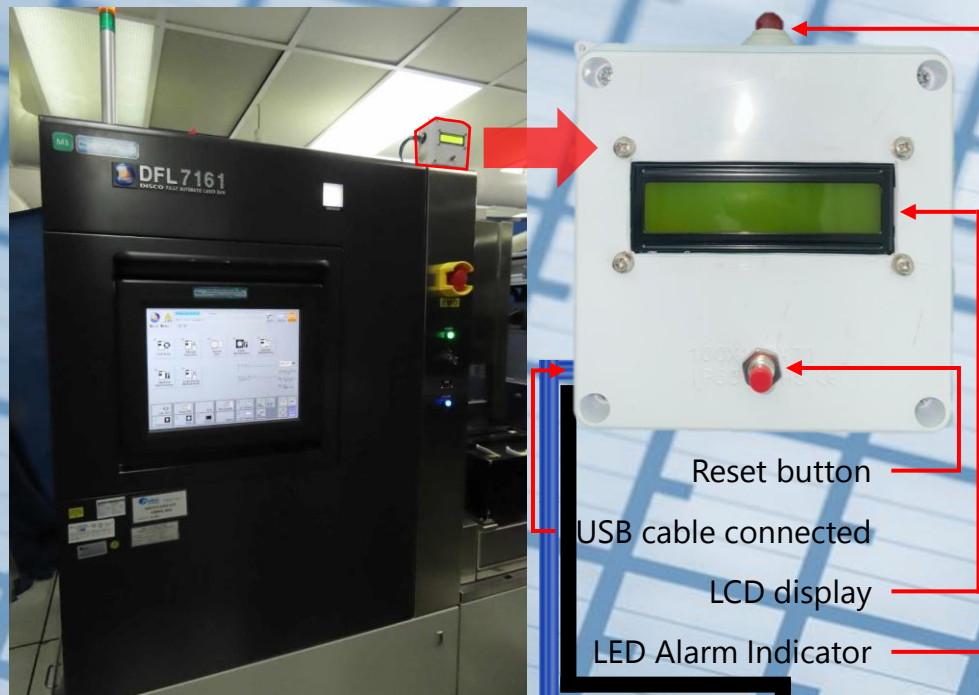
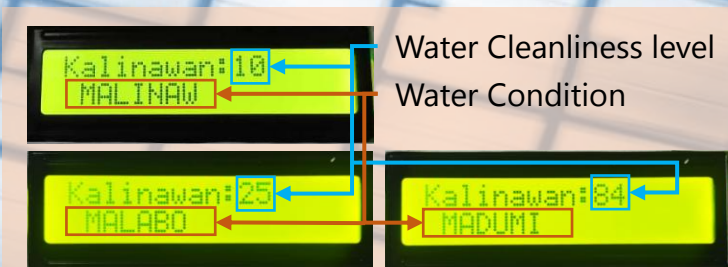
Found out that distilled water inside chiller unit is contaminated and clogged the flowmeter.

Also as per checking, frequency of water replacement of chiller unit is not followed every 3 months.

Dirty chiller unit water causes the following:

- Clogged fittings
- Stucked-up flow meter
- Flow restriction

Limitation on water flow causes:

- Temperature increase on laser head/X-axis
- Deterioration of laser head due to temperature change
- Damage on chiller unit
