# MANHOLE INSPECTION REPORT

Evansville, IN

MH ID:	1673	Surveyor:	DRH	Date:	8/24/2021	Time:	08:45
Address:	701 Ridgeway Ave						
Location:	In alley, behind address listed.						
Weather:	Dry	Rim to Invert (ft):	4.4	Inspection Status:	Remote Inspection		
Location Type:	Alley	Rim to Grade (ft):	0.0	Potential for Runoff:	None		
Surface Type:	Gravel	Grade to Invert (ft):	4.4	Surcharge Evidence:	No		
X-Coord:	2840211.49615	Y-Coord:	994138.632872	Coord. System:	NAD 1983 2011 State Plane Indiana West 1302 Feet

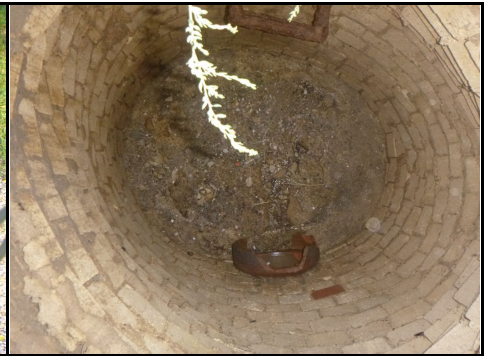
MH Photo: 1640 DAMHYB 20210824 0047

Inflow and Infiltration Defects: **No** Structural Defects: **No** Operation and Maintenance Defects: **No**

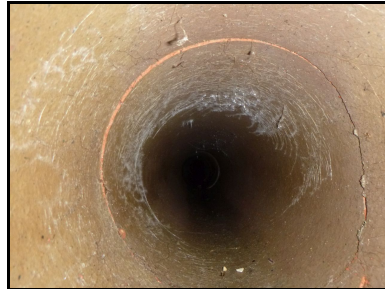
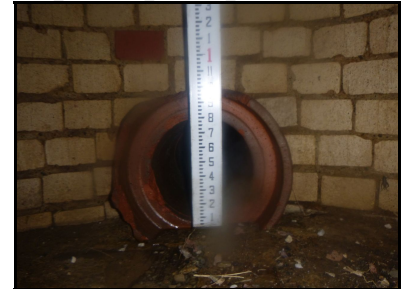
Pipe #:	1	Diameter (in):	8	Zoom Photo:	1640_DAMHYB_20210824_0049	Pipe Photo:	1640_DAMHYB_20210824_0048
Material:	Vitrified Clay						
Bearing (Degrees):	90						
Clock Position (o'clock):	6						
Flow Direction:	Out						
Rim to Invert (ft):	4.4						
Seal Condition:	Sound		Special Condition:	Gravity Release Connection			
				Pipe Shape:	Circular
