WAAS00127466 S15-133 UDREi Bumping

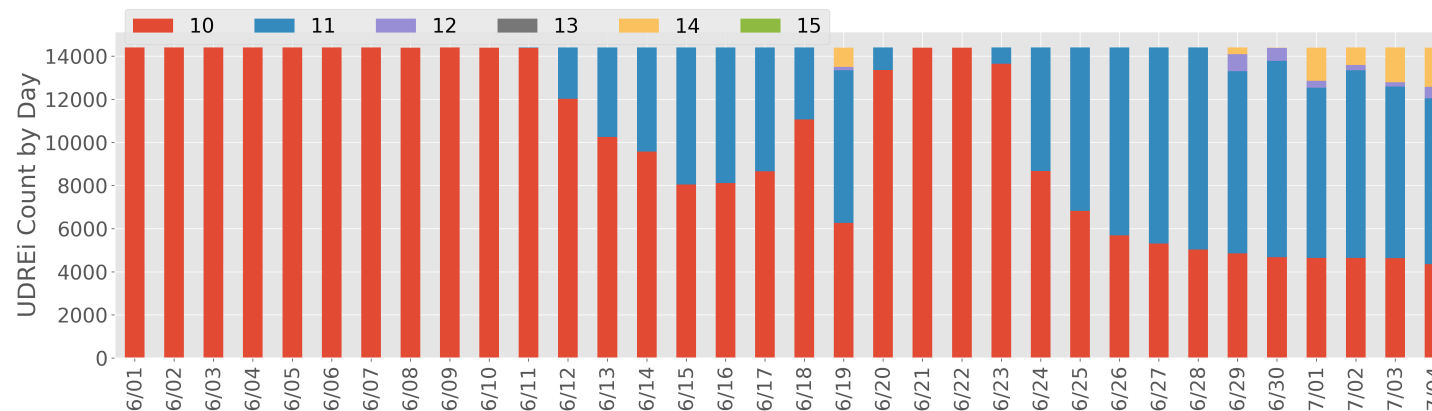
- Timeline:
 - 6/12 - S15-133 started bumping to UDREi 11 for a few hours 2ce/day
 - 6/19 - performed manual switchover in an attempt to mitigate / add new data point
 - 6/23 - after a quiet few days, bumping returned
 - 6/24 - bumping coinciding with SM9 switchover caused LPV200 outage in NW Alaska (both GEOs at 11)
 - 6/29 - started bumping to NM (UDREi 14)
 - 7/6 - jumped briefly to DU

- not issuing a NOTAM at this time
- no current plans to cold start the S15-133 GUSs BR1/CM1
- no current plans to perform another non-cutover related switchover
- considering changing the order of the BR1/CM1 upgrades to avoid unnecessary switchovers
