# HISTORIC AMERICAN TIMBER-FRAMED STEEPLES

## *V. Engineering a Steeple Restoration*

ST. MICHAEL'S EPISCOPAL CHURCH in Charleston, South Carolina, was built by Samuel Cardy between 1752 and 1761. Its architect unknown (possibly Cardy), it follows English pattern book designs popular in the Colonies and somewhat resembles James Gibbs's design for St. Martin-in-the-Fields in London. St. Michael's survived wars, hurricanes, tornadoes, fires and the 1886 earthquake. During the Revolutionary War it was a center of American resistance and the tower was a target for British naval gunners. The 186-ft. steeple served as an observation post and navigational landmark in this and later military conflicts. As a result of the 1886 earthquake, the steeple settled 8 in. with the spire leaning 18 in. away from the nave toward Meeting Street, requiring reconstruction of the portico below. Repaired cracks in the brick masonry can be observed today from the inside of the tower (Fig. 1).

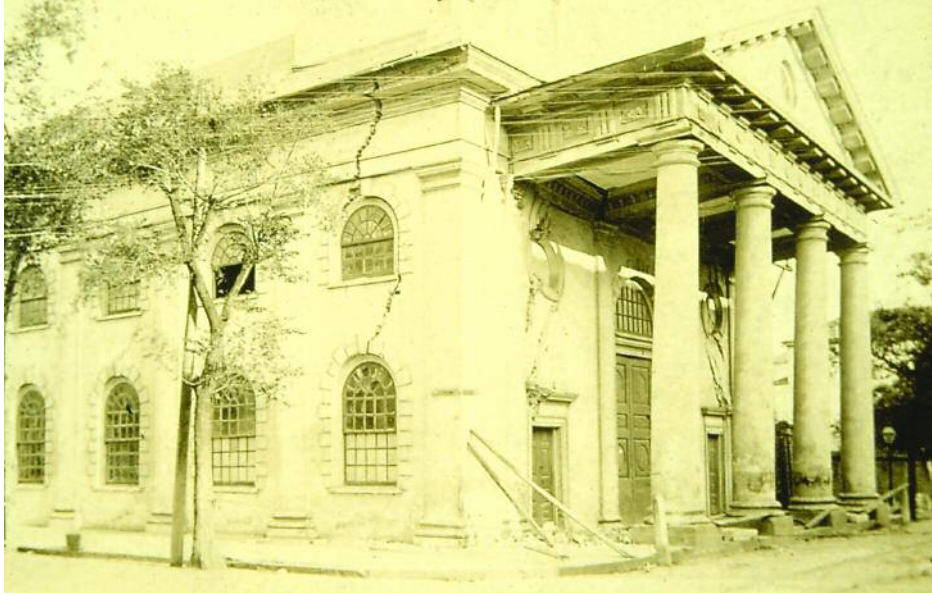
Fig. 1. St. Michael's after the 1886 earthquake. Portico leaning toward Meeting Street was rebuilt and large cracks in first bay repaired.

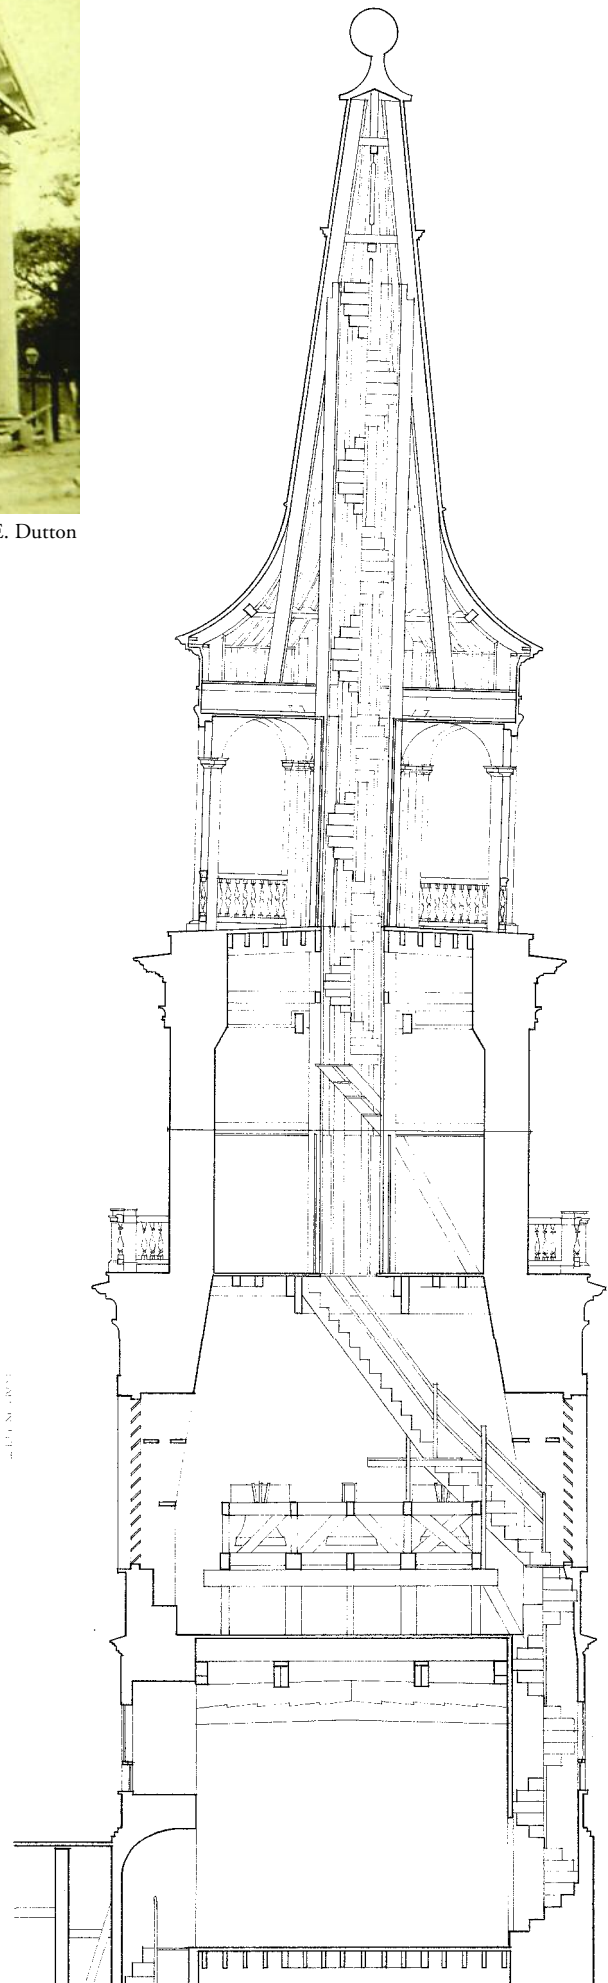
Fig. 3. St. Michael's cutaway steeple elevation looking south. Historic American Buildings Survey, 1963, drawn by Mark W. Steele. Spire and lantern shown listing west, toward Meeting Steet.

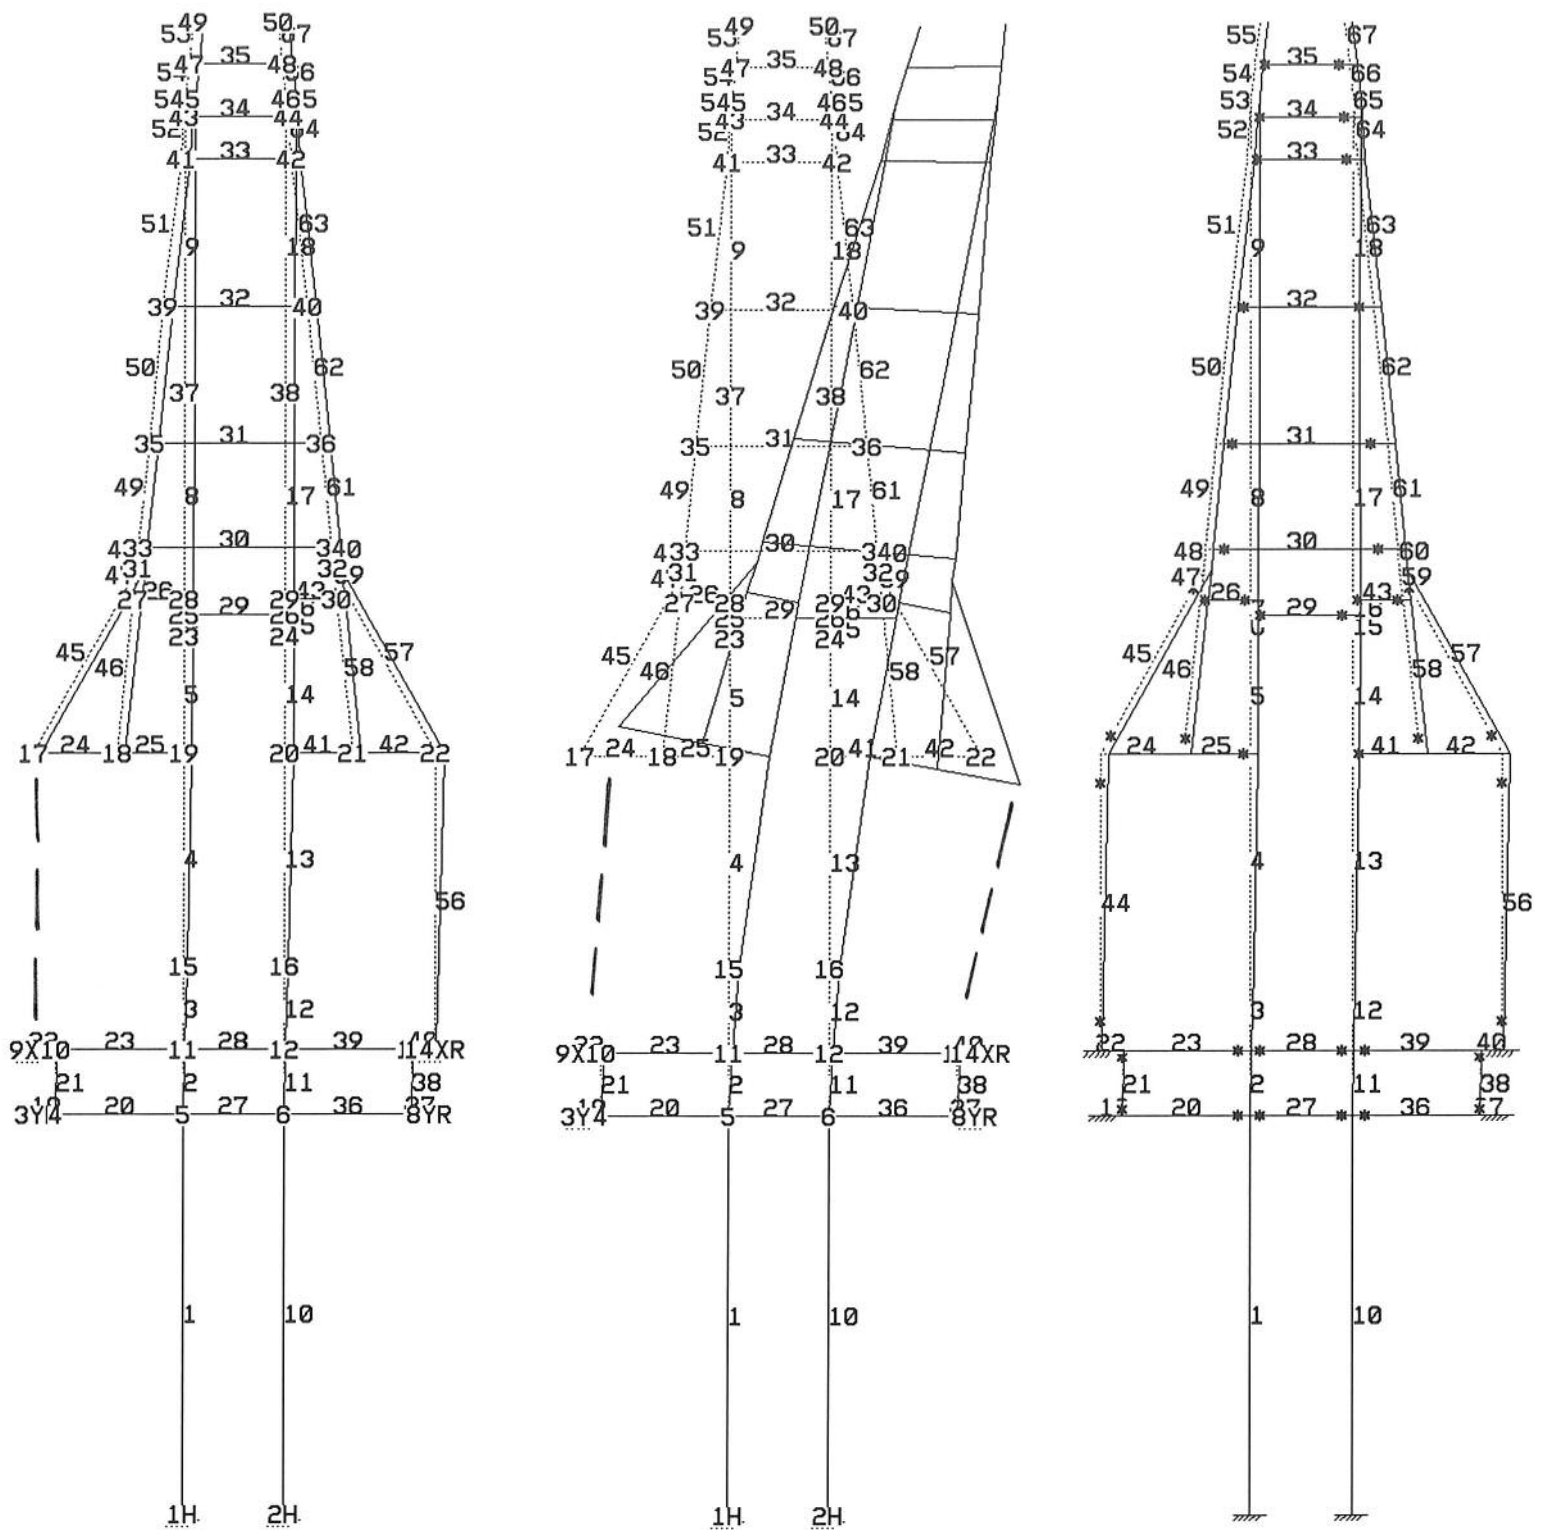
Fig. 8. Wind coming from the left in all cases, drawings represent behavior of a segment of the spire and lantern with the windward post disconnected (model at left, one broken line), windward and leeward posts disconnected (middle model, both broken lines) and both posts connected as built (model at right, solid lines).

At the same time, preliminary observation had indicated that the eight perimeter posts of the lantern had suffered varying amounts of deterioration where they tenoned into the radial floor beams, which would imply a diminution or actual lack of connection. The engineering analysis indicated that the spire frame responded much less stiffly to forces with these joints at the floor disconnected (Fig. 8).

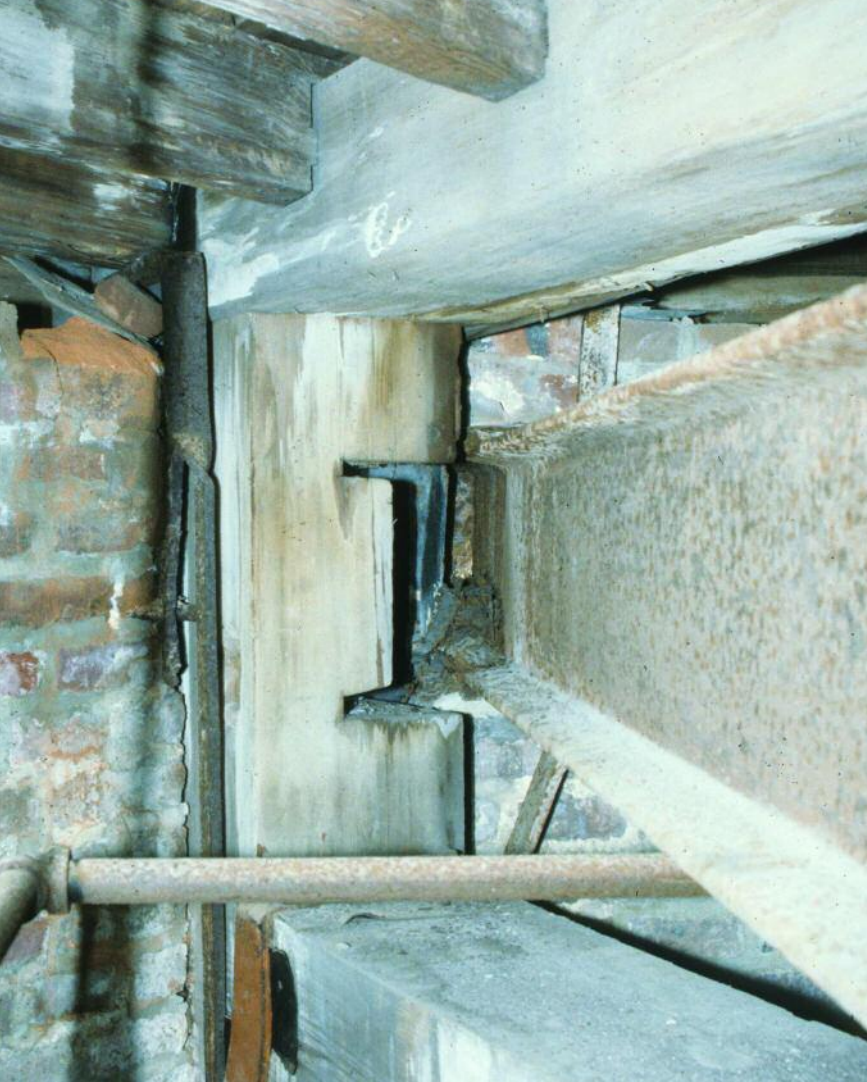
Fig. 9. Stub post in framing just below the lantern floor, cut by steel beam inserted in 1938. Pendant center posts descending from spire were similarly cut, with significant structural effect.

Of prime concern to all of us were the horizontal steel beams introduced into the steeple in 1938, apparently to provide additional vertical support to the steeple frame (Figs. 9–11). The eight original 8x8 pendant core posts descending from the spire to the masonry clock stage were severed two-thirds through to accommodate these struts. In September 1990 we produced a preliminary structural evaluation report including these observations:

The introduction of horizontal steel members in the steeple may have caused a discontinuity which is the second major concern. This steel, while providing vertical support, has nearly severed vertical elements which provide a great deal of the overall stability to the steeple. . . . At first glance it would appear that the open condition of the lantern level of the tower is the source of the steeple's inability to resist lateral forces such as wind. But the original designer did provide an excellent method of lateral stabilization with a vertical cantilever which acts much like a flagpole embedded in the ground. The bundle of eight vertical timbers telescopes from the brick masonry box below. The continuity of the eight timbers which extend from the massive masonry ring below the clock level to well into the spire was disrupted by the steel sections which were inserted in 1938. . . . At this time, we agree with George Fore that the deteriorated steel should be removed from the tower, the masonry pockets filled, and the damaged vertical members repaired. Repairs should include epoxy consolidation, epoxy-aided splicing, replacement-in-kind, and appropriate reinforcing which will not change the intended action of the existing structural system or sacrifice original historic fabric.

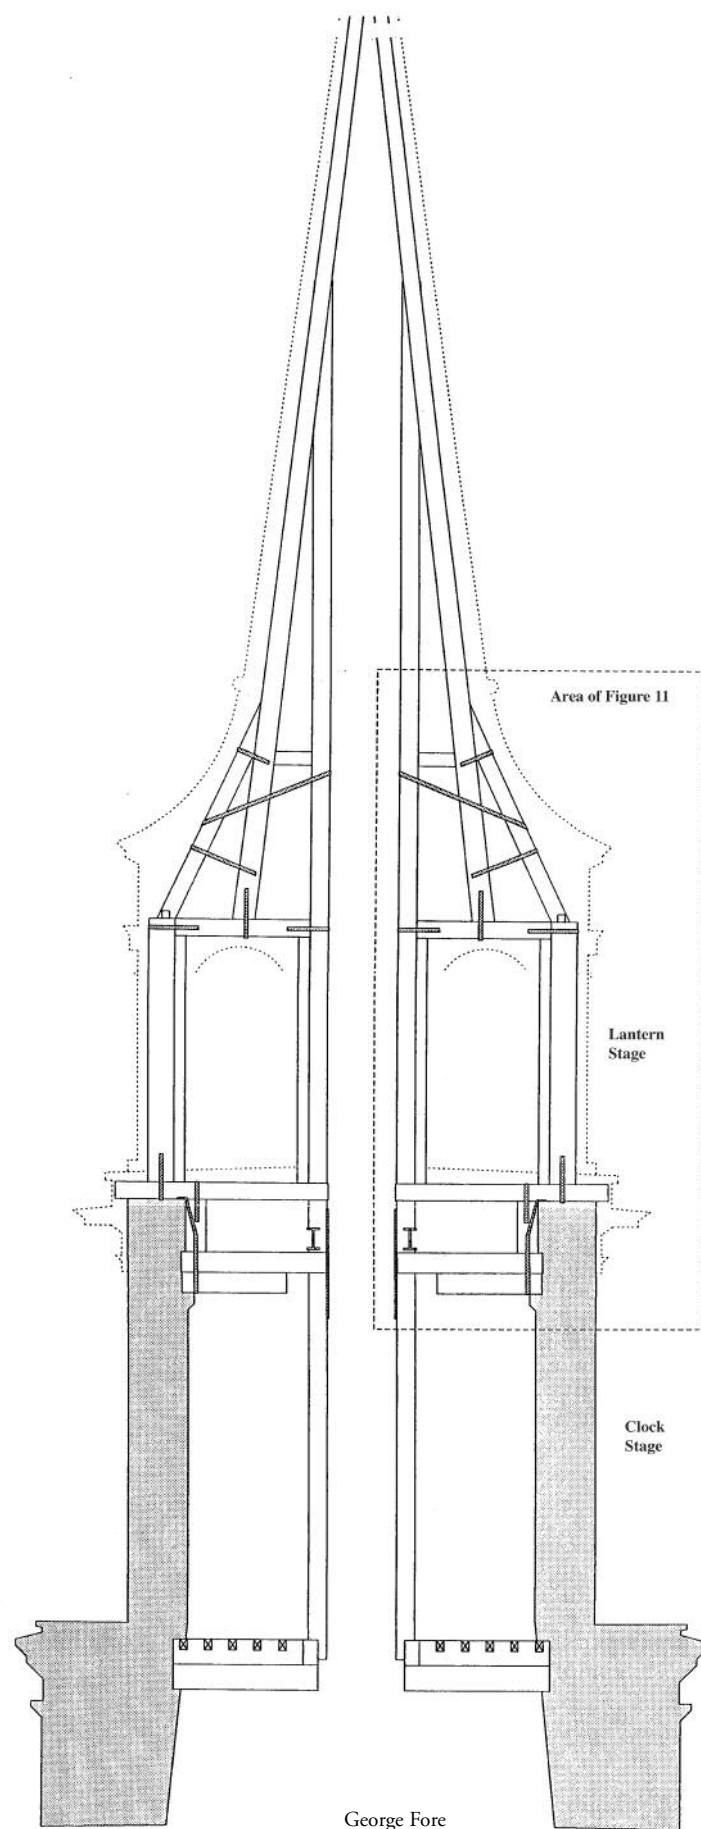
Fig. 10. Framing elevation (no scale) of clock, lantern and spire stages. Eight spire posts form a sort of mast footed at clock stage floor.

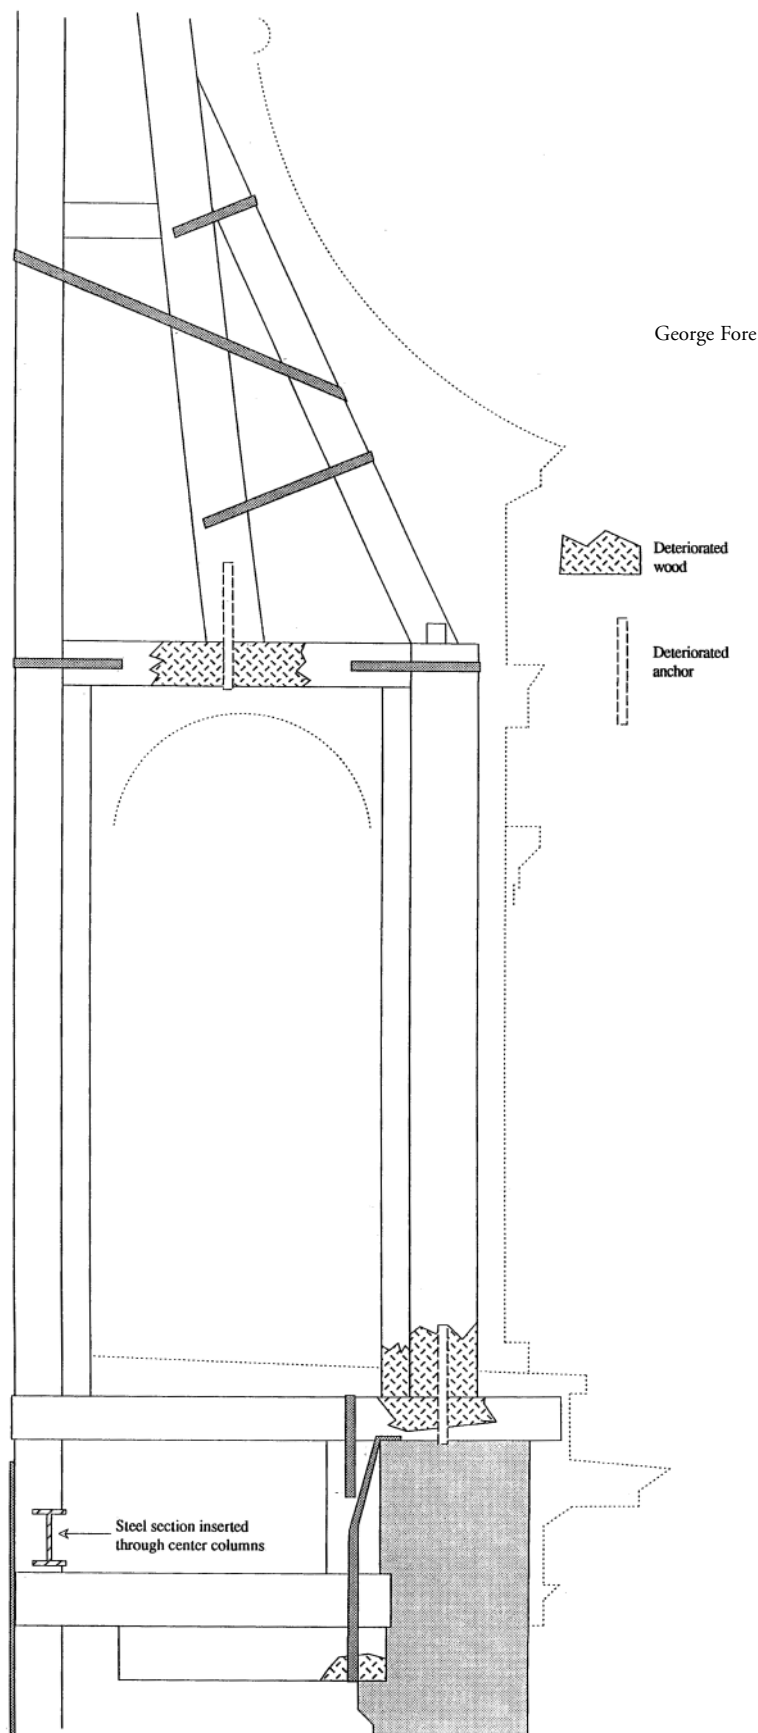
After Hurricane Hugo, materials conservator George Fore, of Raleigh, North Carolina, produced a condition analysis and conservation study of St. Michael's carpentry, masonry, plaster and finishes. He also provided framing details for the steeple as well as evidence of racking of the upper structure attributable to Hugo, and his report graphically located areas of deteriorated wood within the framework (Figs. 11–12).

Fig. 11. Detail (no scale) of frame elevation showing deteriorated materials in upper framing. Note inserted I-beam cutting spire post.

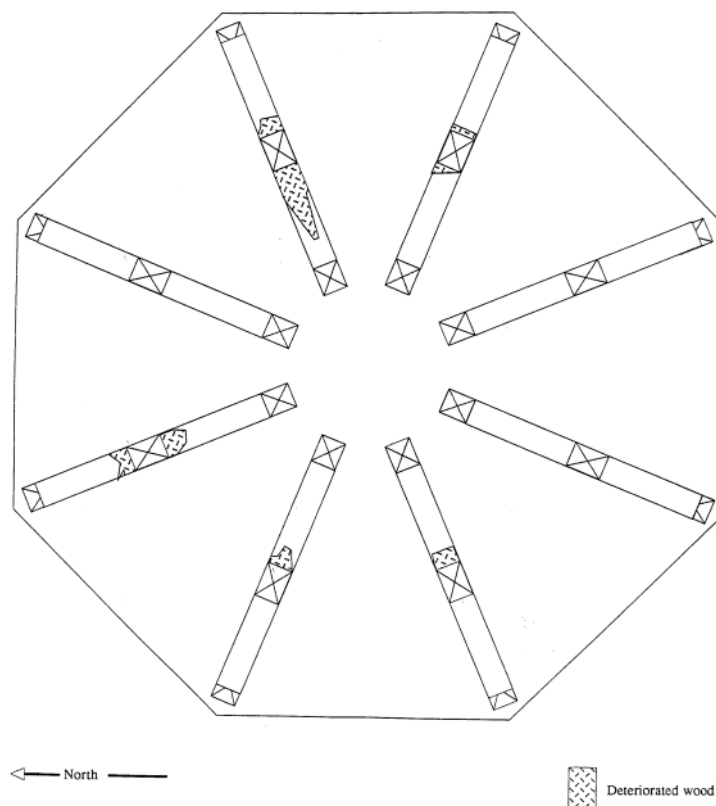
Fig. 12. Plan of framing at base of spire showing deterioration near rafter joints.

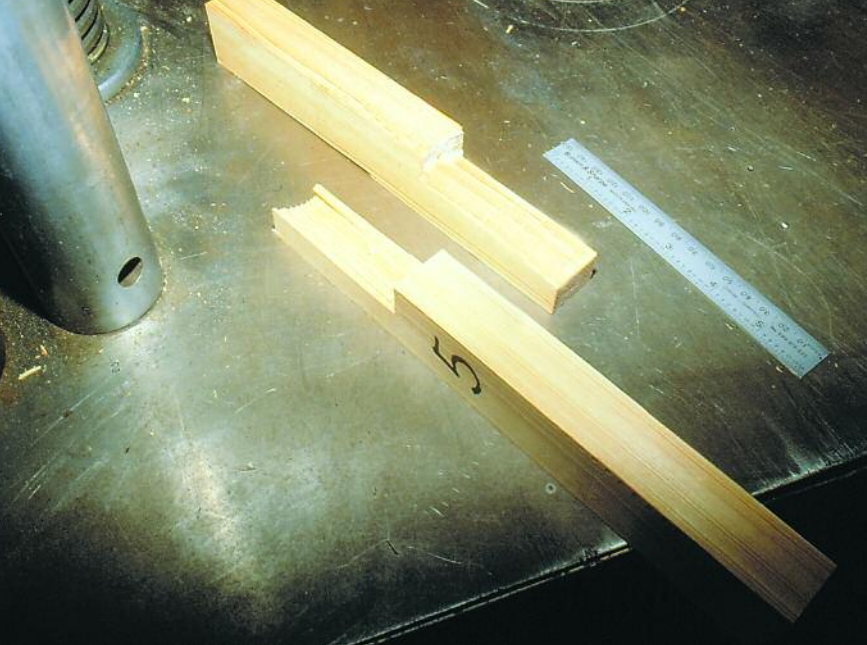
Fig. 13. Gluing-test Specimen 5, establishing joint failure mode.

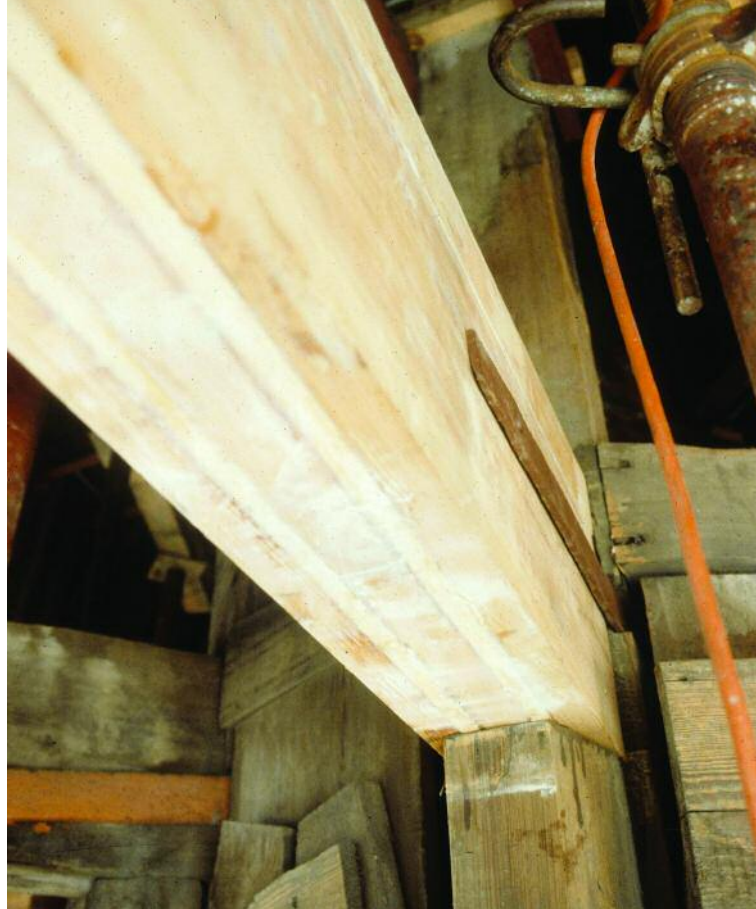
Fig. 14. Vertically laminated cypress beam replaced horizontal strut judged beyond usefulness.

We applied a factor of safety of four to the average value obtained by the testing program and used the result to design moment splices between the original wood and rebuilt ends of several of the spider beams. In one case, we discovered a horizontal strut that was totally deteriorated. To replace it, we laminated five cypress boards together on edge (Fig. 14).

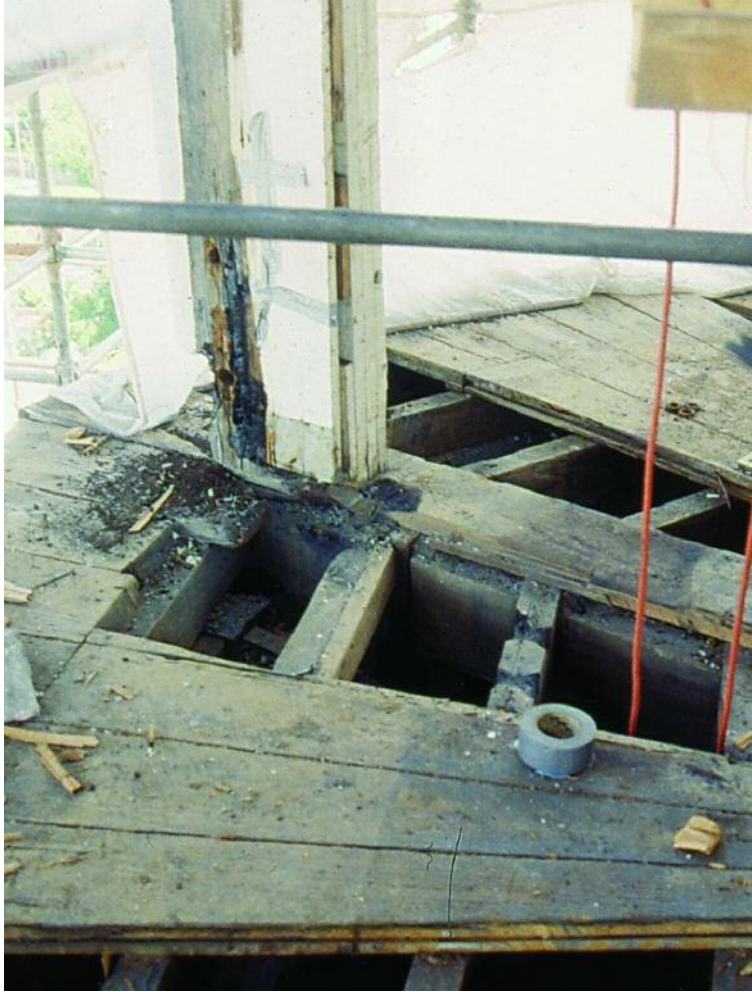
Fig. 15. Decayed perimeter post to spider beam connection under lantern floor.

New bottom tenons or tenoned ends as necessary for those perimeter posts that had deteriorated at the lantern floor were fabricated from dense cypress with a moisture content of 14 to 16 percent, close to the 11 to 14 percent moisture content of the original frame (Figs. 15-16).

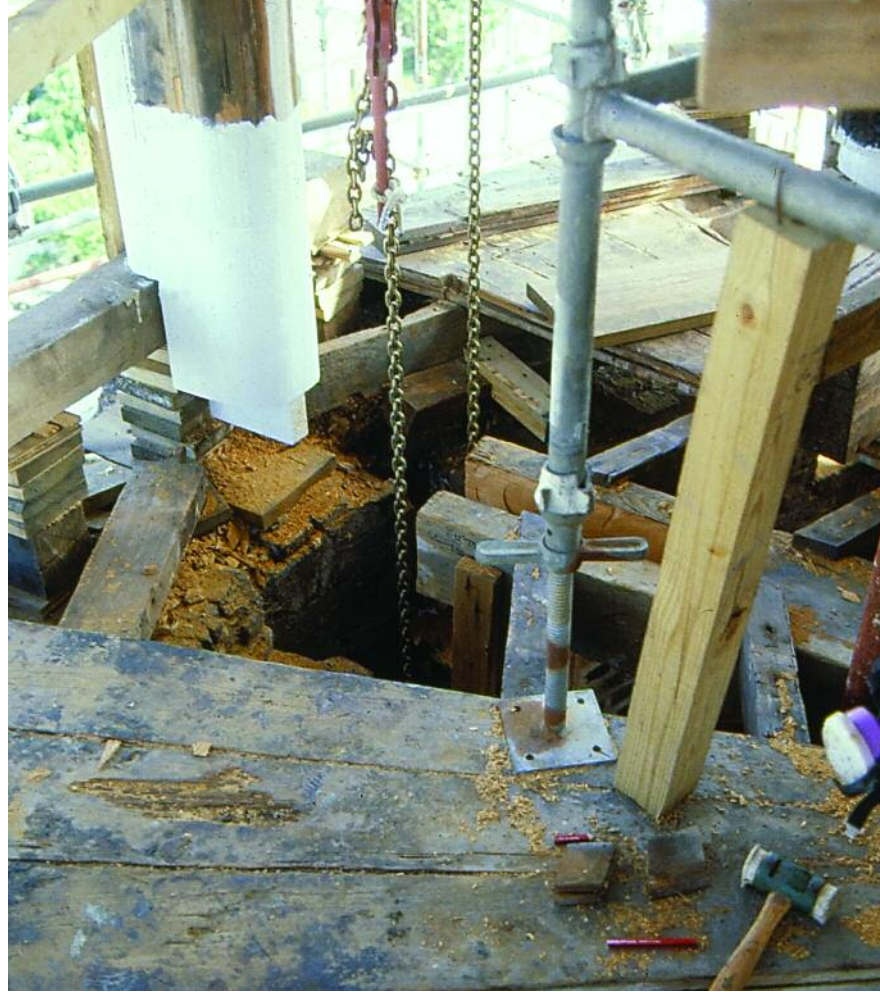
Fig. 16. New post end with tenon completed, bridled beam repair to be fitted and secured.

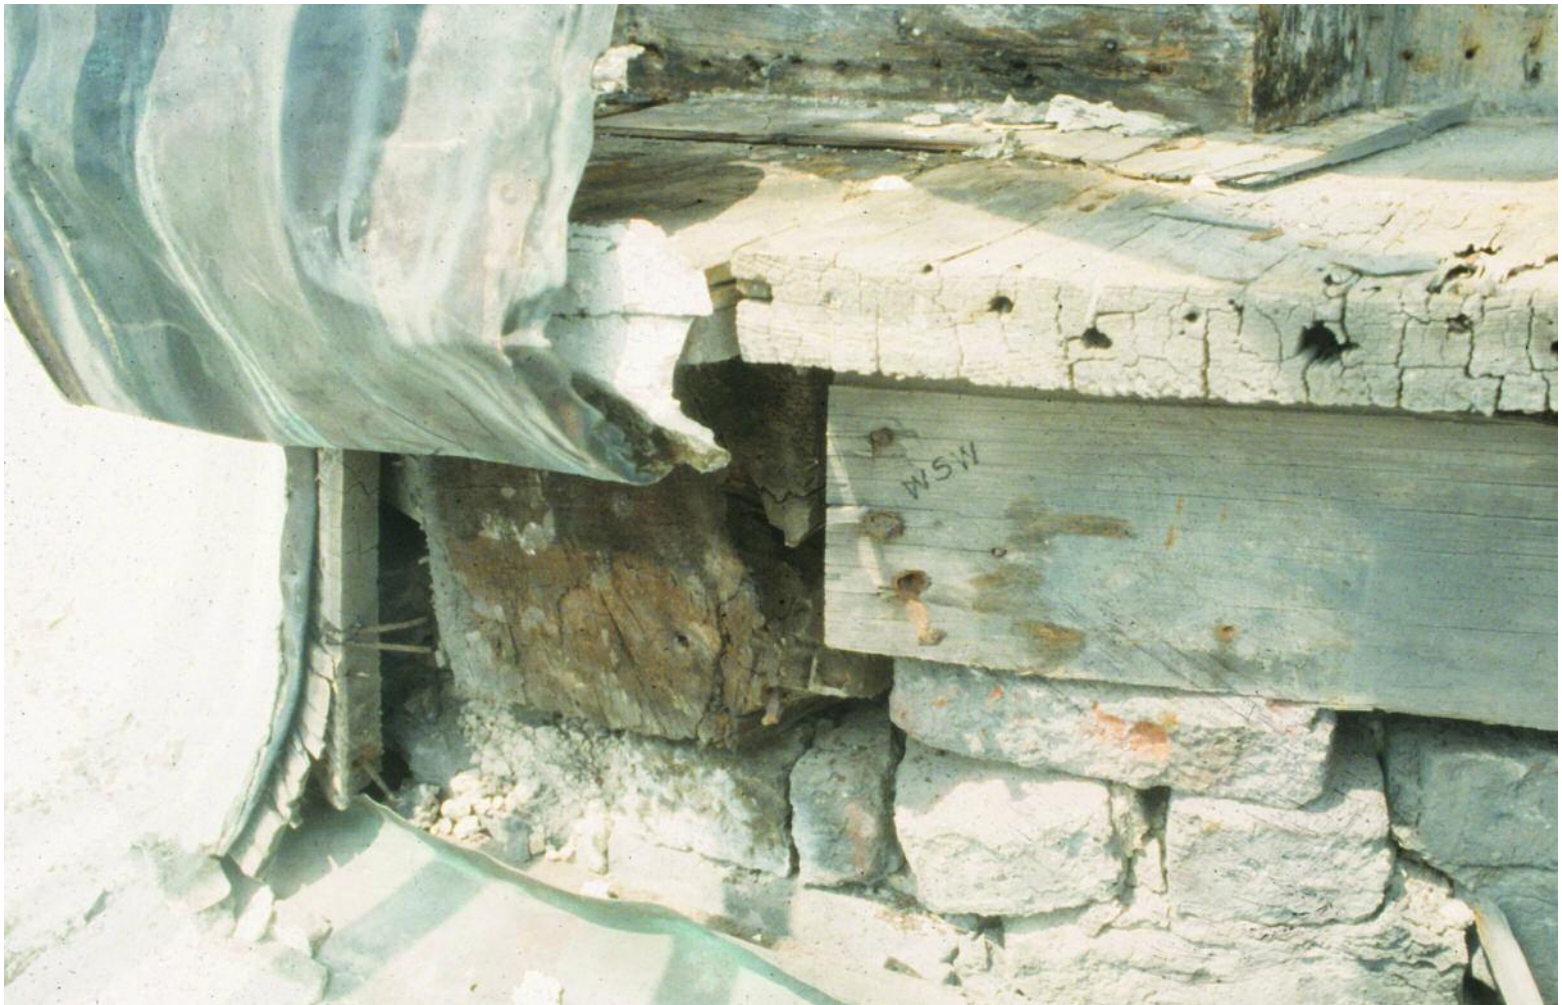
Fig. 17. Lantern floor peeled of its lead skin reveals splined and caulked floorboards and WSW end of one of the eight radial spider beams.

Where the radial 8x10 horizontal timbers (or spider beams as we called them) below the floor of the lantern were severely deteriorated, we replaced them with pressure-treated Southern yellow pine having a 2.5 pcf retention of copper chromated arsenate (CCA) water-borne preservative. These members, embedded 3 ft. deep inside the heavy masonry walls near the top of the clock stage and cantilevered toward the center across brick corbels, provided stabilization and some vertical support to the central spine of the spire. Wrought-iron straps throughout the steeple that had disintegrated too far to be reworked were replaced with stainless steel.
