HISTORIC AMERICAN TIMBER-FRAMED STEEPLES

II. Restoration Strategies

This article is second in a series to discuss the form, function and joinery of selected historic American timber-framed steeples. The series was developed from original research under a grant from the National Park Service and the National Center for Preservation Technology and Training. Its contents are solely the responsibility of the authors and do not represent the official position of the NPS or the NCPTT.

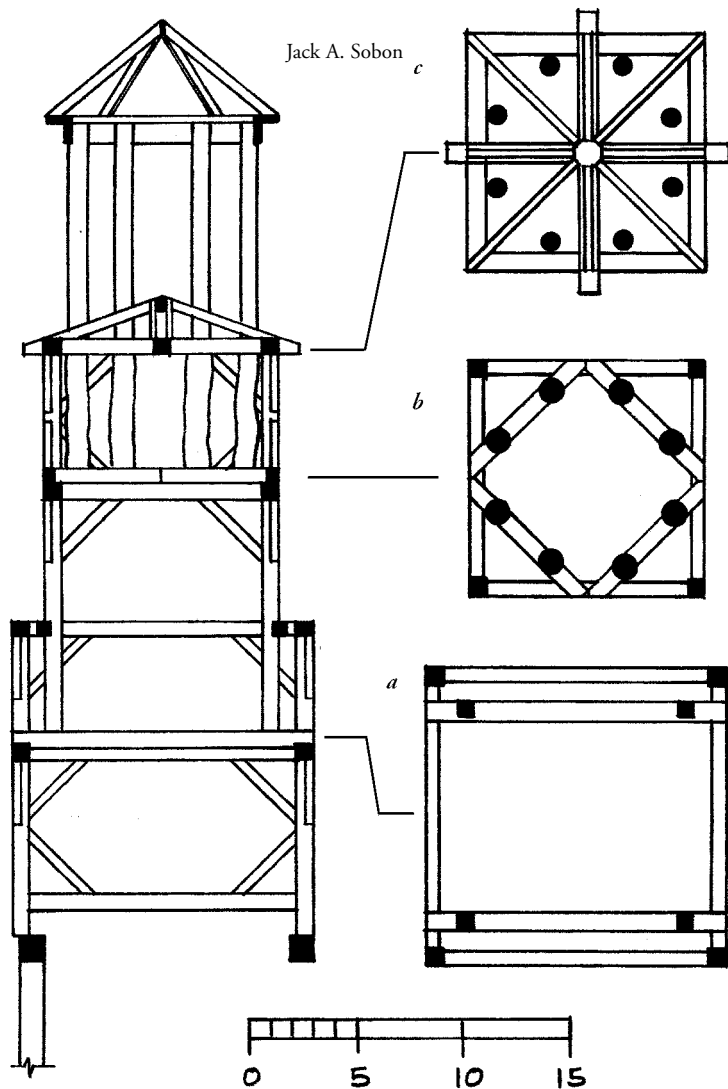
Fig. 1. South Woodstock steeple frame section seen from inside looking toward eaves of church. To form first stage, tower posts rise from tie beam in front wall of church (at left in drawing) and tie beam in first roof truss. To form second stage, posts rise from sleepers resting on girts 6 ft. down within first tower (plan view a) and reach bell deck (plan view c) 18 ft. above, intersected about halfway by horizontal framing (plan view b) to support feet of eight columns surrounding bell. Original columns were lathe-turned where they could be seen in belfry, left in the rough where concealed. Compare Fig. 14 on page 11.

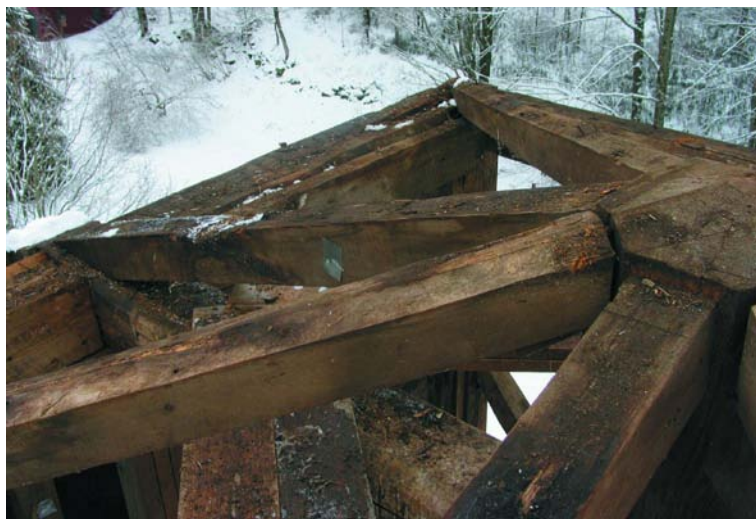
Fig. 2. Original South Woodstock bell deck. Since belfry is open to weather on four sides, deck must be framed and sheathed to shed water. Rafters measure $4 \times 4\frac{1}{2}$, hips $3\frac{1}{2} \times 5$. Short kingpost is 14 in. across flats.

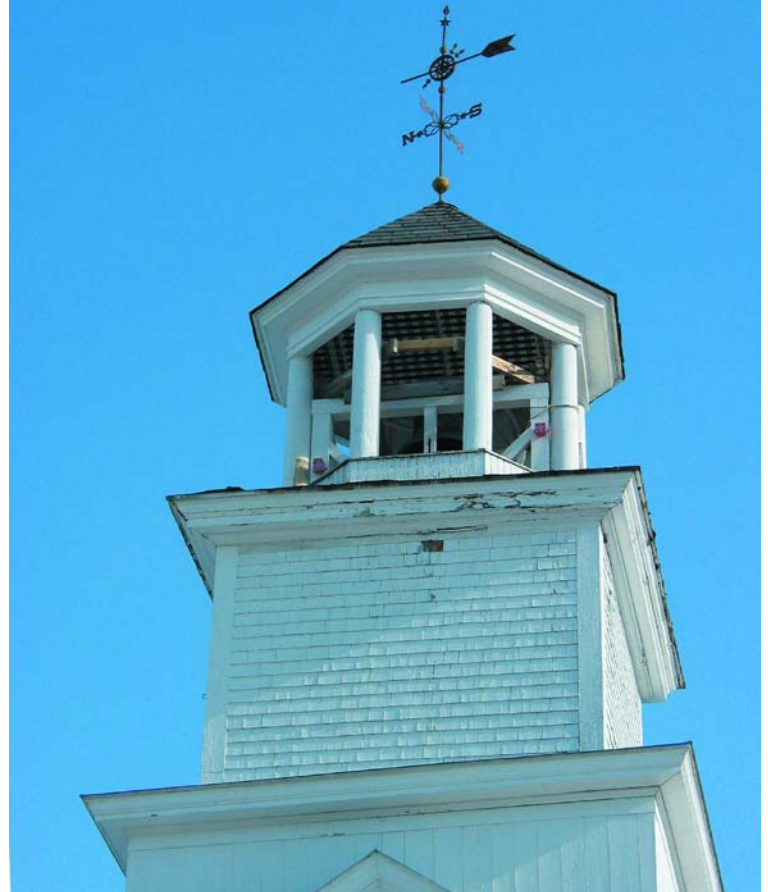
Fig. 3. Steeple of South Woodstock church before repairs. Compound tilt, somewhat unusual, includes typical backward lean from overloading of the first interior truss combined with sideward lean from rotting posts and sleepers along the south side of the tower.

We made structural improvements only where excessive stress was observed. The truss supporting the back of the steeple was not stiff enough to help carry the weight of all the stages above in addition to its own significant roof load, and had sagged noticeably when we began work, a problem endemic to steeple supports of the period. (The resulting backward tilt of many 19th-century steeples is a common sight today in New England.) At South Woodstock, this problem was amplified by extensive water infiltration into the two tower sections and resultant rot.

We strengthened the truss incorporating the rear posts of the lower tower by adding another set of queenpost main braces and another straining beam, parallel to the originals, as shown on the facing page. We installed these when the entire truss was lifted to level on structural scaffolding and the original truss connections, now relaxed, could be wedged tight as well. The structural scaffolding rose from the main floor of the church and from the inset front porch floor, with cribbing below the floor in the crawl space to bring the load to ground (Figs. 4 and 12).

Each pair of scaffolding towers carried large built-up beams passing through the second floor windows of the front gable of the church. Screwjacks atop these lifted the sagged truss chord to slightly above level so that the additional queenpost elements could be installed and then loaded. We also increased the sleepers for the octagon columns from 7x9 to 10x11 inches in response to sagging observed in the originals. After completing repairs to the tower (Fig. 13), we lifted the ensemble, stage by stage, back into position.

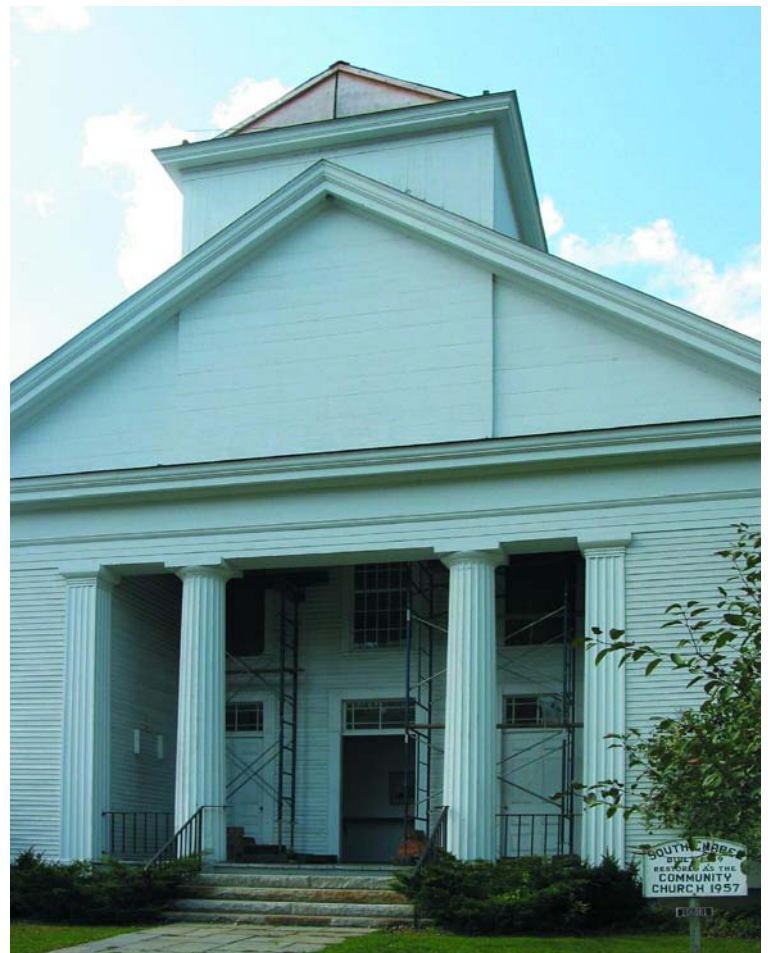
Fig. 4. Greek Revival façade of South Woodstock Community Church after removal of steeple upper stages and capping of tower with light temporary roof. Church was built in 1839 as South Woodstock Congregational Chapel and took its present name in 1957.

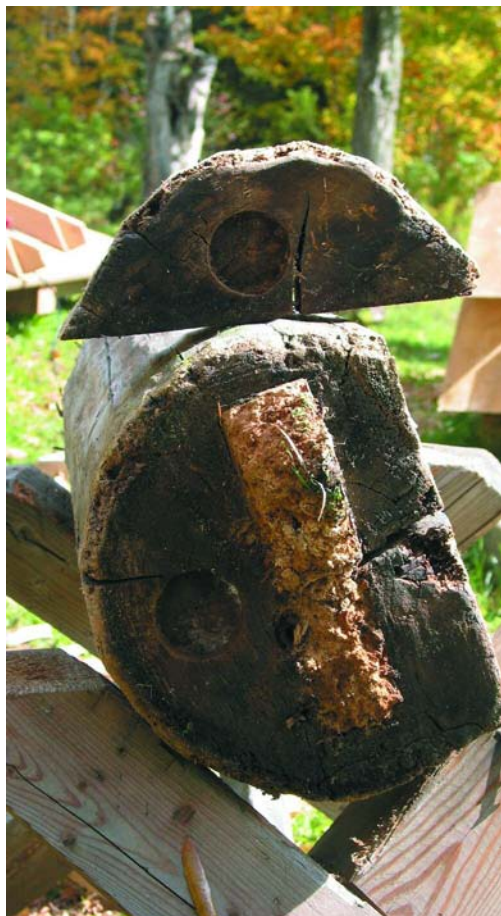
Fig. 5. Original column butt with turning center and regularly offset tenon. Crescent section perched on top is from another column.

With the columns on the ground, we discovered the original turning centers, 2-in.-dia. holes 2 in. deep, giving us reference points for correctly locating tenons on the bottom of restored or replacement columns. An octagonal layout had been superimposed upon the diagonal sleepers, and mortises cut at eight regularly spaced points. We were able to cut (or insert) tenons on the bottoms of the columns at a regular offset from the turning centers to engage the sleeper mortises correctly to hold the columns plumb (Figs. 5–7, 10).

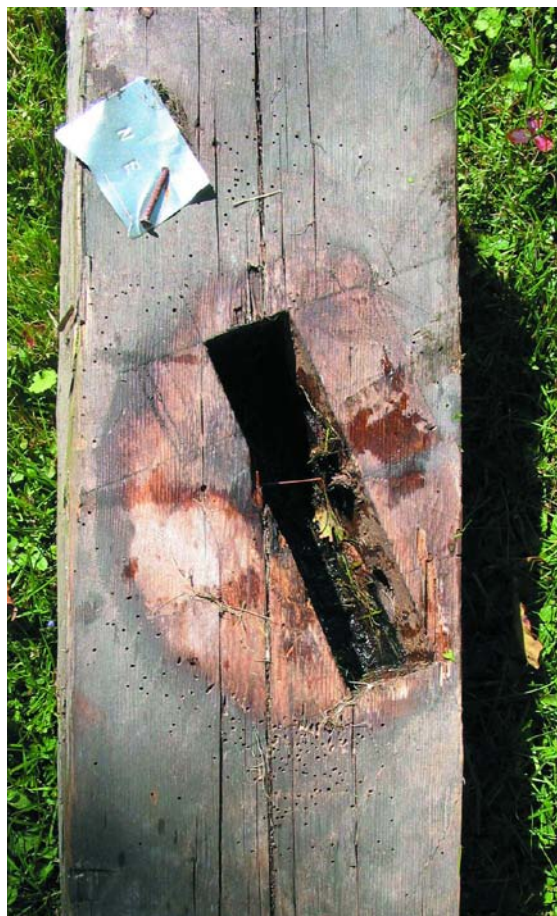
Fig. 6. Original mortise in sleeper, skewed as necessary to follow regular octagonal pattern. Ghost reflects hewn clearance reduction of column in Fig. 5.

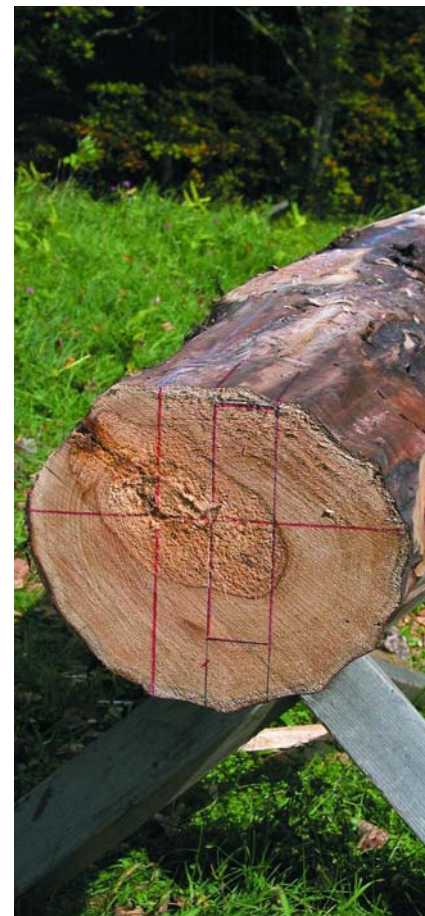
Fig. 7. Layout for tenon on repaired column. Pierced hole at upper left crossing of lines represents reference center.

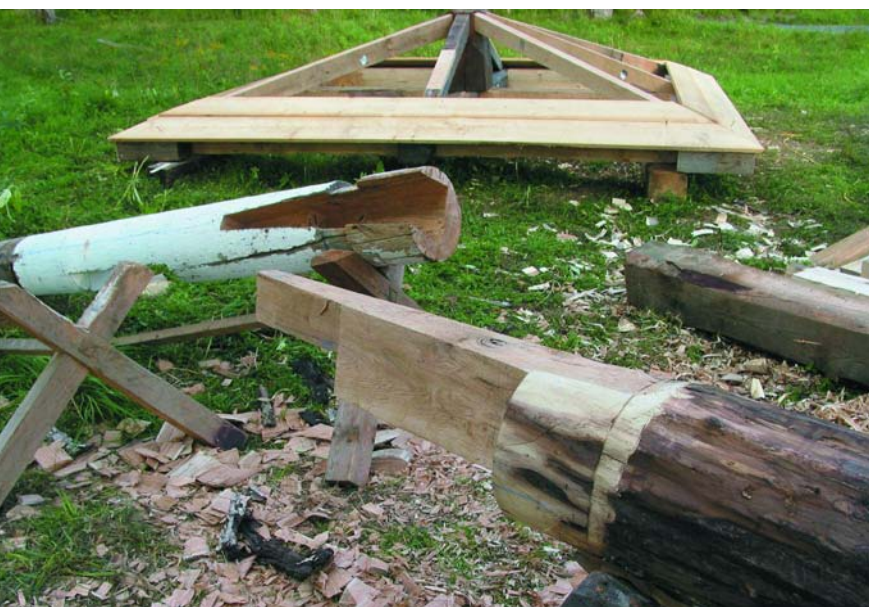
Fig. 8. Distinctive scarf joint in progress between new column bottom and old column top. Mostly rebuilt bell deck in the background.

Restoration required copying the dimensions, species and joinery of the various members and reassembling them. The in-place tower called for extensive free and slotted tenoning since it couldn't be fully pulled apart. We were free to rebuild the second stage, however, as it was originally built. The butternut columns were elaborately repaired and two replaced, although finding reasonably straight and sound 13-in.-dia., 18-ft. butternut logs was difficult because of the present diseased state of the species (Figs. 8–11).

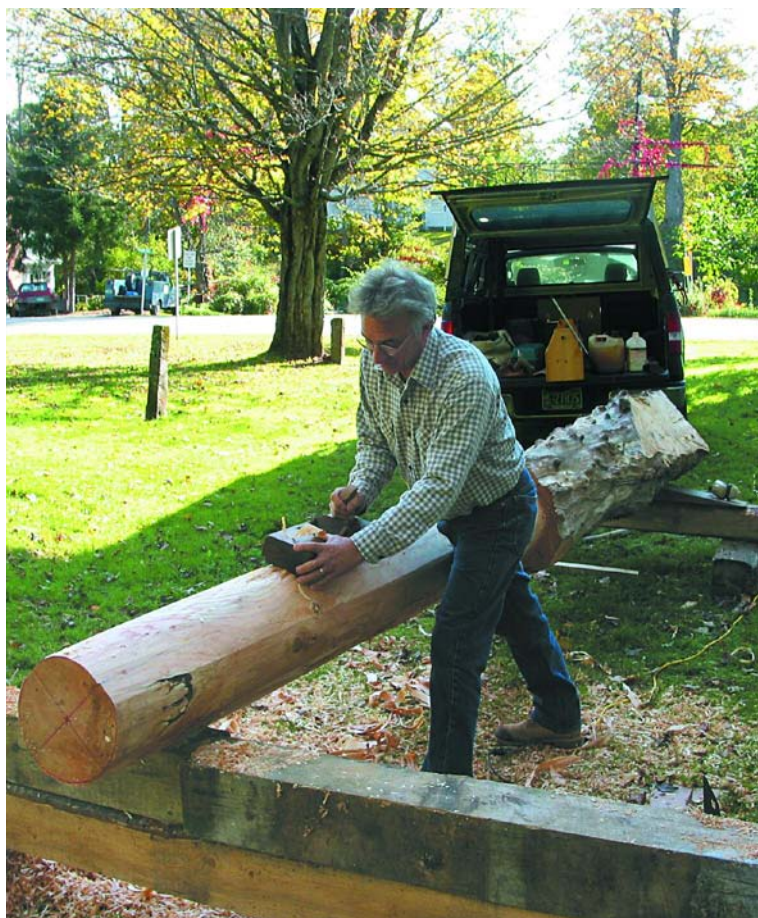
Fig. 9. Author smooths one of two new replacement columns, laid out, sawn, shaved and planed rather than turned as were originals. Bulky surface where left rough suggests difficulty of finding good butternut today.

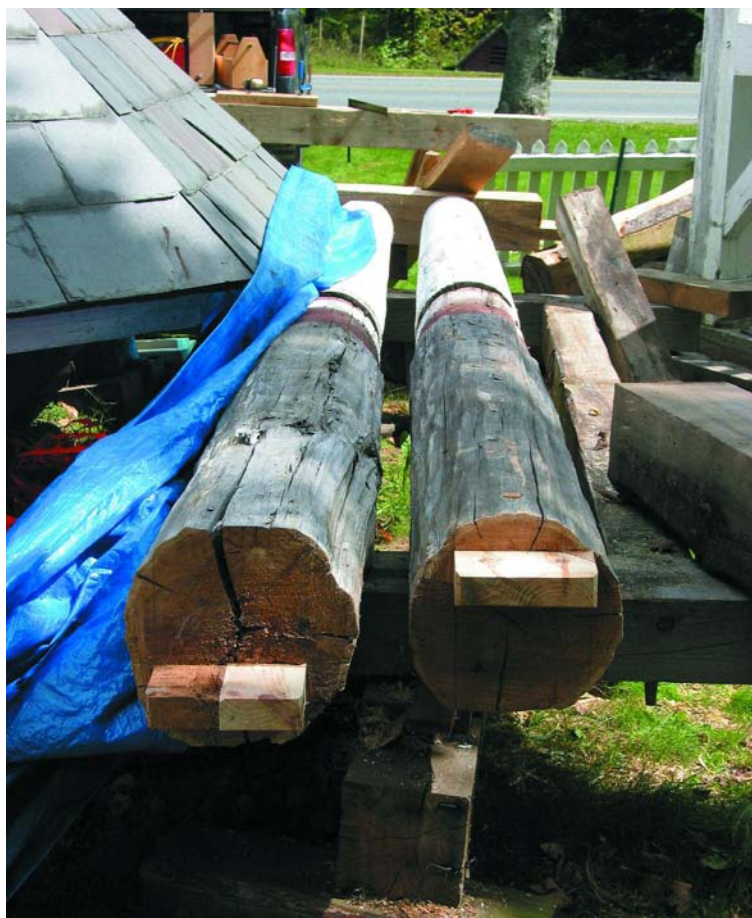
Fig. 10. Repaired columns using original lower ends, shortened to remove decay, in one case leaving enough sound wood for an integral half-tenon. Pale wood indicates free tenons.

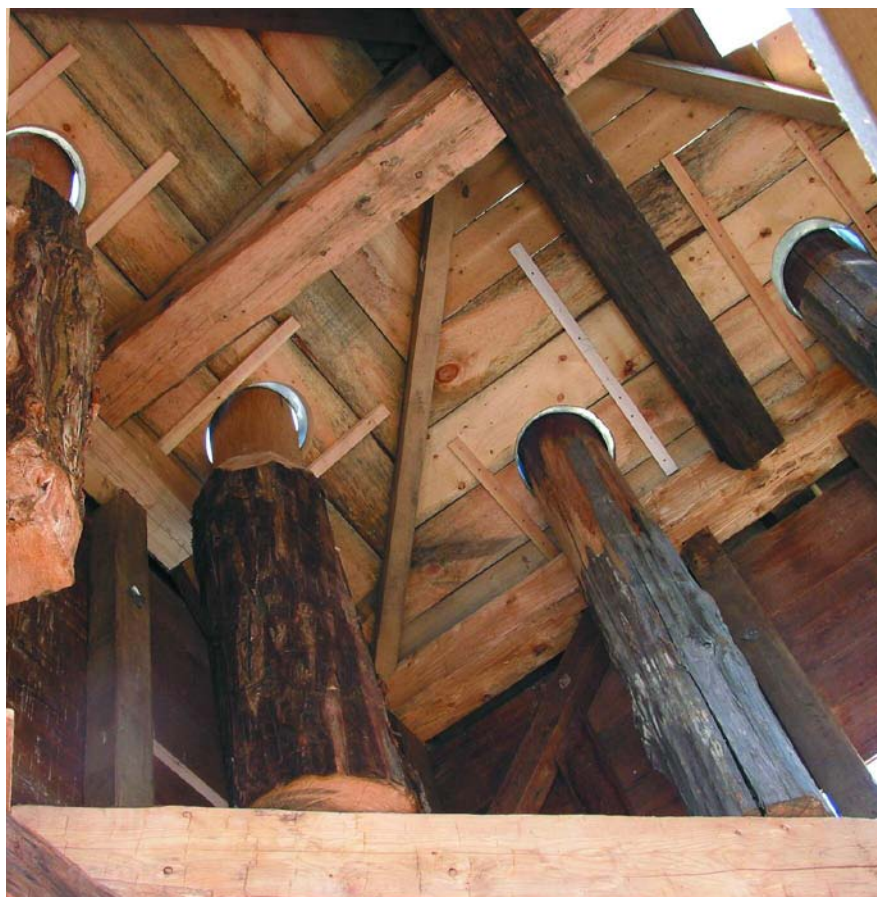
Fig. 11. Reconstructed bell deck admits scarfed and new columns (two at left) through the boarding to appear in the belfry as tapered cylinders.

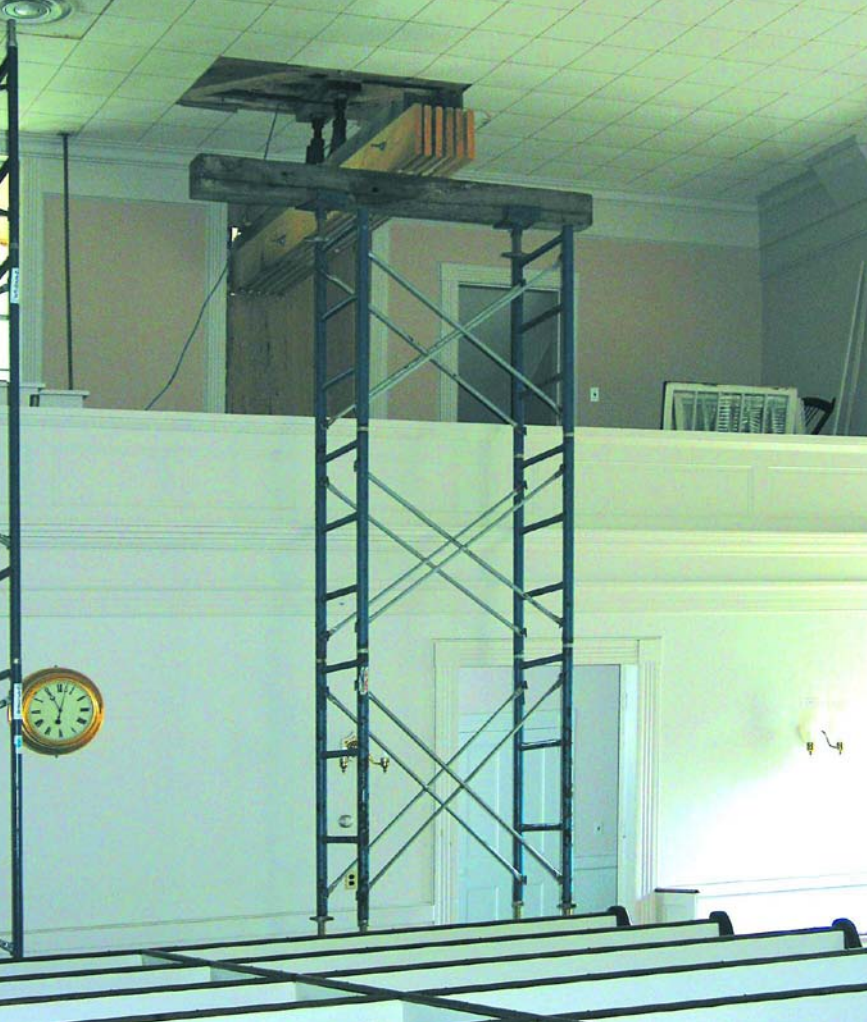
Fig. 12. Structural stage inside church paired with another on the porch outside (see Fig. 4) provided base for lifting elements within tower.

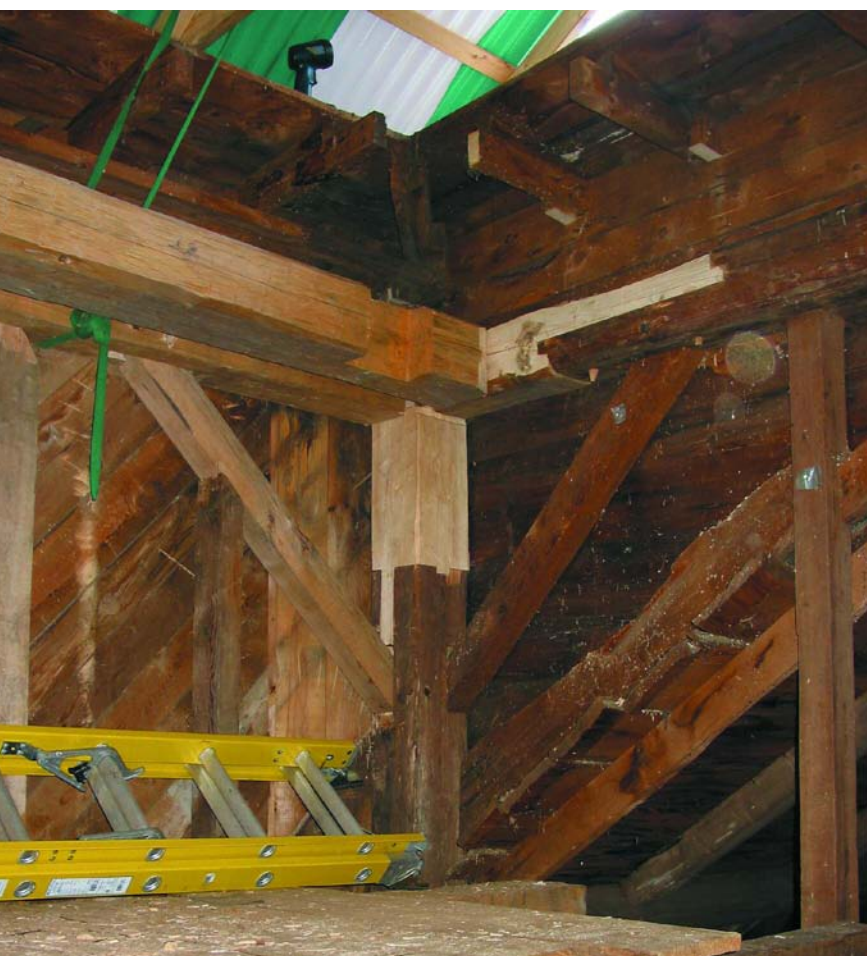
Fig. 13. Tower required numerous scarfed repairs and whole-member replacements, using structural staging as jacking base for insertions.

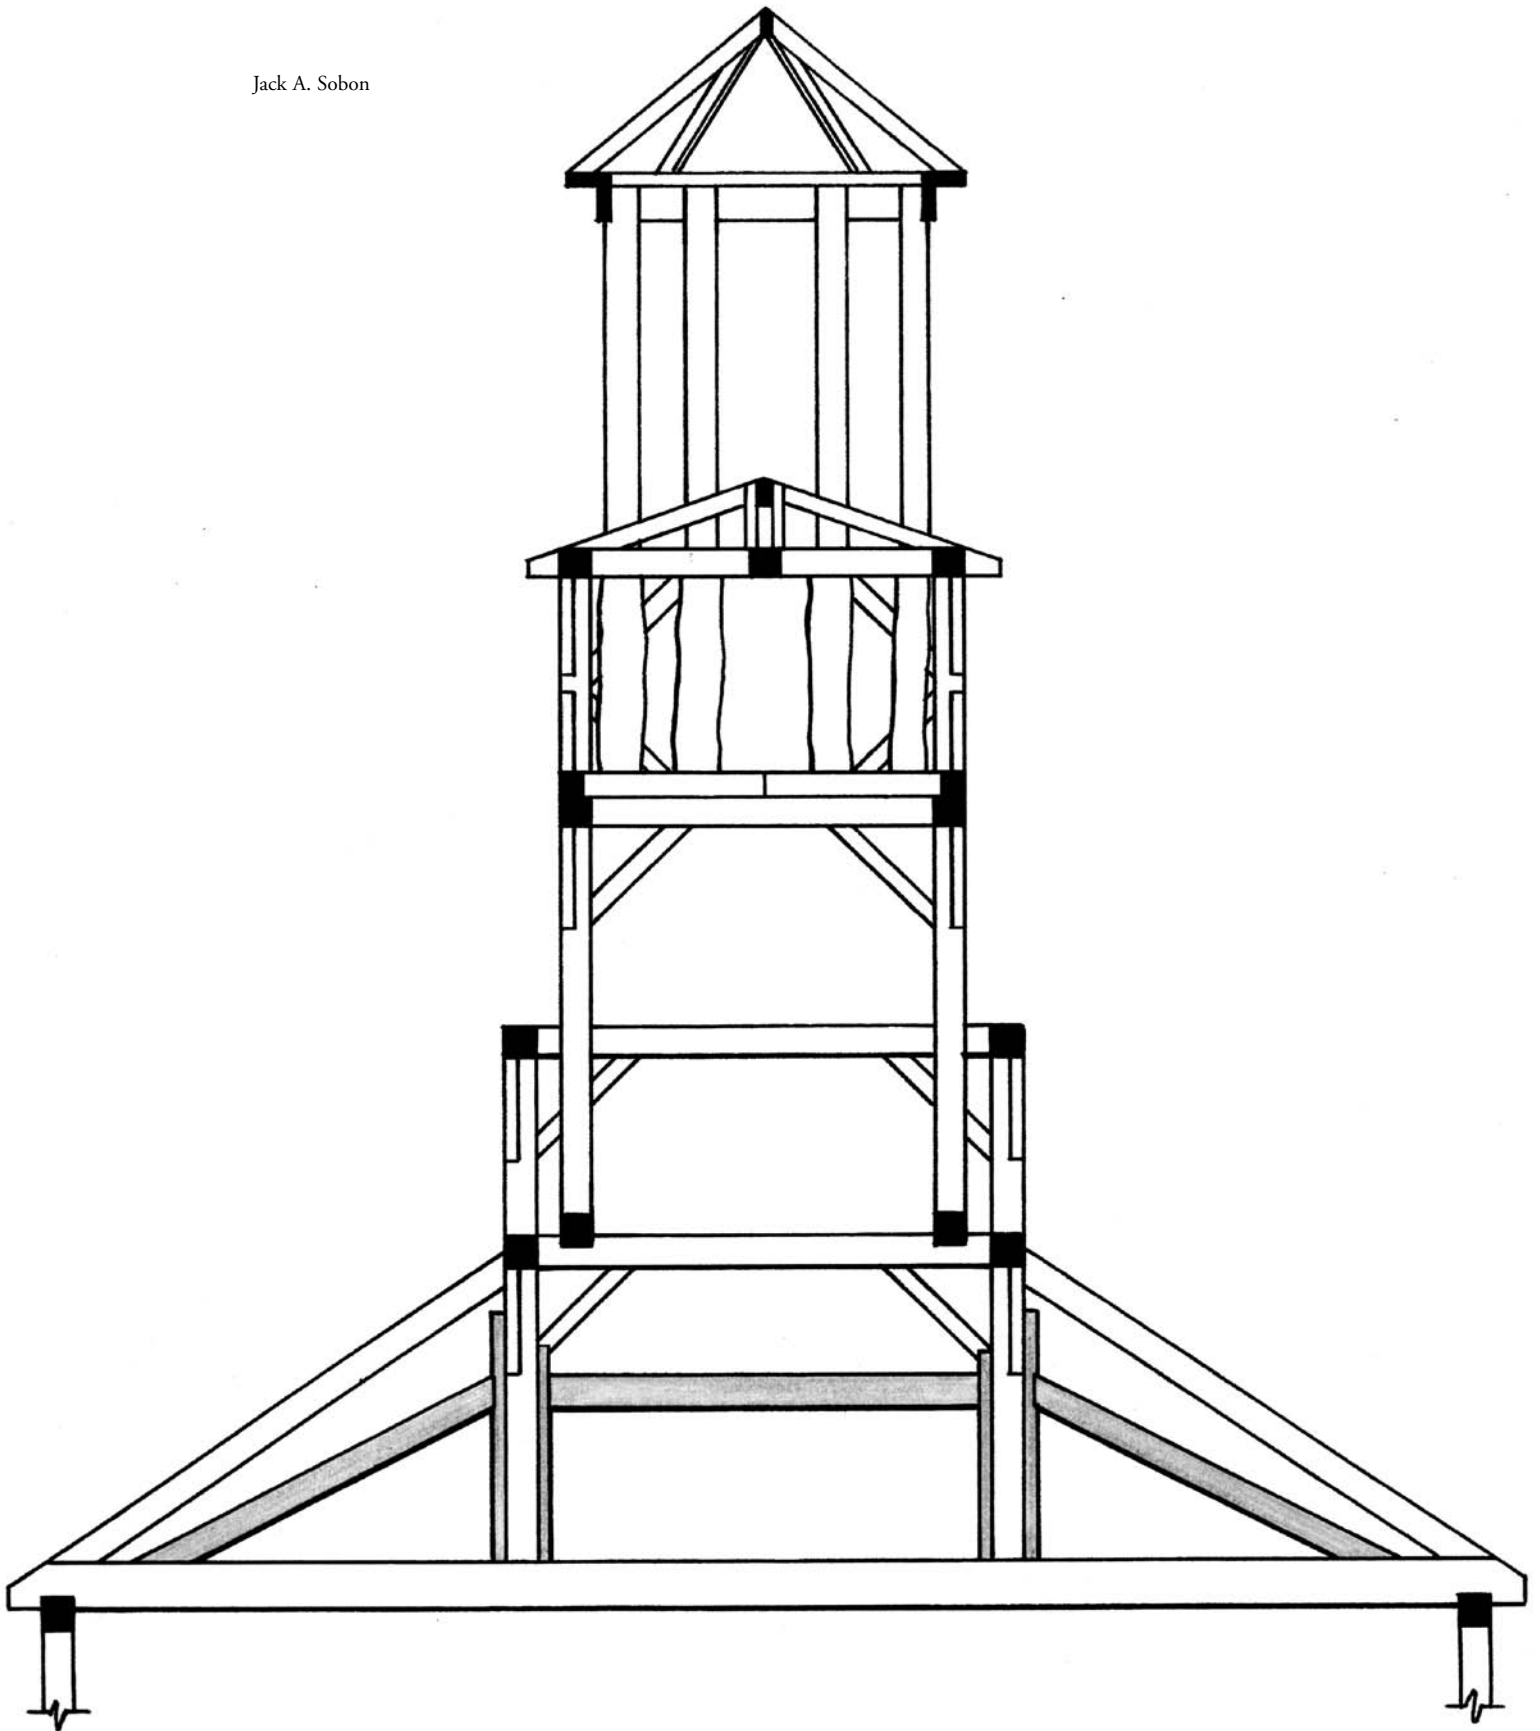
Fig. 14. South Woodstock steeple frame section seen from inside looking toward back of church, showing queenpost truss formed by rear tower posts and truncated principal roof rafters. Shading indicates stiffening elements added during repairs. Posts rising to hipped bell deck are continuous.

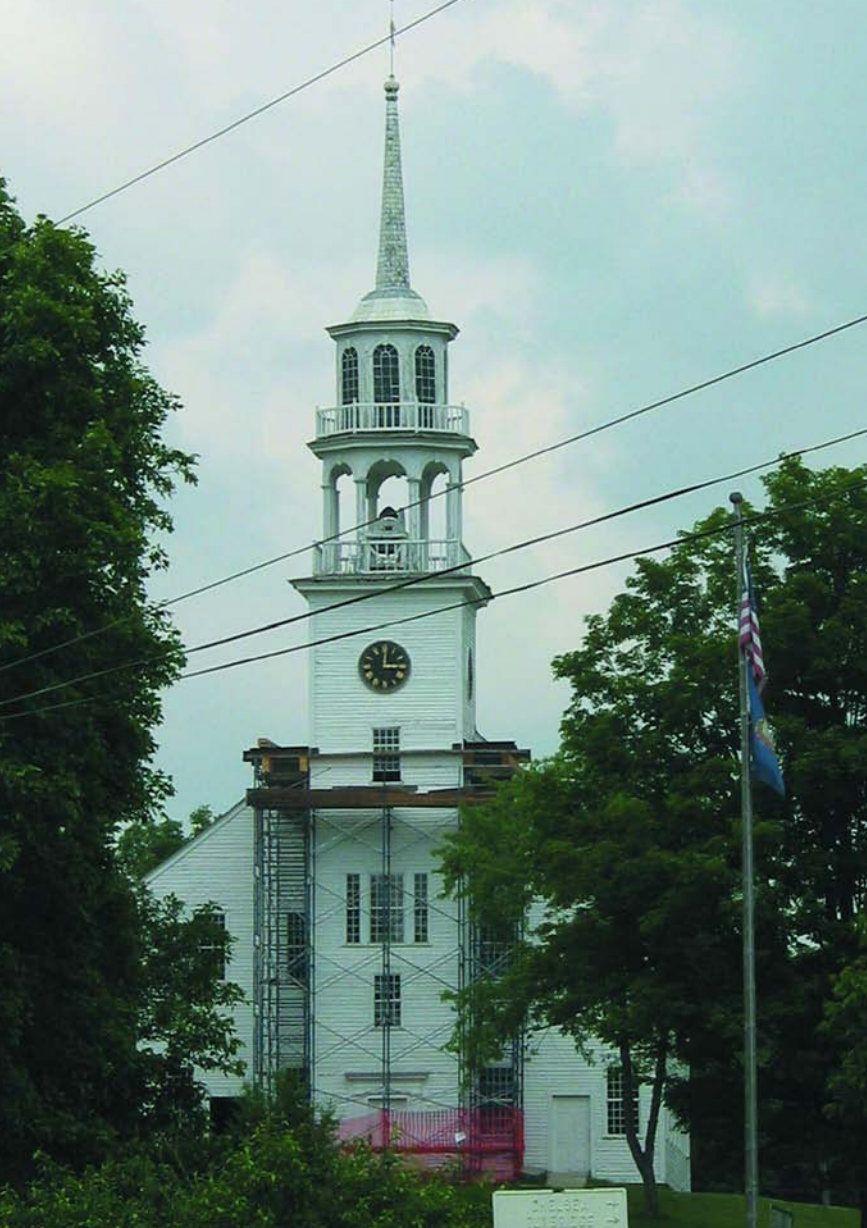
Fig. 15. Strafford Town House, Strafford, Vermont, 1799. Author used structural staging to lift and internally hold 68 ft. of steeple while repairs were made in place to supporting tower girts threatening failure.

IN carrying the belfry sleepers and posts, the tower girts also carry the lantern, spire, vane and all 68 ft. of framing and finish above. The main problem to be remedied at Strafford was the failure of tenons on three of the vital tower girts. The cause of this failure was twofold.

First, water infiltration at the front of the bell deck had run across the tower plate and down the posts. All being chestnut, they suffered little harm. The same water entering the mortises for the tower girts of spruce, pine and beech, however, caused their tenons to be weakened by decay, though not totally destroyed.

structure above was delivered by the sleepers to the inner edges of these timbers (because load always goes to the first point of stiffness). Meanwhile, the tenons of these supporting girts, 2 in. thick, 11 in. tall and set 2 in. from the outside face of the frame, unassisted by any bearing housings for the girts, took the entire eccentric load.

With few exceptions, American scribe and square rule framers from the 17th through the 20th centuries located tenons a framing square's tongue (1½ in.) or blade's width (2 in.) from an exterior reference face, almost ritualistically and regardless of the tenon's relationship to the forces it was expected to resist. At Strafford, with the weakened condition of the tower girt tenons, the eccentric loading and the absence of resistant bearing housings where the girts met the posts, rotation of the girts began to bend and break the tenons, threatening to drop the upper levels of the steeple.

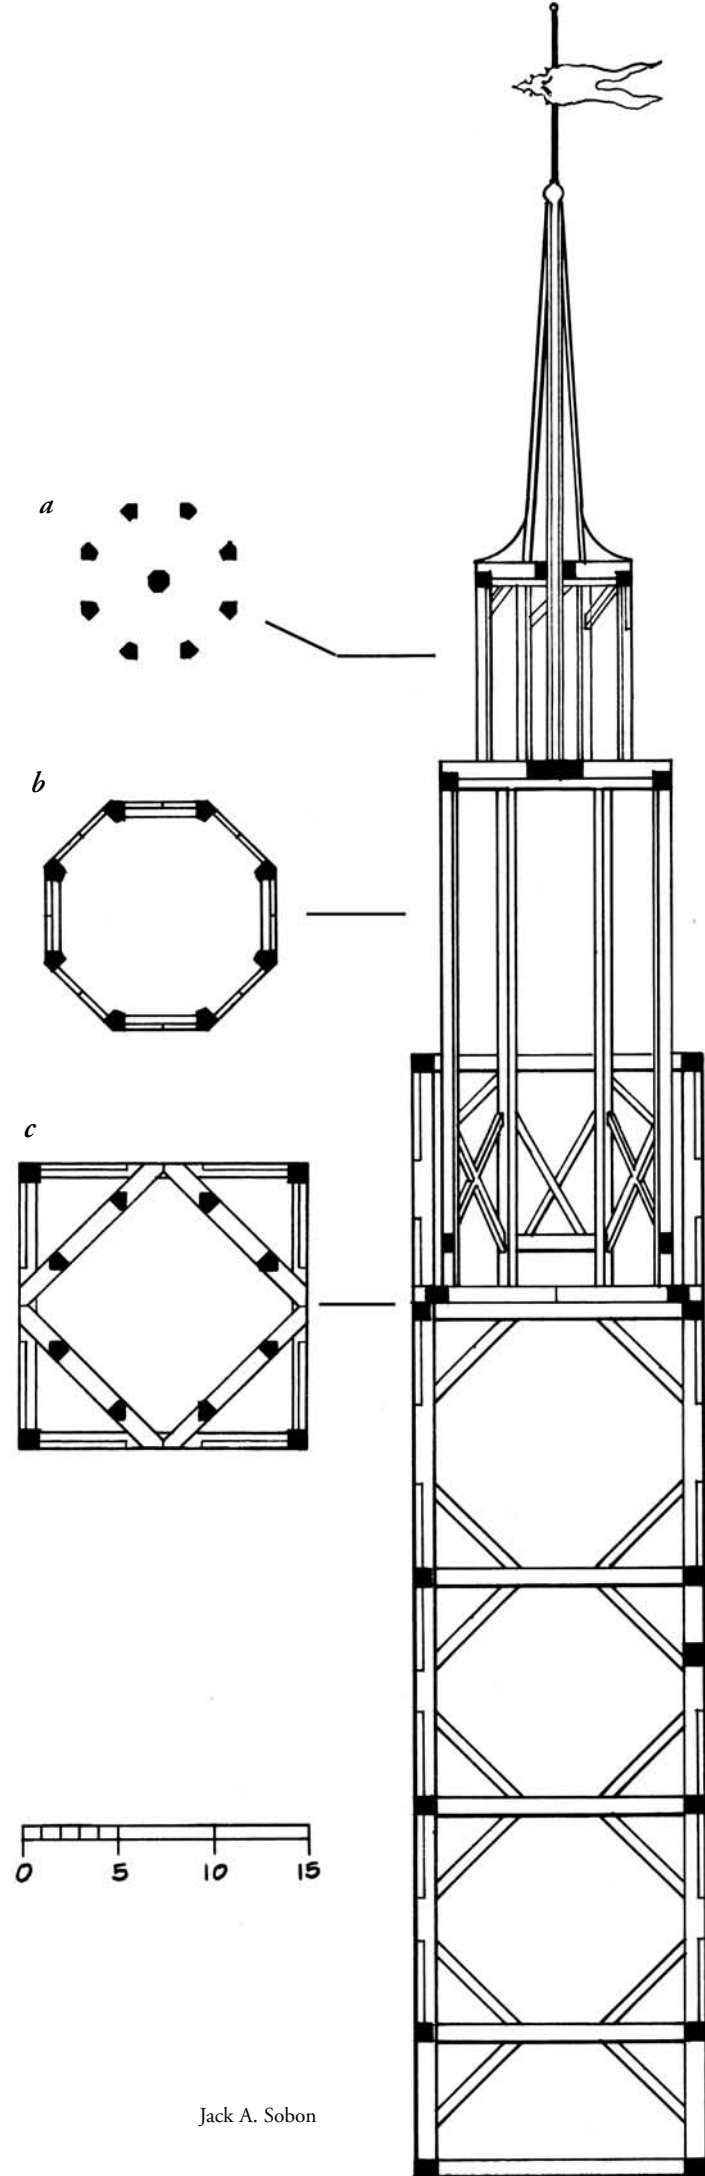
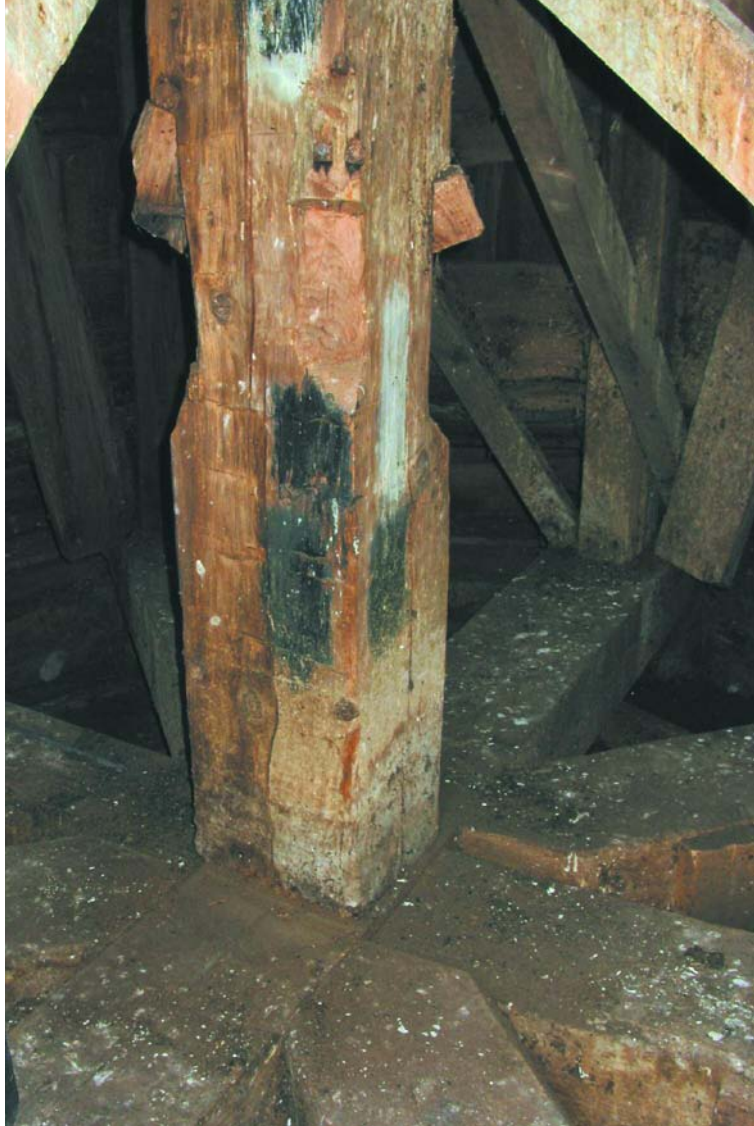
Fig. 16. Strafford steeple section seen from inside looking toward back of meetinghouse. First stage (tower) begins at grade and rises to bell deck, identical with tower roof. Second stage (octagonal belfry) begins on sleepers 14 ft. down in tower (section c) and rises to belfry roof (identical with base of octagonal lantern). Third stage (octagonal lantern) rises to base of spire. Spire mast is footed in belfry roof.

Fig. 17. Mast for Strafford spire is footed in eight-legged crab in belfry roof, which also forms base of octagonal lantern.

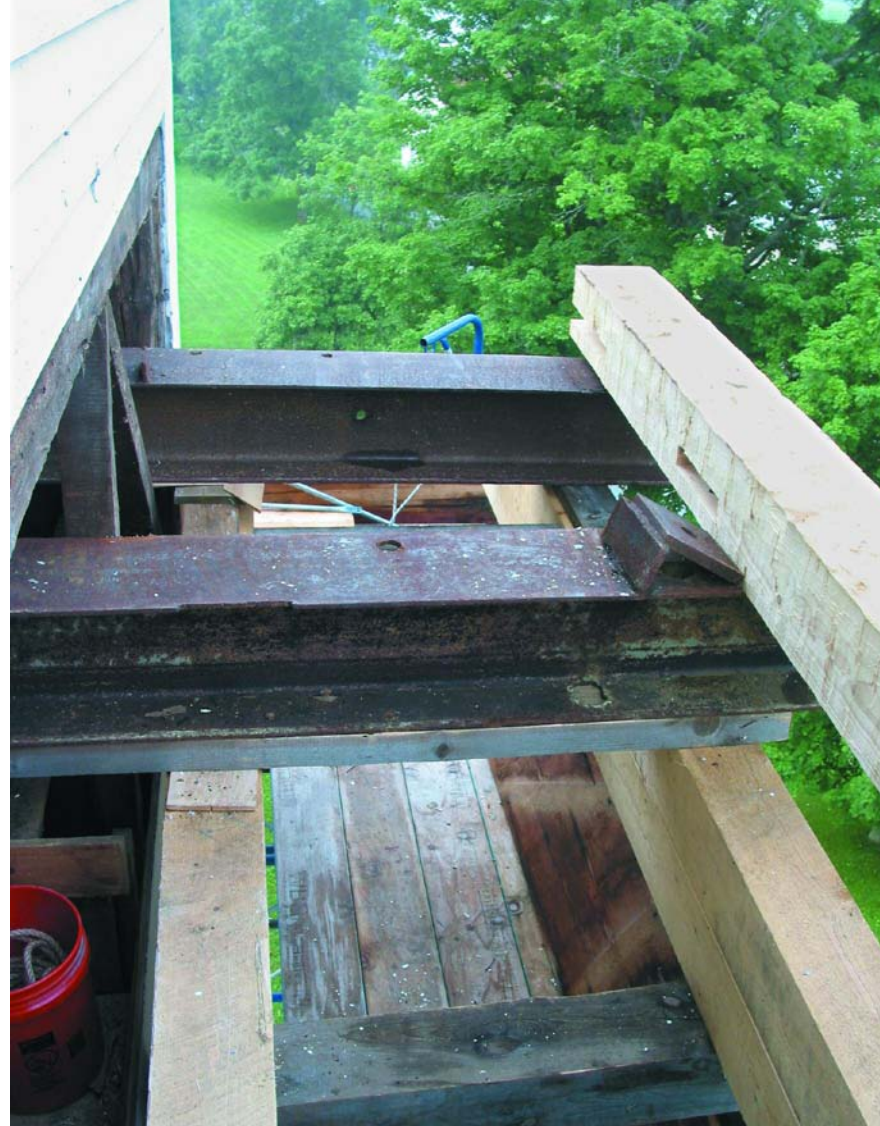
Fig 18. Structural staging supports cribbing to carry steel I-beams that lifted upper stages of Strafford steeple off supporting tower girts.

Since the belfry, lantern and spire were to be left in position at Strafford, the rigging problem was how to lift these upper stages off the tower girts that were failing under load. The solution was to erect 42 vertical ft. of tied-together structural scaffolding around all three sides of the tower, footed on good gravel. On top of the scaffolding at two opposing sides of the tower we established framed cribs, each composed of two levels of stacked 8x9x17 hemlock timbers spread 5 ft. apart by tenoned 6x6s (Figs. 15 and 18).

tion them over the panel points of the scaffolding. From this high platform we carefully removed the original clapboards and wide sheathing boards, saving them and their wrought nails, to expose the girts we would replace and to provide a space for the steel to be slipped through. The 12x12 I-beams, 25 ft. long and weighing about 2000 lbs. each, were lifted by crane and beam tongs and guided into the tower to rest on wooden rollers over 3-in. planks (Fig. 18).

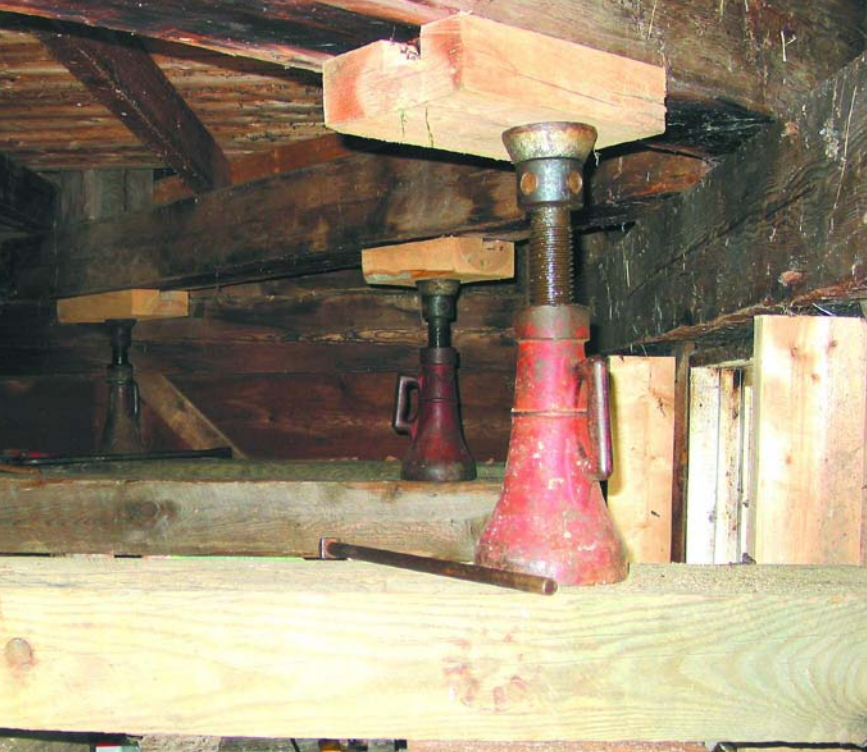
Fig 19. Eight 20-ton screwjacks (three visible here) push up under belfry post positions to lift Strafford's upper steeple stages.

We placed heavy cribbing spanning the I-beams and 20-ton screwjacks atop these, pressing on 4x10 hardwood blocks under the belfry post positions on the belfry sleepers (Fig. 19).

Turning these eight jacks at first deflected the I-beams a couple of inches and then readily lifted the approximately 20,000 lbs. of upper steeple off the girts. At this point we were free to cut out the damaged girts and replace them with new timbers (spruce of very high quality), free-tenoning one end to engage the fixed frame, and then repair or reposition the diagonal braces that rose to the girts.

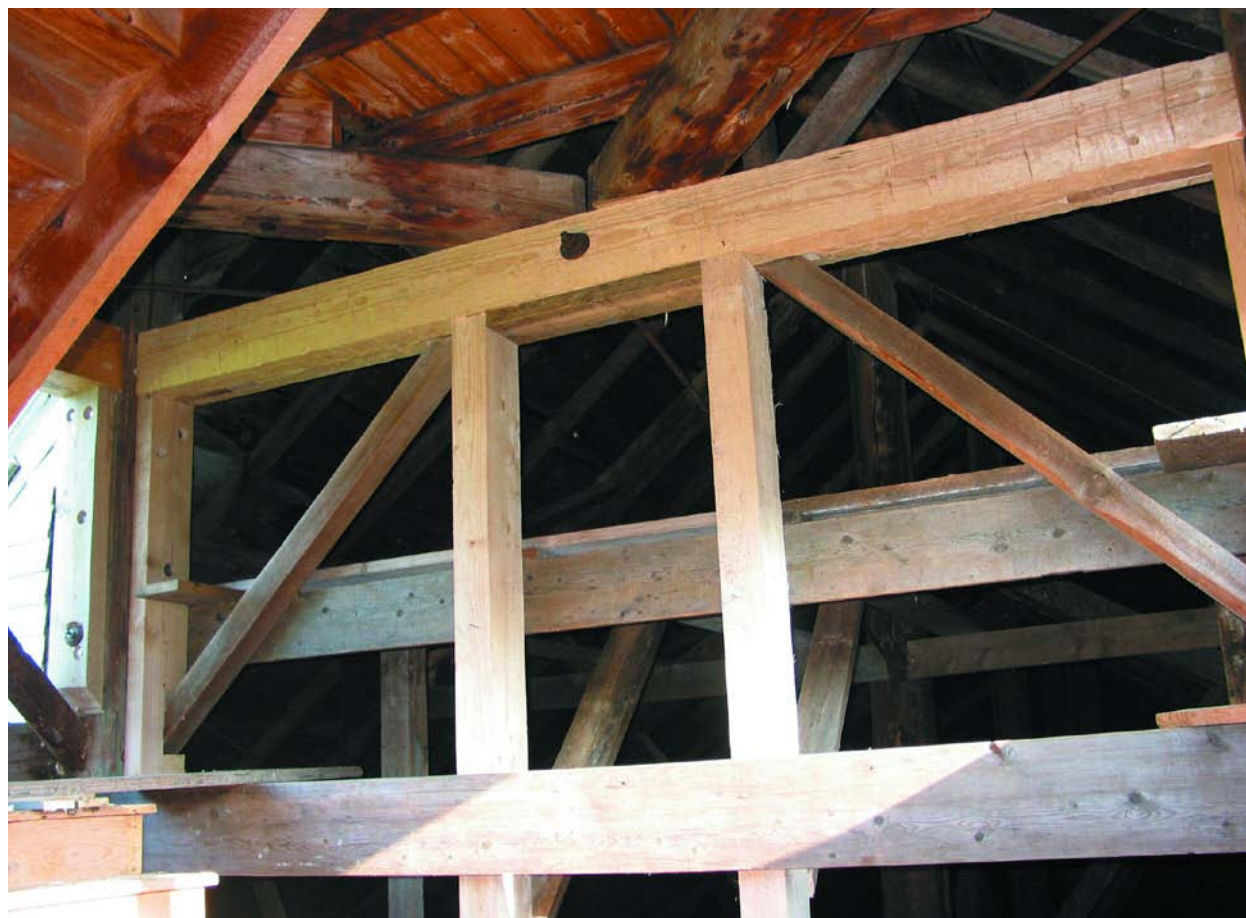
Fig. 20. New spruce tower girt supports diagonal sleepers carrying upper stages. Bolted 4x9 sisters at each end relieve 2-in. splined tenons of shear forces; long braces and median posts stiffen middle of girt against bending. At girt center, nutted iron rod (old but not original) runs back to tie beam of second interior roof truss.

Resistance to the fatal inward roll of the girts, as well as support for the free-tenon ends, were provided by bolting 4x9 hardwood studs to the corner posts right under a girt joint to the post and at two additional locations under a girt where belfry sleepers bear (Fig. 20).

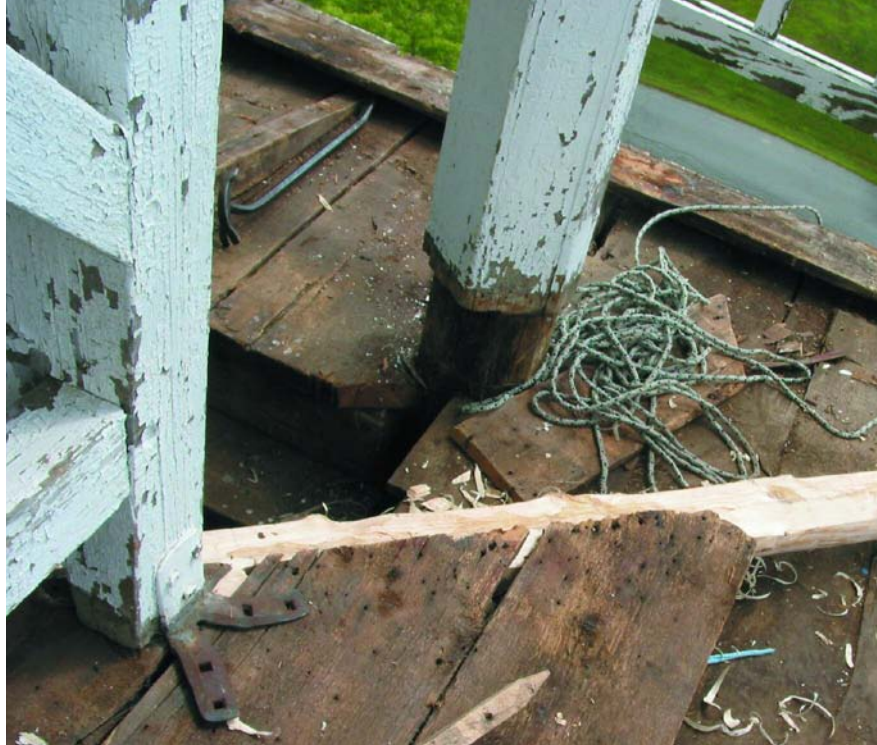
The bell deck was of great interest, with two versions still in place. The first, resting upon heavy bell girts crossing each other from the tower plates, comprised wide pine boards 1½ in. thick used in a sort of giant shingling (Fig. 21). The butt joints of these planks and the eight openings around the belfry posts had been caulked with oakum (rope fibers) mixed with tar, like the deck of a ship. However, unlike a ship's deck, no large crew would check the condition of its oakum caulking every day, so this deck failed to keep water out. Another had been built on top of it using 4x5 hardwood rafters, pine and spruce boards and painted pine shingles. Sometime in the 20th century this second deck was covered with galvanized metal. Throughout these changes, the columns were kept well flashed where they passed through the deck, a common locus of deterioration, and no problems occurred there.

Fig. 21. Old bell deck covering of thick planks caulked with oakum and tar revealed by removal of younger deck of rafters, boards and shingles.

Repairing the deck was straightforward. The metal and the wood shingles were removed, two hip rafters replaced in kind and the rotten boards renewed. The town had decided to try a membrane covering and a contractor laid it on ½-in. plywood so as not to attach it irreversibly to the historic bell deck. We left the original plank and oakum deck in place as a rare survivor.

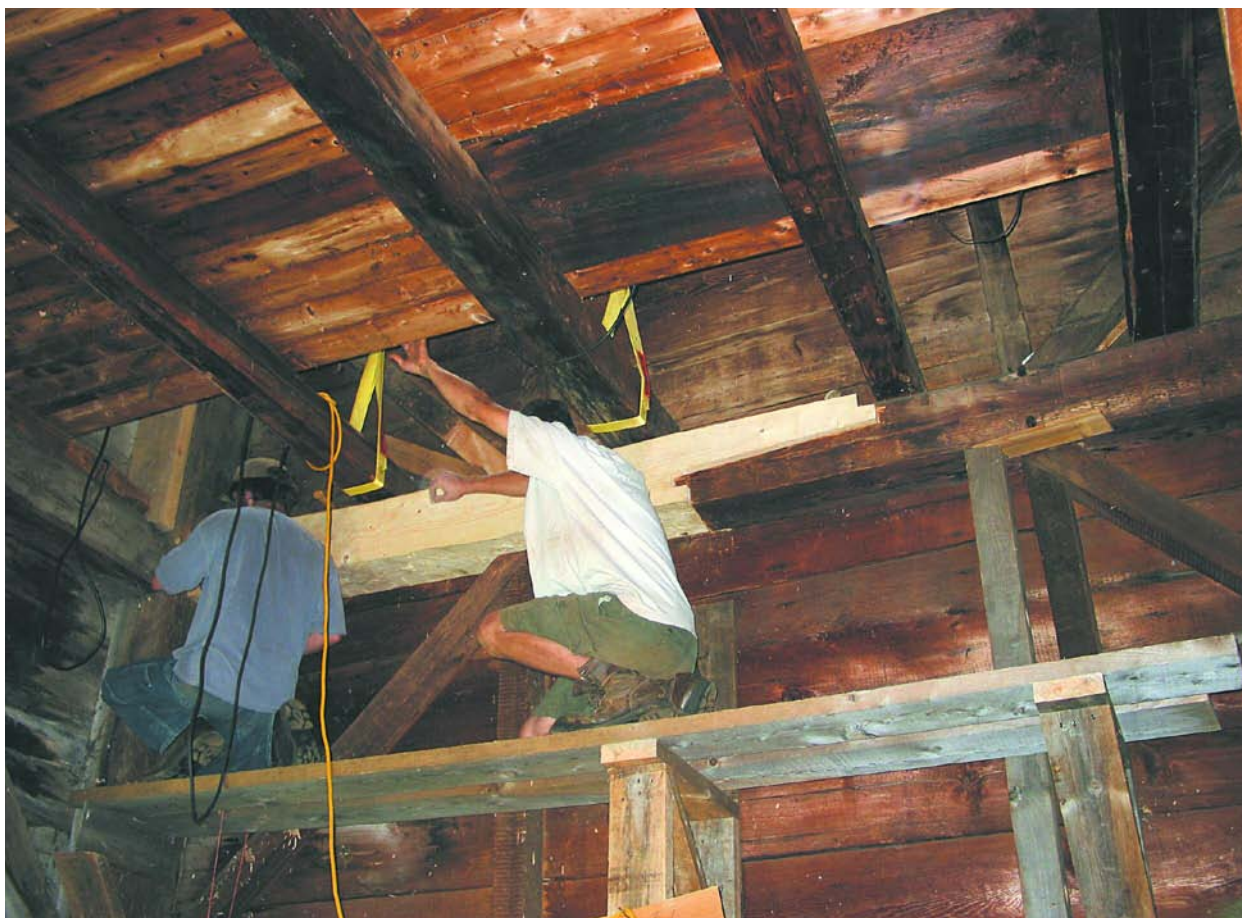
Other problems at Strafford included a horizontal tower girt (not directly bearing upper steeple loads) rotted for half its length and needing a scarfed timber repair (Fig. 22 overleaf). The bell deck was leaking and in need of a new covering as well as replacement of some of its structural members, including two hip rafters.

Fig. 22. Seth Kelley (at left) and Michael Cuba install stop-splayed and tongued scarfed repair to rotted wall girt in Strafford tower. Girt carries relatively light clock-room floor, does not support upper steeple stages. Free tenon (hidden by Kelley) allows insertion of new piece from side.
