1978 Catalina 30 Hull Number CTYN0987M78F Refit Replacement of Pipe Stem/Gate Valve Thru-Hulls

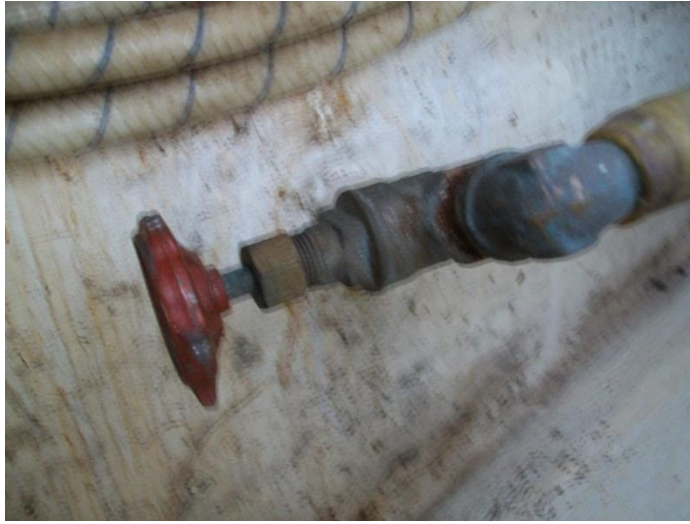
Catalina drilled holes through the hull, placed brass pipe nipples in the holes, and glassed the brass pipe nipples to the hull. Brass gate valves were then threaded onto the pipe nipples. This comprised the original thru-hull equipment. There are three thru-hulls: one brings in water for the helm (under the port settee), one is the raw water intake for engine cooling (engine compartment on the port side), and one is the sink drain (port side aft of the engine compartment next to the water lift muffler). Here is one of the original thru-hulls:

Much was said about the need to replace these on the C30 forum, they were also identified as requiring replacement by the purchase survey.

The comments on read on the C30 forum and the survey report made this sound like a critical issue and a serious safety hazard. One person on the C30 forum said the pipe nipples almost “fell out of the hull” when pushed on. It took me around three hours per thru-hull to remove. They were fastened to the hull like iron.

After I remove all attached hoses I tried removing the valves with a wrench. That did not work, and I was forced to use my small rotary tool and a cutting wheel to cut through the fiberglass surrounding the pipe nipple as well as the pipe nipple. This was very slow work. Once I had the valve and most of the nipple cut out of the way I thought I would be able to push the remainder of the pipe nipple out of the hull. This did not work either; the remaining pipe nipple would not budge. I was forced to drill a sequence of holes in the hull all around the pipe nipple to get it out.

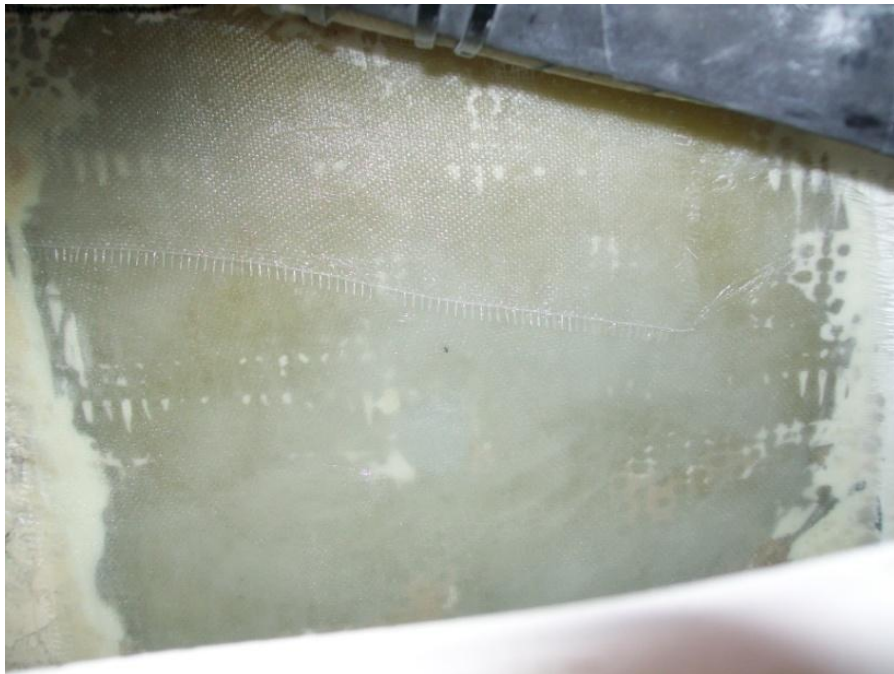
Here is the inside hull area around the thru-hull under the forward settee.

A household cleaner was used to remove as much filth as possible from around the area of the old pipe nipples on the inside of the hull. A right-angle grinder with a 36 grit sanding wheel was used to grind away all of the old fiberglass and gel coat down to the original hull glass layers in roughly a one square foot area around each opening. The holes through the hull were smoothed with a rat tail file. The area was then cleaned thoroughly with acetone.

Tape was placed on the outside of the hull over the holes. The prepared area was painted with epoxy, and then a layer of epoxy thickened with milled fiberglass was spread over the area filling the hole. Two layers of fiberglass cloth, a layer of woven roving, two layers of fiberglass cloth, a layer of woven roving, and two layers of fiberglass cloth were then applied.

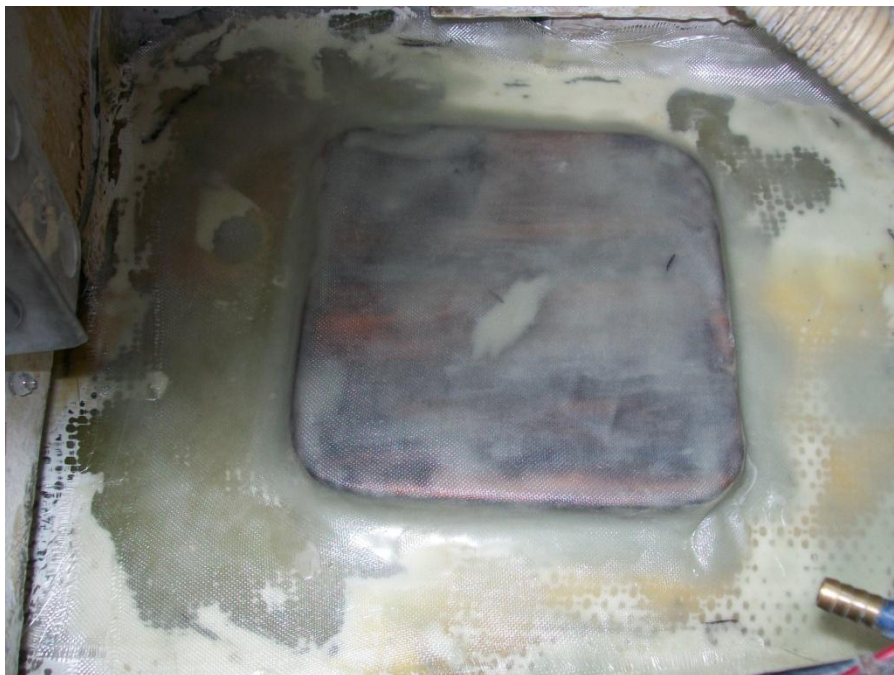
Here is the inside hull area around the thru-hull at the aft end of the engine compartment.

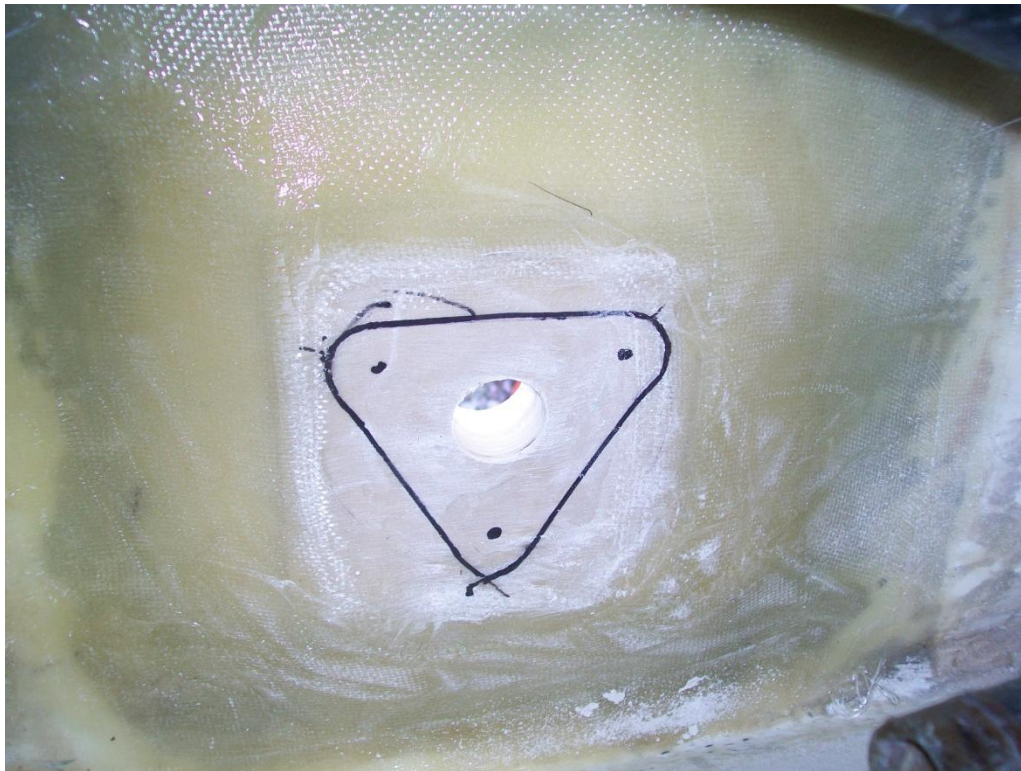
Here is the thru-hull under the forward port settee. This is ready for drilling to install the seacock.

A one-half inch thick piece of solid fiberglass board material was then applied as a backing board. Following sanding and cleaning of the underlying fiberglass with acetone, the area was painted with epoxy and then covered with a thick layer of epoxy and milled fiberglass mixed to a peanut butter thickness. This thickened mixture filled in the gaps between the straight fiberglass board and the curved hull. The fiberglass board was held in place by a small machine screw (#6), washers, and nut placed in a hole drilled through the center of the hole in the hull.

When this had set, the area was again sanded and cleaned with acetone. The edges of the fiberglass backing board and surrounding area were painted with epoxy and a fillet of epoxy thickened with milled fiberglass was placed around the edges of the fiberglass backing board. The edges of the fiberglass backing board and the surrounding hull area was then covered with six layers of fiberglass cloth.

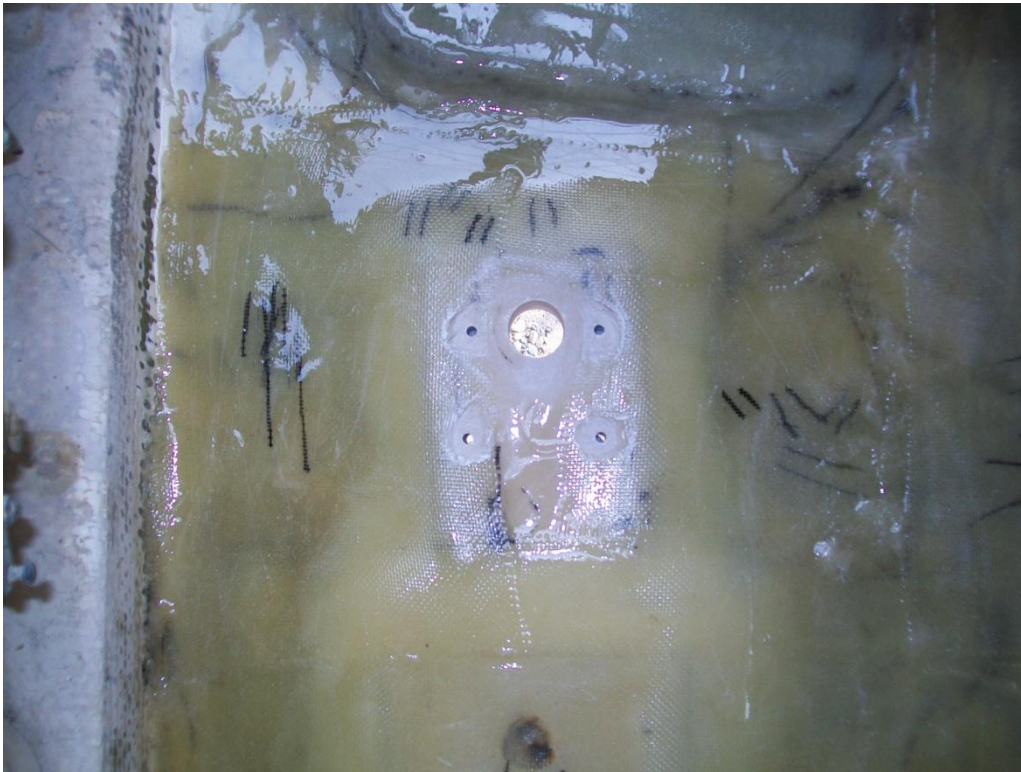
Here is the thru-hull for the engine scoop; the depth gauge and speed holes are at the bottom of the picture. The area where the engine scoop nut will tighten against as well as the bolt nuts has been sanded flat. You can see the solid fiberglass backing board, the fillet of thickened epoxy, and cloth layers.

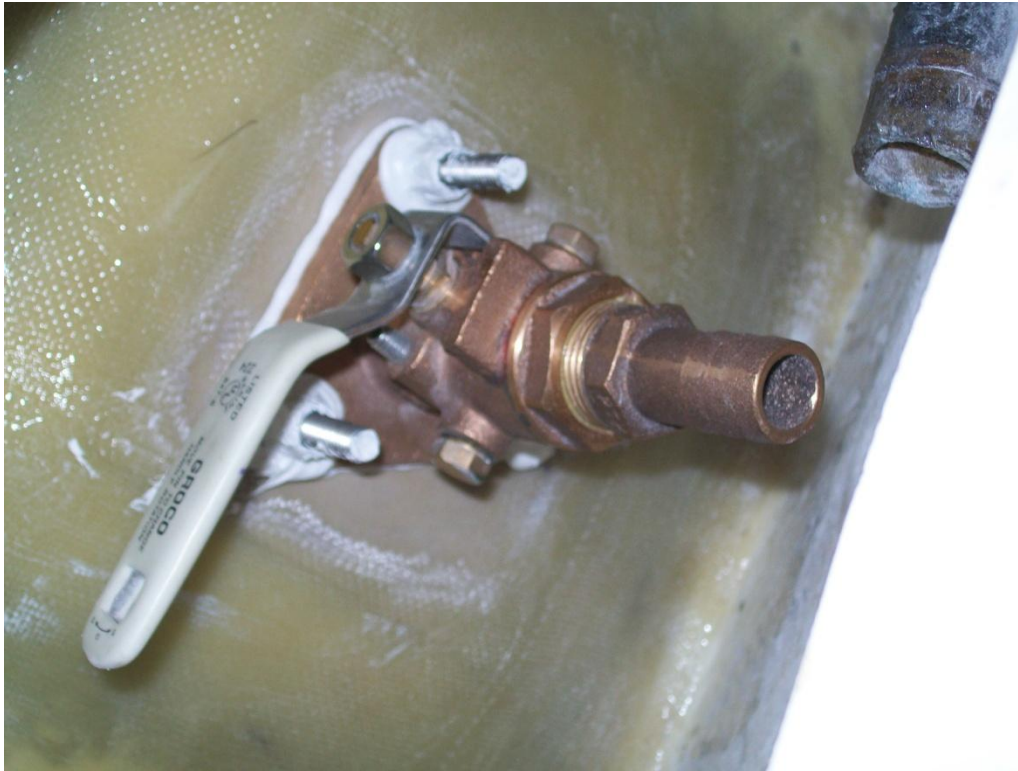
Here is the installed seacock under the forward port settee.

The holes through the hull and bolt holes were drilled. The bolt holes on the outside of the hull were countersunk. Stainless steel bolts, washers, lock washers, and nylon lock nuts were used. Brass would have been ideal, but is a soft metal and difficult to work with. Stainless steel and brass are fairly close on the compatibility scale. A liberal coating of LifeCalk sealant was used.

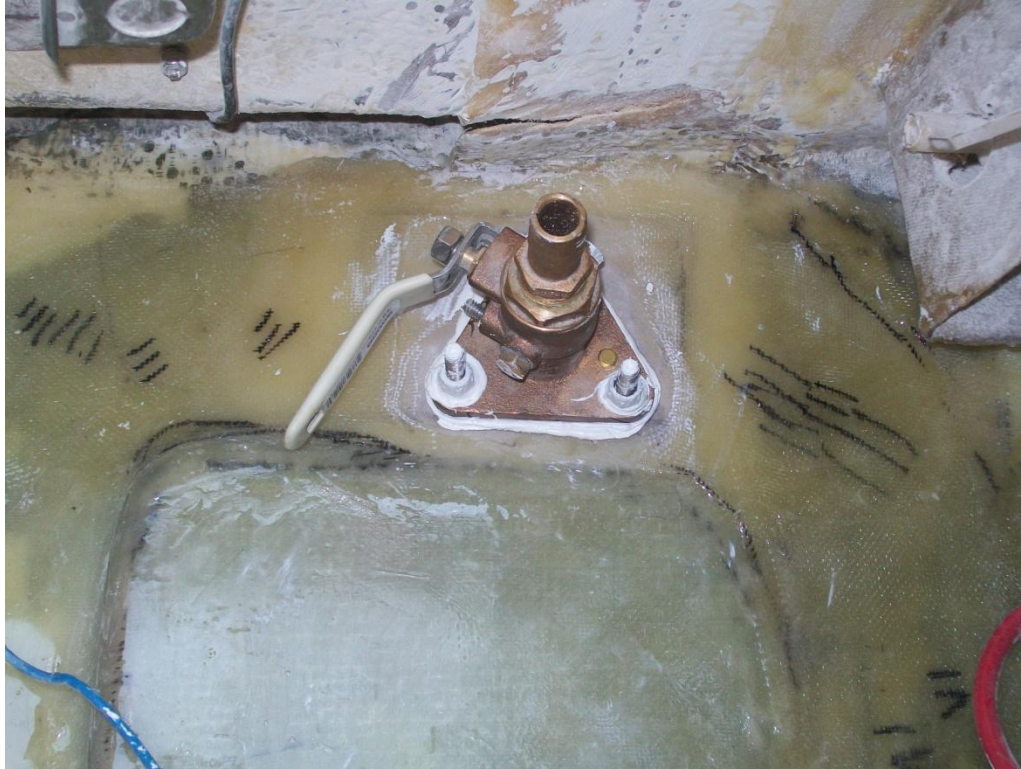
Here is the installed seacock at the port aft end of the engine compartment.

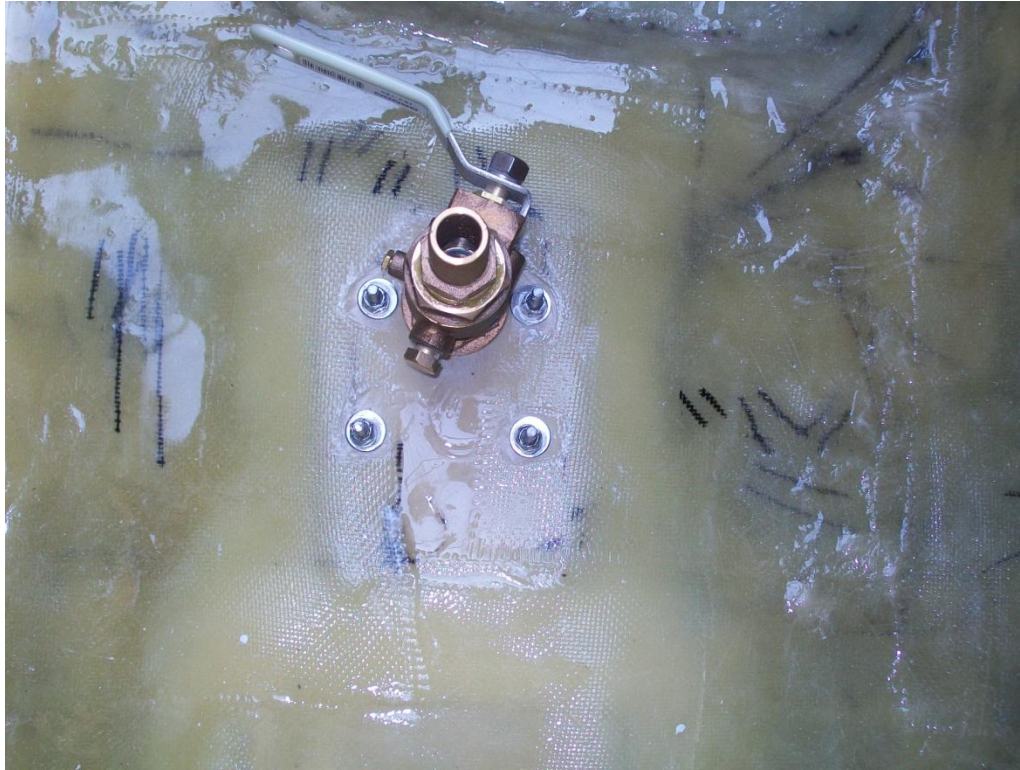
Here is the installed engine scoop.

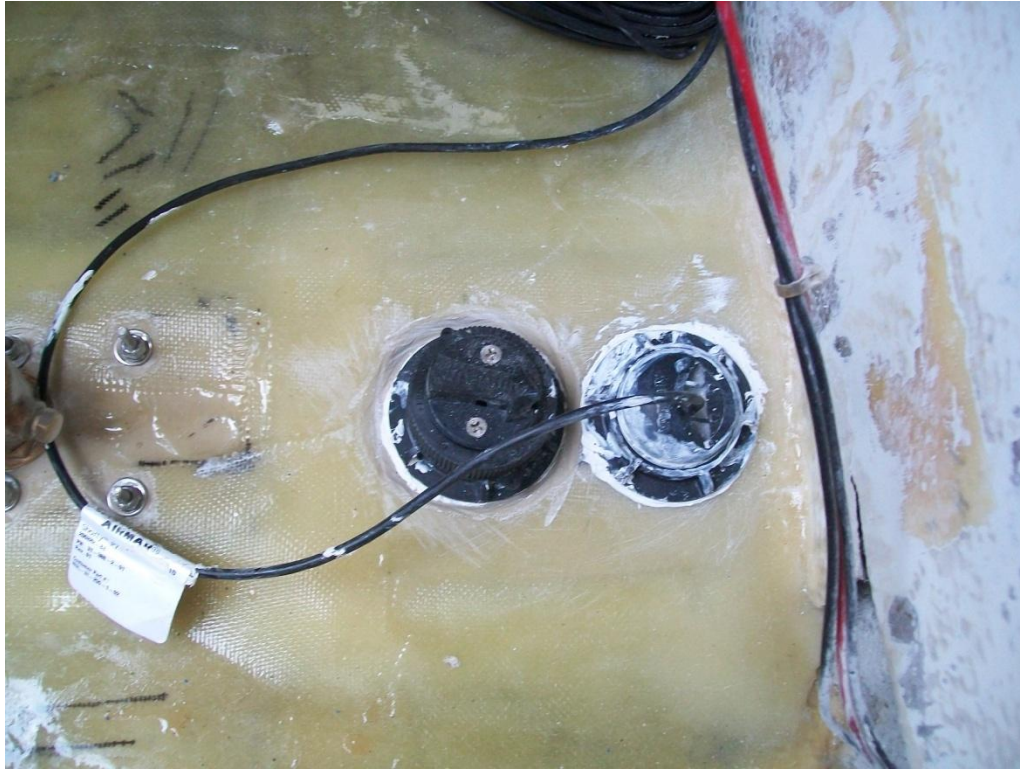
Here is the installed depth and spend thru-hulls.
