- **WMO ID 6903269**
  - SBE41CP
  - 229 profiles
  - Deploy 2019/09/11
  - Levantine sub basin
  - Active

### OWC results

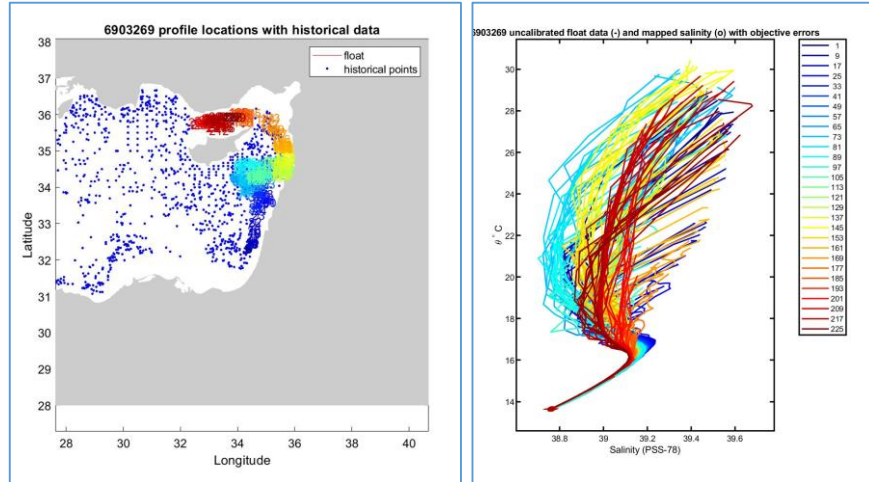
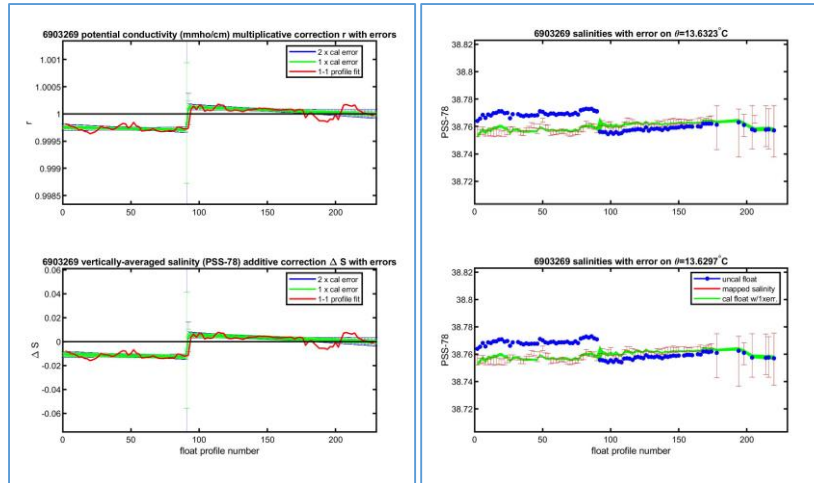
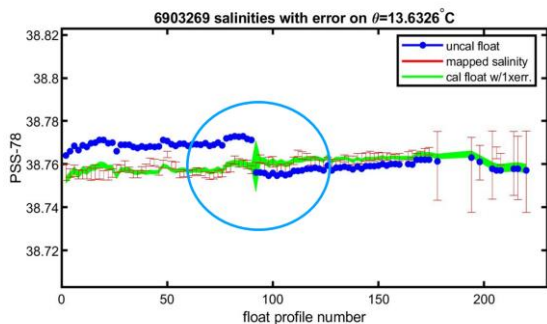
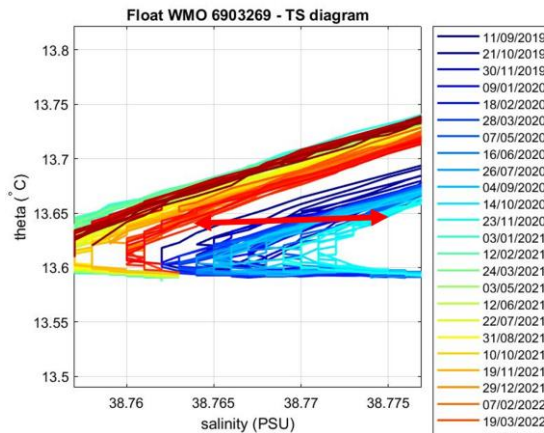
What happened at cycle 90? The jump is not due to natural variability or different water masses. Sensor problem? After cycle 90, is the salinity correct?
