## STM32H745xI/G, STM32H755xI, STM32H747xI/G, STM32H757xI device errata

This document applies to the part numbers of STM32H745xI/G, STM32H755xI, STM32H747xI/G, STM32H757xI devices and the device variants as stated in this page.

It gives a summary and a description of the device errata, with respect to the device datasheet and reference manual RM0399.

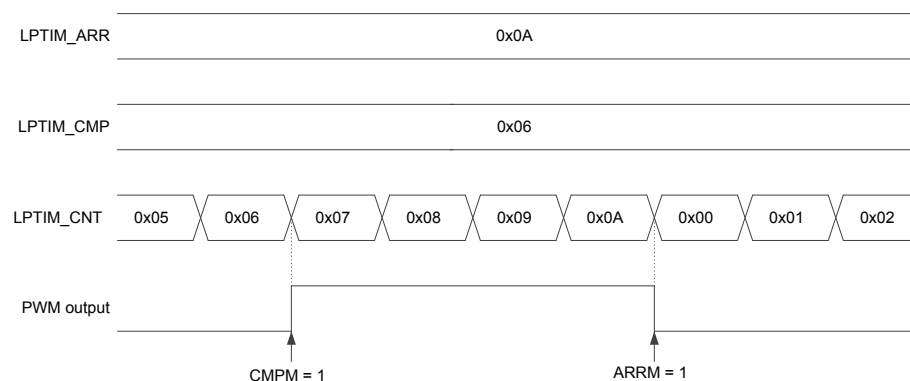
**Figure 1. Example of PWM output mode**

The following waveform gives the example of PWM output mode and the effect of the delay:

Set the compare value to the desired value minus 1. For instance in order to generate a compare match when LPTIM\_CNT = 0x08, set the compare value to 0x07.

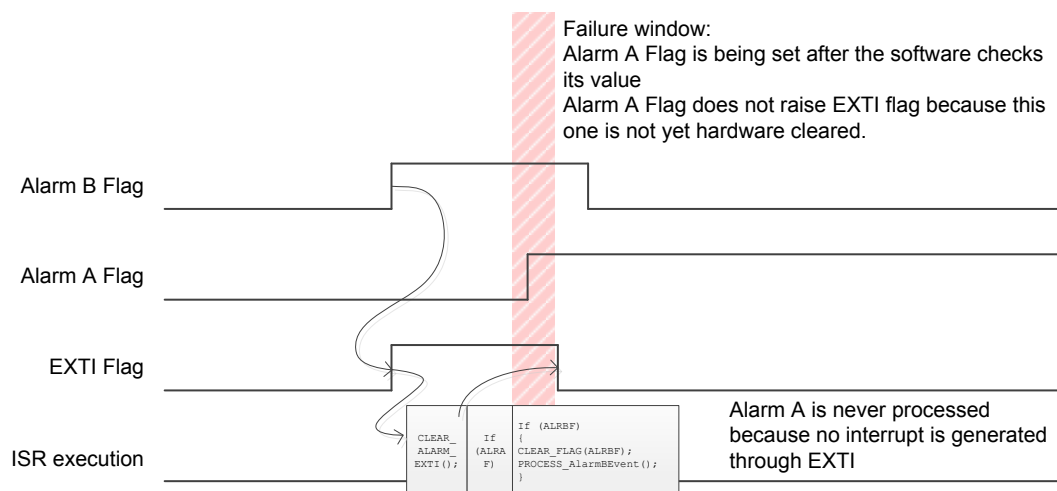
**Figure 2. Masked RTC interrupt**

The following code example and figure illustrate the failure mechanism: The Alarm A event is lost (fails to generate interrupt) as it occurs in the failure window, that is, after checking the Alarm A event flag but before the effective clear of the EXTI interrupt flag by hardware. The effective clear of the EXTI interrupt flag is delayed with respect to the software instruction to clear it.
