SUBJECT : Notice for Suspension

Audit Findings: FAS Dock Audit - Interchanged Polycard

Final Assembly Process Inspection Record

INTERCHANGED POLYCARD		
Product No. 36064-64PE0, 36062-64PA0 Lot No. 59ZV51 & 59AJ73 Serial No. 60 Polycard Serial: 24 Defect Encountered: 7/25/2019

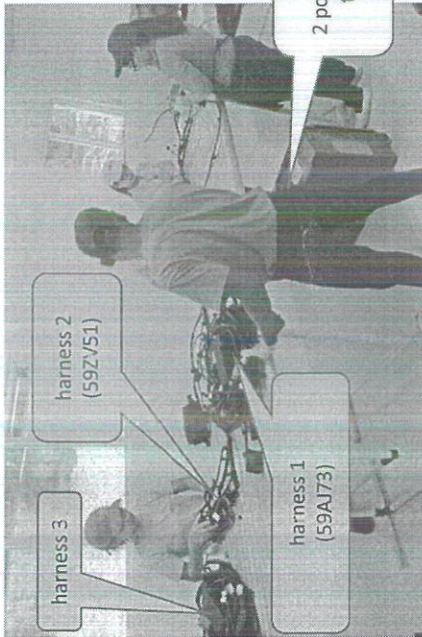
Three harness were located in the table where in 2 polybox were also together under the table.

2 polybox under the table

<p>Three harness were located in the table where in 2 polybox were also together under the table.</p>	<p>1. Re-educate inspectors for the risk of same defect occurrence if not following the SOP of one harness only at a time. 2. Implementation of one harness only at a time (no opening of another polybox until such running product is already packed) 3. One by one checking of lot number after packing and before transferring to FG pallet.</p>

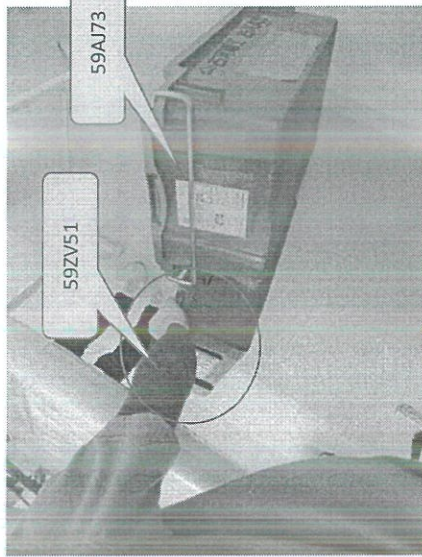
Inspector mistakenly get the polybox of 59ZV51 instead of 59AJ73

<p>Inspector mistakenly get the polybox of 59ZV51 instead of 59AJ73</p>	<p>1. Implementation of one harness only at a time (no opening of another polybox until such running product is already packed). One polybox only under the table Provision of Work Instruction for step by step procedure of FALP Dock audit inspection (registered last: July 08, 2019)</p>

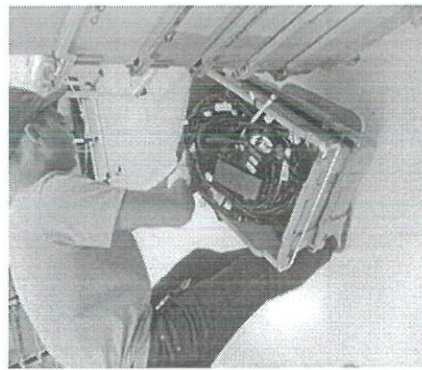
After packing, no checking conducted and did not use manual barcode scanner . Also no checking conducted before transferring to pallet.

MACHINE	<p>Forgot to barcode by manual scanner due to unavailability. Only two scanner were available in Dock audit area 1 due to limited stocks.</p>	<p>Already requested additional scanner, waiting for the arrival</p>
