# Report on the accident at Windscale No. 1 Pile on 10 October 1957<sup>\*</sup>

To cite this article: William Penney *et al* 2017 *J. Radiol. Prot.* **37** 780

William Penney<sup>1,6</sup>, Basil F J Schonland<sup>2,6</sup>, J M Kay<sup>3,6</sup>,  
Jack Diamond<sup>4,6</sup> and David E H Peirson<sup>5,7</sup>

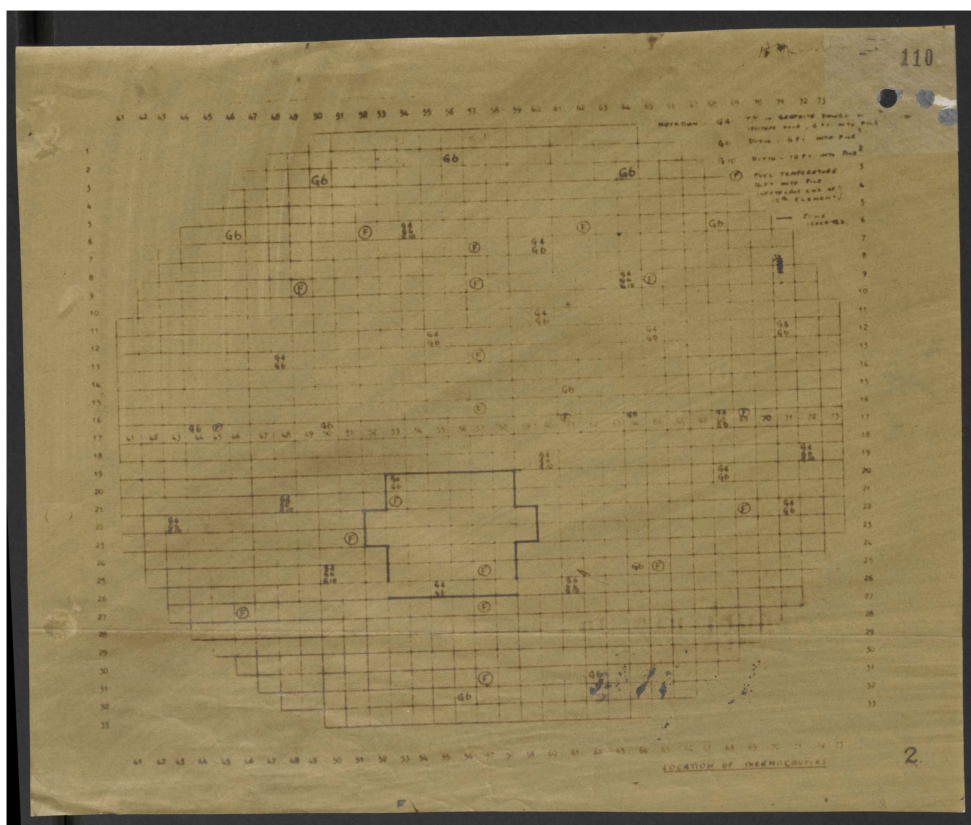
## Appendix B. Location of thermocouples

\* The location of the uranium and graphite thermocouples is shown at appendix B.

101. A major technical defect contributing to the accident was the inadequacy of instrumentation for the safe and proper operation of a Wigner release. The uranium thermocouples were correctly positioned for normal operations, but not for Wigner releases; moreover, in the condition of stagnant air which had necessarily been created within the pile, there was no means of detecting the smouldering uranium cartridges, which we believe to have been a key event in the development of the accident.
