Case Study of an Electric Vehicle Battery Thermal Runaway and Online Internal Short Circuit Detection

Wei Gao, Xiaoyu Li, Mina Ma, Yuhong Fu, Jiuchun Jiang, *Member, IEEE*, and Chris Mi, *Fellow, IEEE*

Index Terms—Electric Vehicles, Lithium Ion battery, Thermal Runaway, Internal Short Circuit, Fire Accident

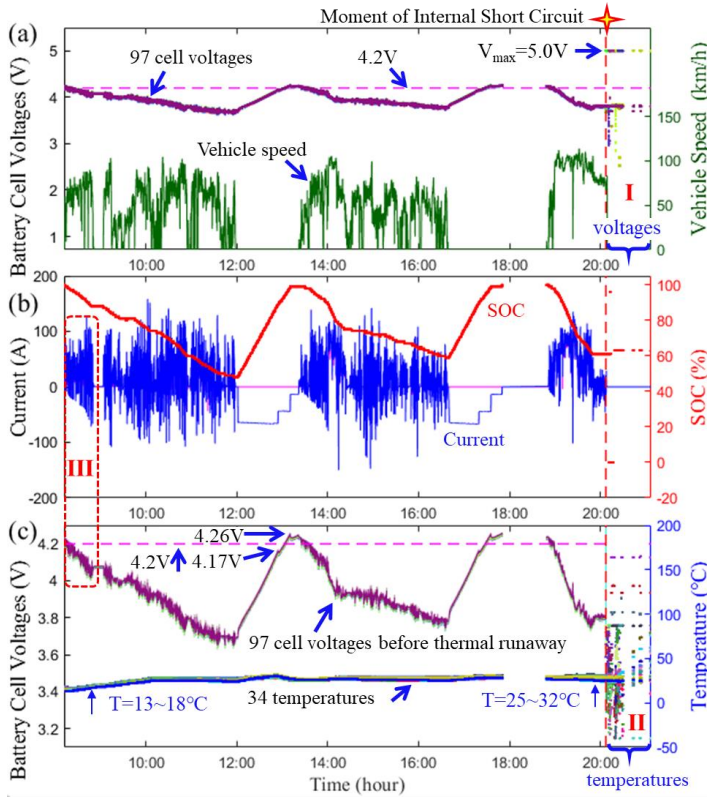
Fig. 1 shows the vehicle operation data of the day when TR happened. The vehicle started to operate from about 8:00 am and operated normally during the day until TR occurred at 20:07pm. The battery temperatures were between 13°C~32°C, and the maximum charging/discharging currents were below one C-rate. The vehicle was driven more than 400 km during the day. The odometer reading was about 10000km, which suggests the vehicle was fairly new.

After TR started at 20:07pm, many signals began to show fault readings, as depicted in region I and II of Fig. 1. A zoomed in figure after TR is shown in Fig. 2. The battery cell voltages scattered between 2V~5V. Some batteries experienced continuous voltage drop, including cell 27, 26 and

Fig. 1. Electric vehicle operation data of the day. (a) Cell voltages and vehicle speed. (b) Current and SOC. (c) Cell voltages and temperatures.

Fig. 1(c) shows that each charging process consists of three stages: 65A charging to 4.17V, then 44.7A and 13.5A charging to 4.26V, respectively. For most LiNMC traction batteries, the charging cutoff voltage is set to 4.2V, and many OEMs are trying to avoid fully charging the batteries to ensure safety and prolong battery cycle life. However, the OEM of this EV is trying to overcharge the batteries to achieve a longer driving range. According to Table I, approximately 10% more energy (6 kWh) was charged to the batteries in stage 2 and 3, which could extend the EV driving range by 44km (13.5kWh/100km). Fig. 1(b) area III also shows that this EV allows braking energy recovery from 100% SOC, which should be prohibited above 95% SOC.

Although we cannot draw a concrete conclusion that overcharge is the cause of this TR accident, it is still highly recommended not to overcharge the batteries.

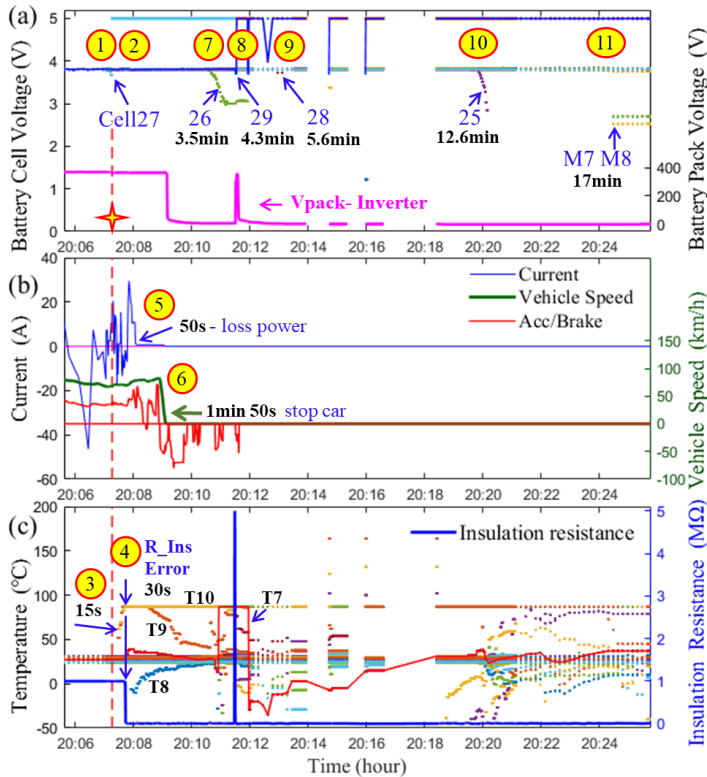
Fig. 2. Battery thermal runaway and its propagation. (a) Battery cell voltages and battery pack voltage. (b) Current and vehicle speed. (c) Temperatures and insulation resistance.

Temperatures in Fig. 2(c) scattered between -40°C~85°C, which is the limit of temperature readings in the BMS. Negative temperature coefficient (NTC) sensors are usually used to measure temperatures. High sensor resistance indicates low temperature. When the NTC signal wires got burned in the fire during the accident, the resistance of the signal wires would increase dramatically, thus, inducing low temperature readings in the BMS. After the fire went out, temperature readings would recover gradually. Therefore, subzero temperature readings can be used as evidences of fire in the battery pack.

Step 4: 20:07:43 (30s): T9 and T10 rose to above 85°C, while T8 dropped to subzero. The insulation resistance (R_{Ins}) dropped from 1M Ω to zero, which means there was a high voltage leakage to the vehicle chassis. The clues indicate that the flame had burst out of submodule 5. Then in the next three minutes, T8 and T9 recovered towards normal temperature gradually, indicating the flame of battery cell 27 went out gradually.

Step 6: 20:09:03 (1minute 50s): The vehicle speed was about 61km/h, then the driver stopped the car, and the DC bus voltage of the inverter was disconnected. However, the Acc/Brake pedal signal in Fig. 2(b) shows that the driver did not evacuate immediately but tried to restart the vehicle two minutes later on Step 8.

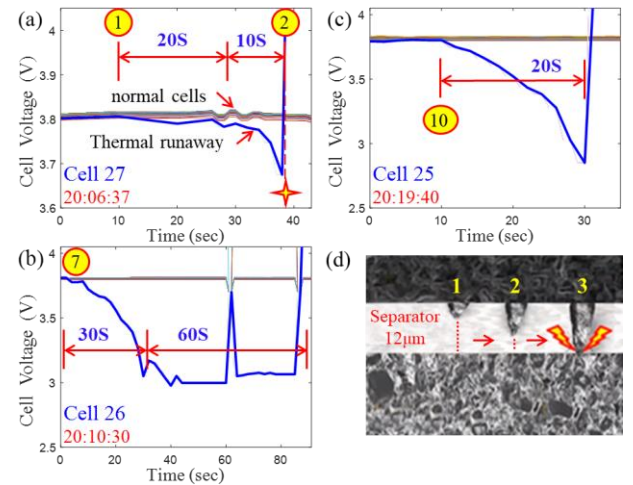
Due to the BMS setting, the measured battery voltages out of normal range (i.e., 2.8V~4.3V) were recorded as 5V to indicate error state. Therefore in Fig. 3, the voltage readings jumped to 5V during the voltage drop process, although in fact the voltages were still dropping.

Step 1: 20:06:47 (-26s before thermal runaway): Fig. 3(a) shows that the voltage of battery cell 27 (V27) started to diverge from other batteries gradually, which indicates ISC began to develop inside battery cell 27.

A possible theory of the TR is that: a lithium dendrite or burr was growing on the surface of anode or cathode, and finally it pierced through the separator after hundreds of charging cycles and caused micro short circuit, as illustrated in Fig. 3(d). Heat and gas generated in the process aggravated the short circuit, and 26 seconds later, a violent TR occurred.

Fig. 3. Voltage drop of battery thermal runaway. (a) Thermal runaway of battery cell 27. (b) Thermal runaway of battery cell 26. (c) Thermal runaway of battery cell 25. (d) Separator pierce process of cell 27.

Step 7: 20:10:52 (3.5 minutes): TR started in battery cell 26 due to overheat, as depicted in Fig. 3(b). V26 dropped from

3.8V to 3.0V in 30 seconds, then sustained for 60 seconds before it dropped out of the normal range. This is because the separator holes were closed under 140~170°C [1], thus the TR was stopped temporarily, then with a totally melted down of the separator, a violent TR happened again [7].

Step 10: 20:19:53 (12.6 minutes): TR occurred in battery cell 25, as depicted in Fig. 3(c). Then the explosion caused the battery measurement unit (BMU) to restart, thus V1~V47 signals were offline for a few seconds as shown in Fig. 4(a).

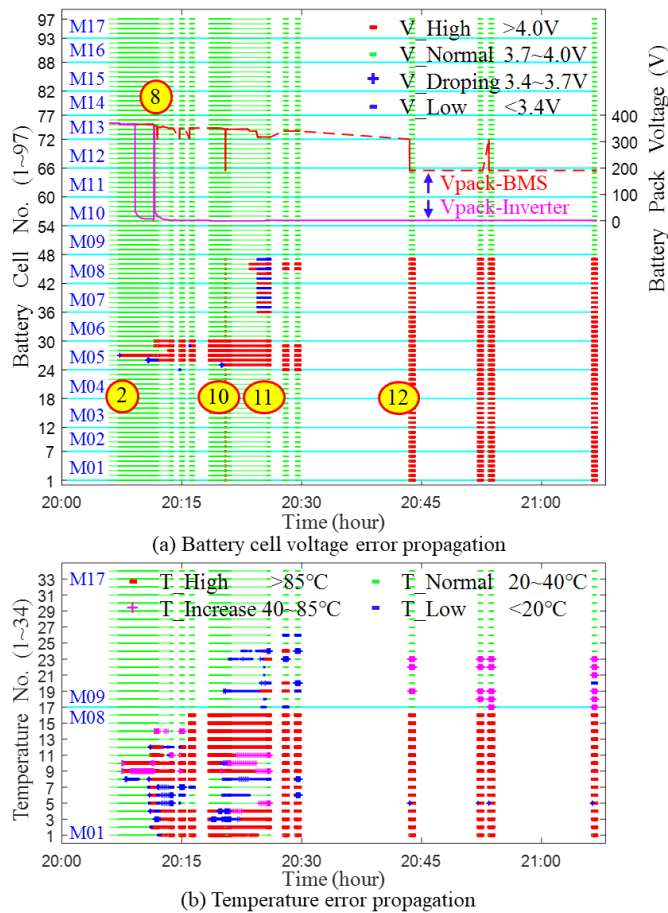
Fig. 4 shows the battery cell voltage and temperature fault signals propagation in the battery pack. The gaps in the signals suggest that the BMS was waken up 9 times after TR.

Fig. 4. Battery cell voltage and temperature fault signals propagation map.

Step 11: 20:23:09 (17 minutes): Battery voltage signal errors of V36~V47 (M07 and M08) were detected. But the pattern seems like signal wire or BMS failure but not a TR.

Step 12: 20:43:29 (37 minutes) to **21:06:00** (1 hour): In M01~M08, all signals (V1~V47 and T1~T14) were offline. This suggests the BMU was damaged in the fire. It is not clear whether TR spread to other submodules besides M05. In M09~M17, all battery cell voltages were normal, suggesting TR was not spread to these submodules. However, there were still high temperatures detected in M09~M11.

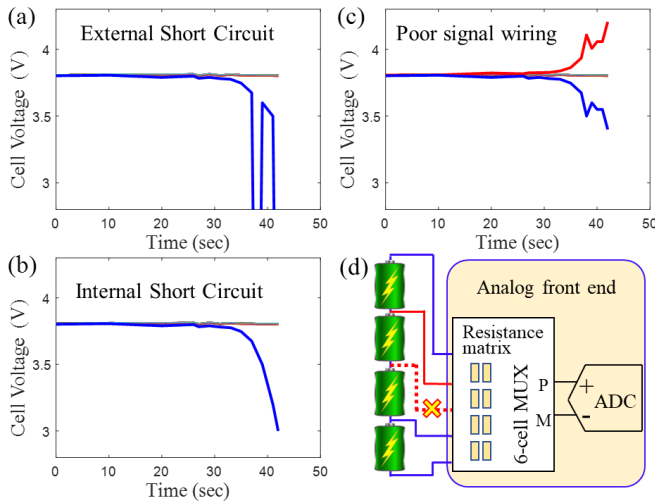
Fig. 5 compares three different battery voltage fault signal patterns. When an external short circuit occurs, the battery voltage would drop dramatically to nearly zero, and may jump back and forth. In the case of ISC, there would be a continuous voltage drop process. Poor voltage signal wiring is usually caused by a loose connector. In this case, usually the two adjacent voltage readings would diverge to opposite directions, because the poor contacted voltage signal is floating, while the upper voltage channel loses ground reference, as depicted in Fig. 5(c)-(d). Therefore, the continuous voltage drop is a unique feature of battery ISC, and this feature can be used to detect ISC online.

Fig. 5. Different patterns of battery cell voltage fault signals. (a) Battery external short circuit. (b) Battery internal short circuit. (c) Poor voltage signal wire connection. (d) Voltage measurement and poor signal wiring.

Based on the analysis, in the BMS software, a ten-second time window could be established to monitor the latest $\Delta V'_{\max}$ value. If the signal is detected to be continuously in the range of 5~150mV/s for more than 8 seconds, and if the possibility of signal wiring failure could be ruled out, then the BMS could confirm that a battery ISC occurred.
