INSPECTION REPORT Nr LNP/BJ-12/048-CD01	
J-PECO Job nr: LNP/BJ-12/048

PROJECT: Ghana Early Phase Gas Infrastructure Project	Ref: JPP/HF-12/048
J-PECO Client: Sinopec International Petroleum Service Company (SIPSC)	P/o nr: / (client to J-PECO)
Manufacturer: SICHUAN KEYCON VALVE MANUFACTURING CO., LTD (KCON)	P/o nr: / (client to Manufacturer)
Inspection requested by: Sinopec International Petroleum Service Company (SIPSC)

No.	SUPPLY / SUBJECT OF INSPECTION	KCON Serial Nr	Project TAG Nr	QTY
1	12"-1500LB Top Entry Trunnion Ball Valves (PNEUMATIC ACTUATOR)	J-31362-1	ESDV-01-001-GP	1 set
2	12"-1500LB Top Entry Trunnion Ball Valves (GEAR OPERATOR)	J-31361-1, J-31361-2, J-31361-3, J-31361-4.	J-PECO-01-001-GP, J-PECO-01-002-GP, J-PECO-01-003-GP, J-PECO-01-004-GP.	4 sets

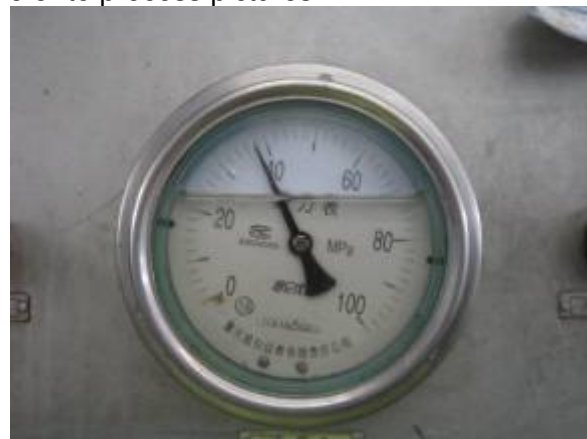
P=38MPa

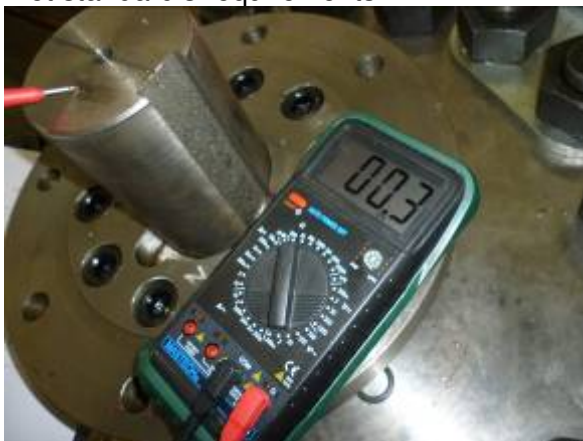
J-PECO inspector witnessed the anti-static testing process. KCON tested the anti-static with multimeter (12V). Required value is less than 10ohm. Actual values are about 0.4ohm, which met standard's requirements.

Between stem and body

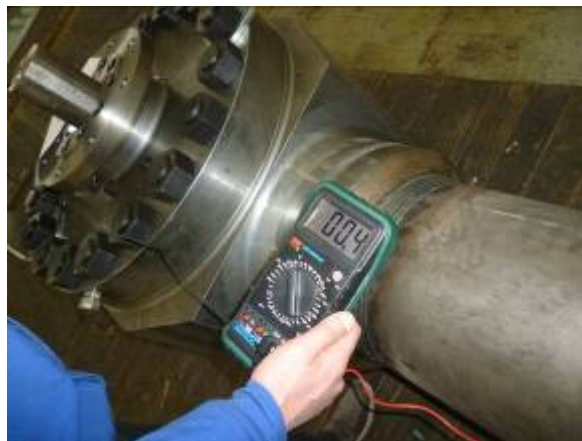
Between stem and ball

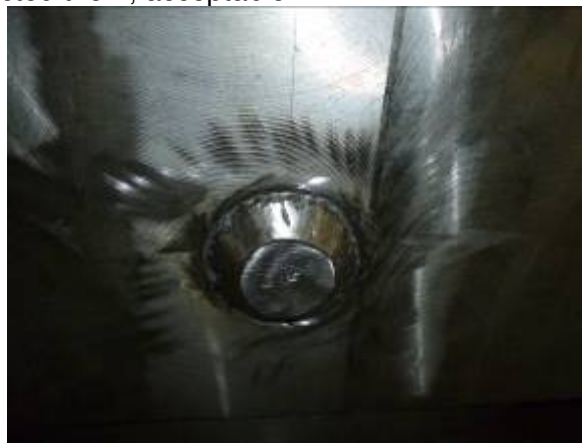
Plugs were welded

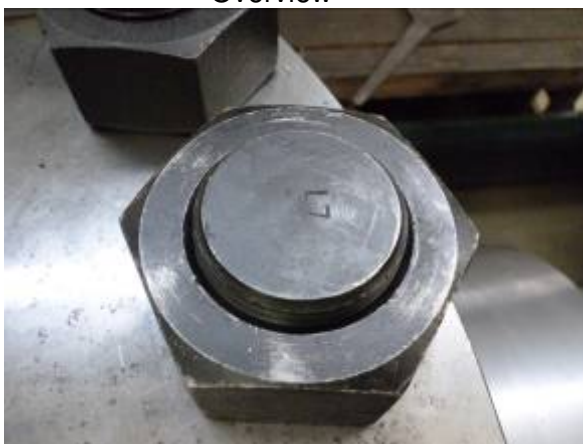
Before correcting

J-PECO inspector checked the Visual quality as per approved drawings and spec. The 2 plugs were welded after pressure testing, it met drawing's requirements. J-PECO inspector found one nut was installed incorrectly. KCON corrected them, acceptable.
