INSPECTION REPORT Nr LNP/BJ-12/048-CD01	
J-PECO Job nr: LNP/BJ-12/048

PROJECT: Ghana Early Phase Gas Infrastructure Project	Ref: JPP/HF-12/048
J-PECO Client: Sinopec International Petroleum Service Company (SIPSC)	P/o nr: / (client to J-PECO)
Manufacturer: SICHUAN KEYCON VALVE MANUFACTURING CO., LTD (KCON)	P/o nr: / (client to Manufacturer)
Inspection requested by: Sinopec International Petroleum Service Company (SIPSC)

No.	SUPPLY / SUBJECT OF INSPECTION	KCON Serial Nr	Project TAG Nr	QTY
1	12"-1500LB Top Entry Trunnion Ball Valves (PNEUMATIC ACTUATOR)	J-31362-1	ESDV-01-001-GP	1 set
2	12"-1500LB Top Entry Trunnion Ball Valves (GEAR OPERATOR)	J-31361-1, J-31361-2, J-31361-3, J-31361-4.	J-PECO-01-001-GP, J-PECO-01-002-GP, J-PECO-01-003-GP, J-PECO-01-004-GP.	4 sets

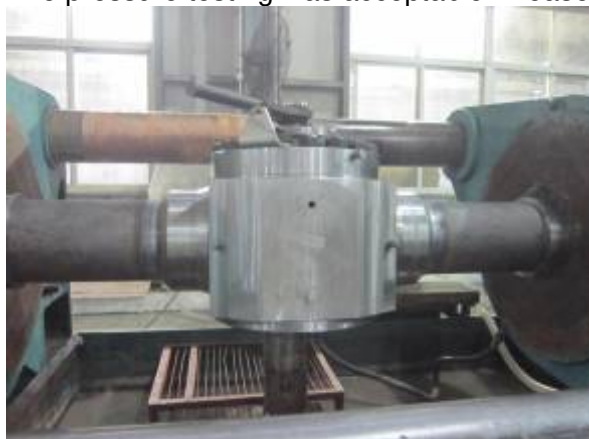
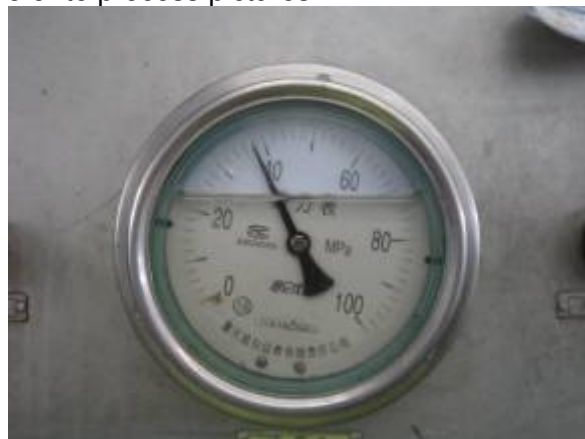
Shell strength testing

P=38MPa

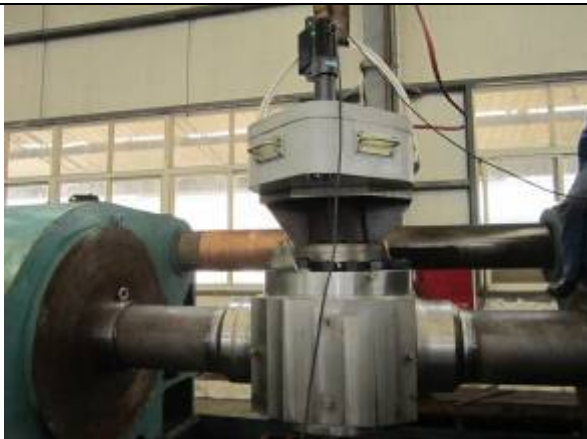
Overview of test torque for item1

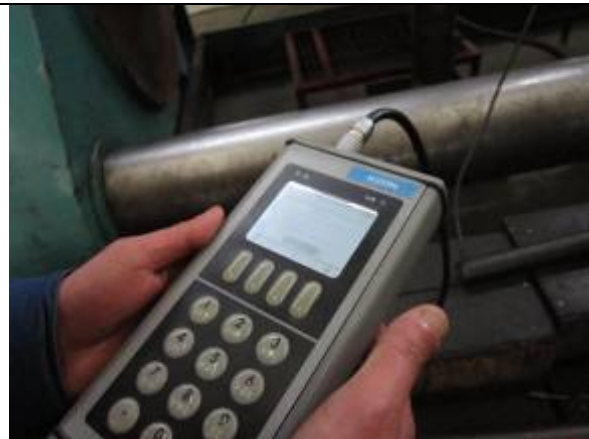
Testing process

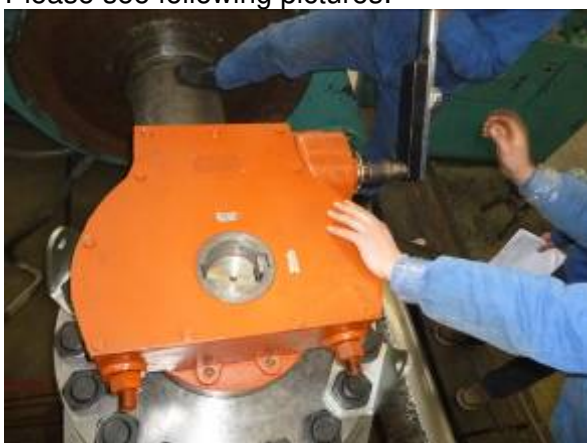
Overview of test torque for item2

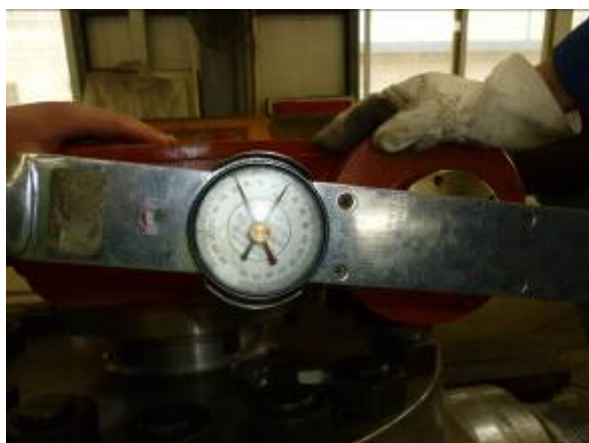
Testing values

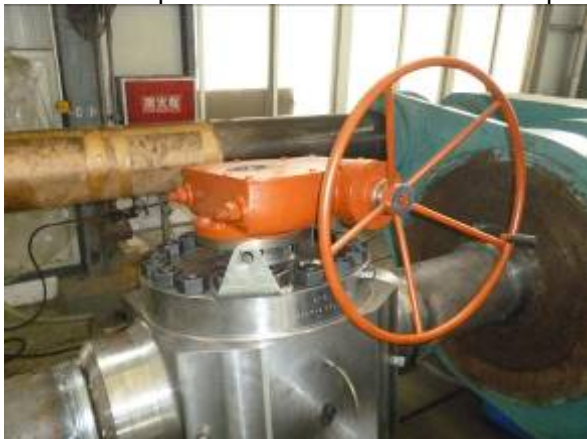
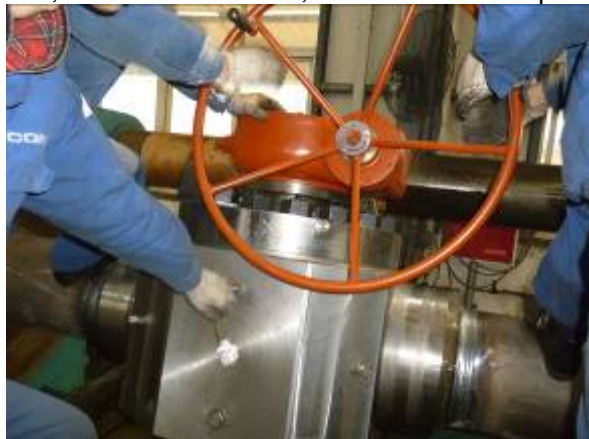
Because the PNEUMATIC ACTUATOR didn't arrive at KCON site (buy it from aboard). So, KCON did the function test with gear box (it's same with item2).

J-PECO inspector witnessed the function process, and run the wheel, it's smooth. Accepted.

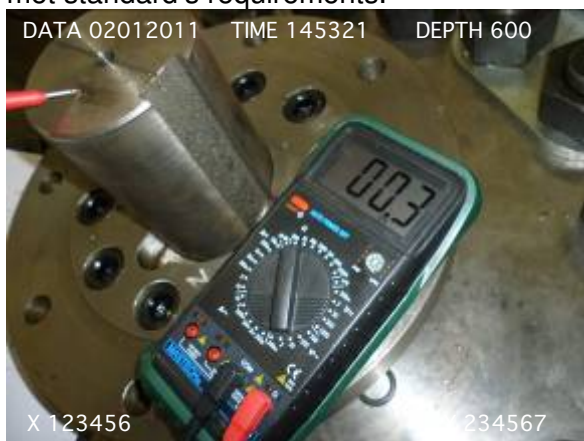
J-PECO inspector witnessed the anti-static testing process. KON tested the anti-static with multimeter (12V). Required value is less than 10ohm. Actual values are about 0.4ohm, which met standard's requirements.

Between stem and body

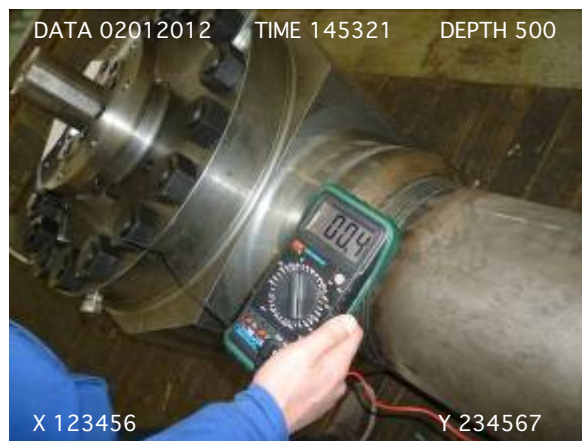
Between stem and ball

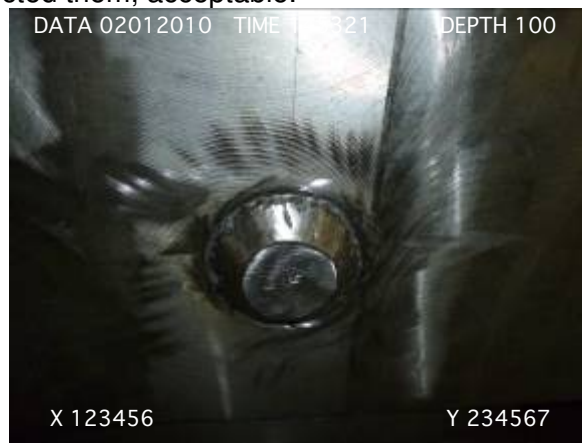
Plugs were welded

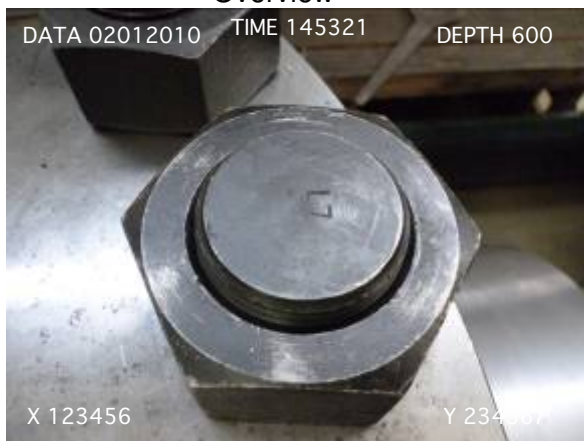
Before correcting

J-PECO inspector checked the Visual quality as per approved drawings and spec. The 2 plugs were welded after pressure testing, it met drawing's requirements. J-PECO inspector found one nut was installed incorrectly. KON corrected them, acceptable.

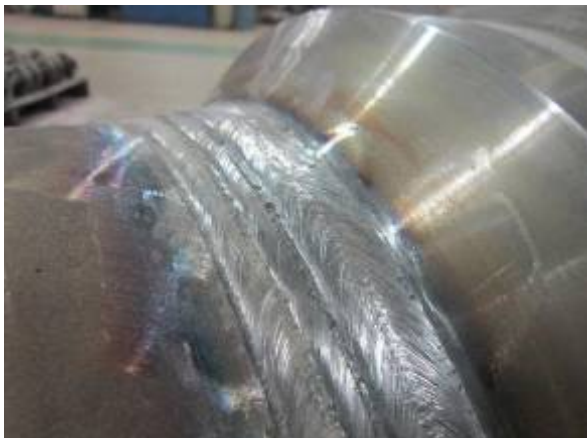
Weld seam check

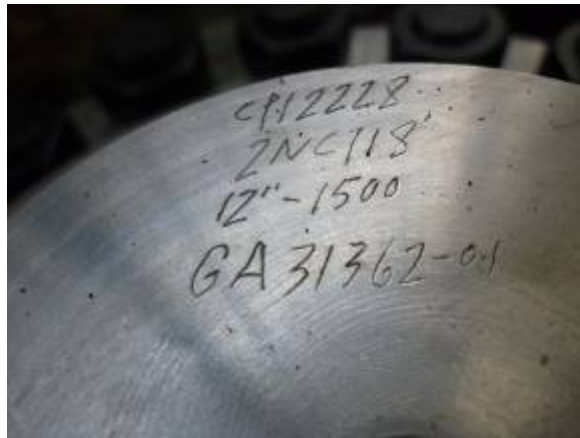
Traceability check

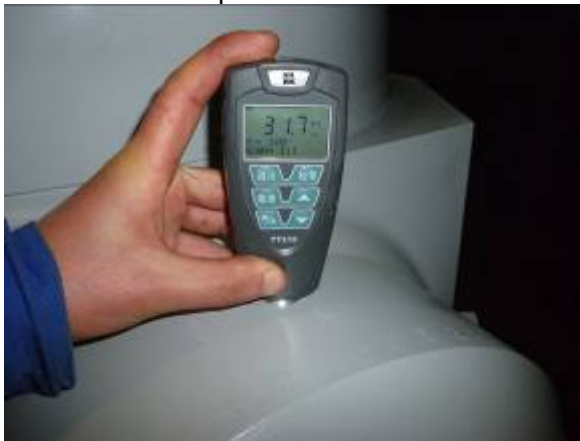
Check DFT

KCON do the painting as per KCON' specification. And DFT met KCON's procedure. KCON didn't complete top coat till J-PECO inspector leave.

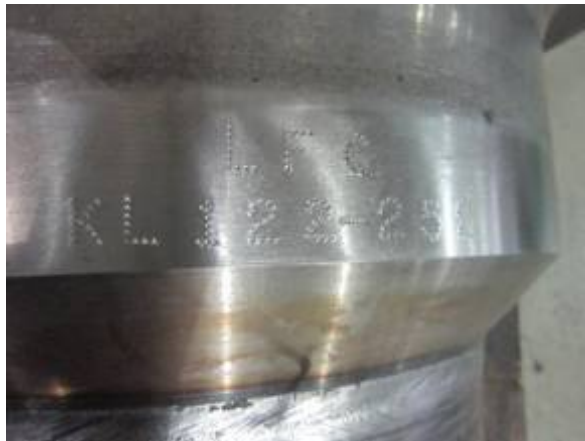
Before correcting

J-PECO inspector found the heat number was wrong as per my experience. KCON contacted the forging supplier, and confirmed this thing. And the forging supplier corrected and issued the MTC. KCON corrected the heat number on the surface of parts.
