<b>MAJOR TURNAROUND 2025 PRESSURE VESSEL INSPECTION REPORT</b>	Report no.: <b>PLANT/01/VR-R-201/TA2025</b> Report date: 22 Nov 2025 Plant/Unit/Area: Plant 1
--	--	---

Equipment tag no: R-201  
Equipment description: Catalytic Reactor

DOSH registration no.: MK PMT 1001

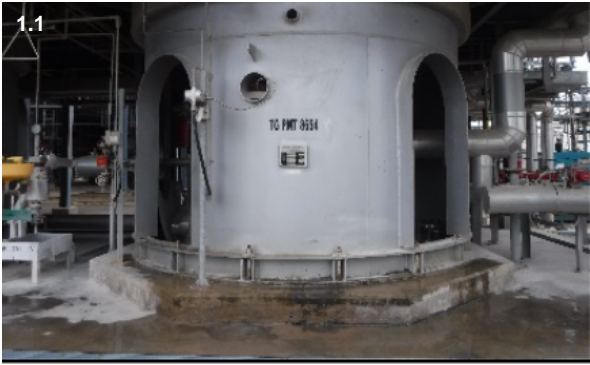
Photo 1

- 1 1.1 Through-wall corrosion detected with active leak or imminent failure risk
- 1.2 External corrosion detected on shell surface, localized area approximately 50mm x 50mm with minimal metal loss
- 1.3 General corrosion observed with pitting depth up to 2mm across affected area
- 2 2.1 General corrosion observed with pitting depth up to 2mm across affected area
- 2.2 Severe corrosion with significant metal loss exceeding 3mm depth

- Finding:**
- 1.1 1.1 Through-wall corrosion detected with active leak or imminent failure risk
  - 1.2 External corrosion detected on shell surface, localized area approximately 50mm x 50mm with minimal metal loss
  - 1.3 General corrosion observed with pitting depth up to 2mm across affected area
- Recommendation:**
- 1.1 1.1 1.1 Schedule repair during next planned shutdown within 30 days
  - 1.2 Engineering assessment required to determine repair methodology

- 1: 1.1 1.1 Schedule repair during next planned shutdown within 30 days
- 1.2 Engineering assessment required to determine repair methodology
- 2: 2.1 nill

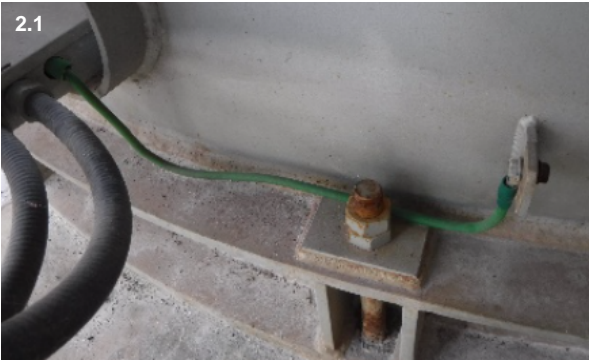
Photo 2

**Finding:**  
2.1 2.1 General corrosion observed with pitting depth up to 2mm across affected area

2.2 Severe corrosion with significant metal loss exceeding 3mm depth  
**Recommendation:**  
2.1 2.1 nil

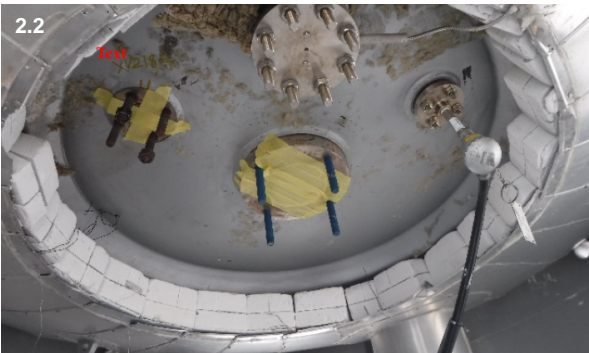
**Finding:**  
2.2 2.1 General corrosion observed with pitting depth up to 2mm across affected area

2.2 Severe corrosion with significant metal loss exceeding 3mm depth  
**Recommendation:**  
2.2 2.1 nil
