<b>MAJOR TURNAROUND 2025 PRESSURE VESSEL INSPECTION REPORT</b>	Report no.: <b>PLANT1/VI/HX-301/TA2025</b> Report date: 19 Nov 2025 Plant/Unit/Area: Plant 1
--	--------------------------------------------------------------------	----------------------------------------------------------------------------------------------------------

Equipment tag no: HX-301  
Equipment description: Shell and Tube Heat Exchanger

DOSH registration no.: MK PMT 1001

PHOTOS REPORT

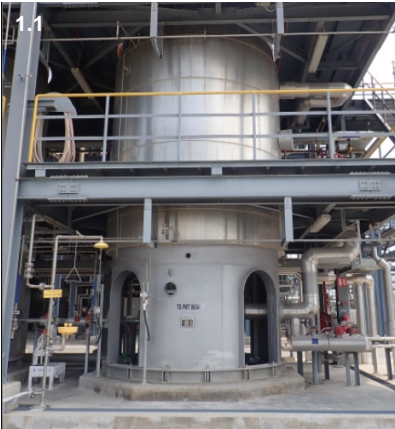
Photo 1

- Finding:
- 1.1 1.1 Severe corrosion with significant metal loss exceeding 3mm depth
  - 1.2 General corrosion observed with pitting depth up to 2mm across affected area
  - 1.3 External corrosion detected on shell surface, localized area approximately 50mm x 50mm with minimal metal loss
- Recommendation:
- 1.1 1.1 Plan repair for next major turnaround
  - 1.2 Schedule repair during next planned shutdown within 30 days
  - 1.3 Engineering assessment required to determine repair methodology

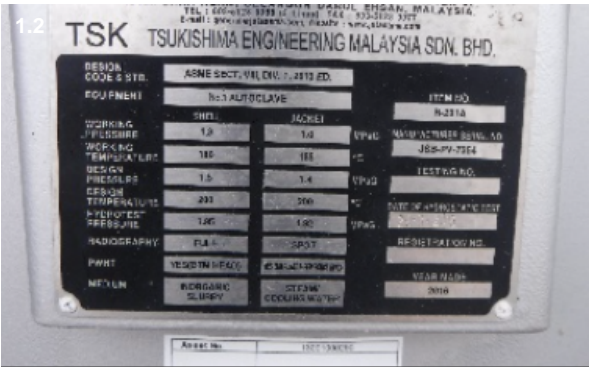
- Finding:
- 1.2 1.1 Severe corrosion with significant metal loss exceeding 3mm depth
  - 1.2 General corrosion observed with pitting depth up to 2mm across affected area
  - 1.3 External corrosion detected on shell surface, localized area approximately 50mm x 50mm with minimal metal loss
- Recommendation:
- 1.2 1.1 Plan repair for next major turnaround
  - 1.2 Schedule repair during next planned shutdown within 30 days
  - 1.3 Engineering assessment required to determine repair methodology

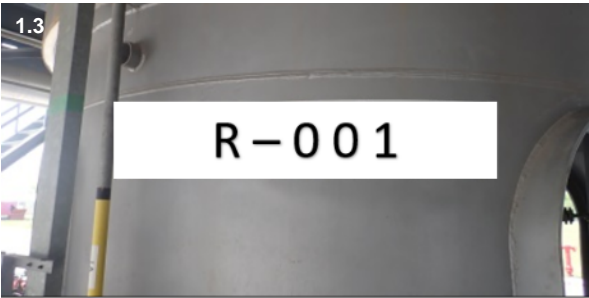
- Finding:
- 1.3 1.1 Severe corrosion with significant metal loss exceeding 3mm depth
  - 1.2 General corrosion observed with pitting depth up to 2mm across affected area
  - 1.3 External corrosion detected on shell surface, localized area approximately 50mm x 50mm with minimal metal loss
- Recommendation:
- 1.3 1.1 Plan repair for next major turnaround
  - 1.2 Schedule repair during next planned shutdown within 30 days
  - 1.3 Engineering assessment required to determine repair methodology
