<b>MAJOR TURNAROUND 2025 PRESSURE VESSEL INSPECTION REPORT</b>	Report no.: <b>PLANT/01/VR-V-001/TA2025</b> Report date: 05 Dec 2025 Plant/Unit/Area: Plant 1
--	--	---

Equipment tag no: V-001  
Equipment description: Test Pressure Vessel

DOSH registration no.: MK PMT 1001

PHOTOS REPORT

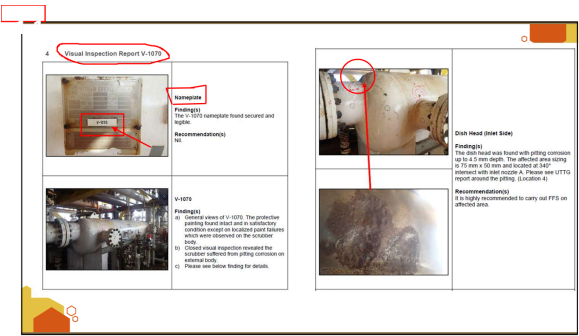
Photo 1

1.1 1.1 Through-wall corrosion detected with active leak or imminent failure risk

1.2 External corrosion detected on shell surface, localized area approximately 50mm x 50mm with minimal metal loss

1.1 1.1 Engineering assessment required to determine repair methodology

1.2 Plan repair for next major turnaround

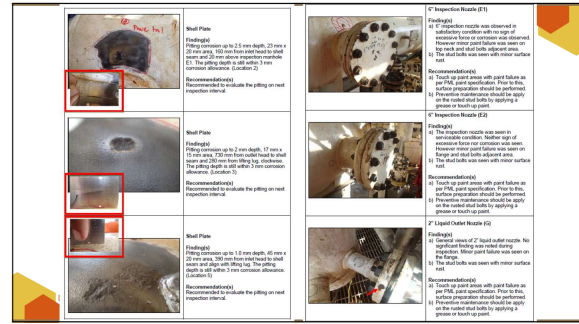
1.2 1.1 Through-wall corrosion detected with active leak or imminent failure risk

1.2 External corrosion detected on shell surface, localized area approximately 50mm x 50mm with minimal metal loss

1.2 1.1 Engineering assessment required to determine repair methodology

1.2 Plan repair for next major turnaround
