MAJOR TURNAROUND 2025 PRESSURE VESSEL INSPECTION REPORT	Report no.: PLANT 3/VI/R-201/TA2026 Report date: 13 Jan 2026
--	--	--

Equipment tag no: R-201
Equipment description: Catalytic Reactor

Plant/Unit/Area: Plant 3
DOSH registration no.: MK PMT 1001

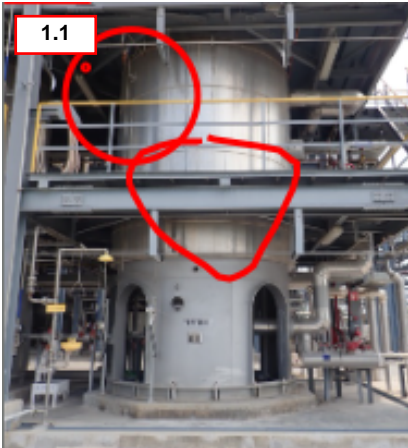
PHOTOS REPORT	
Photo 1

<p>1.1</p>	Finding: 1.1 General view of equipment R-001 facing plant north side. Equipment was found fully insulated. Insulation noted in serviceable condition. Recommendation: 1.1 Nil.
Photo 2

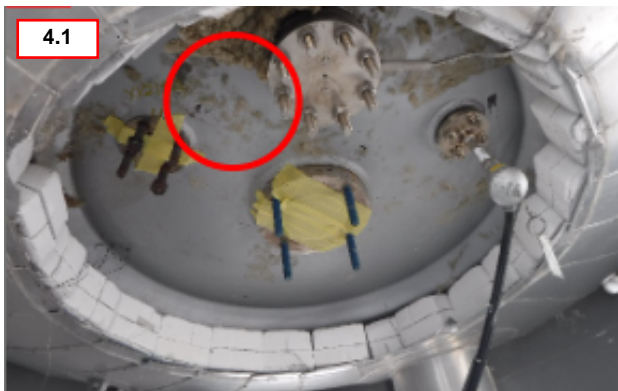
PHOTOS REPORT	
Photo 4

<p>Finding:</p> <p>4.1 Bottom dish head found in satisfactory condition. No evidence of significant damage noted.</p> <p>Recommendation:</p> <p>4.1 Nil.</p>
Photo 5

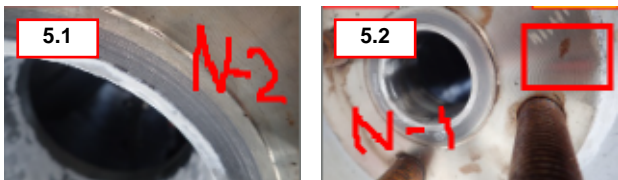
- 2.3 All internal attachment and internal nozzles were found securely intact with no visible defect.
2.4 Nozzles N-2 and N-15 flange included its gasket seat area found in satisfactory condition.
2.5 H-1 and M-1 flange and cover noted with no sign of anomaly. Gasket seat area was found free any significant damage.
2.6 Internal top dish head surface noted with discoloration.
Internal top dish head surface noted with discoloration.
H-1 and M-1 flange and cover noted with no sign of anomaly. Gasket seat area was found free any significant damage.

<p>Finding:</p> <p>5.1 - 5.2 Nozzles N-2 and N-15 flange included its gasket seat area found in satisfactory condition. No sign of flange imperfection noted.</p> <p>Recommendation:</p> <p>5.1 - 5.4 Nil.</p>
Photo 6

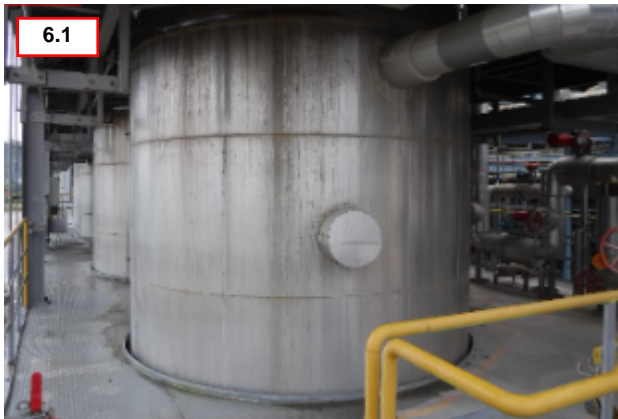
<p>Finding:</p> <p>6.1 Equipment shell noted in good condition with insulation securely intact.</p> <p>Recommendation:</p> <p>6.1 Nil.</p>

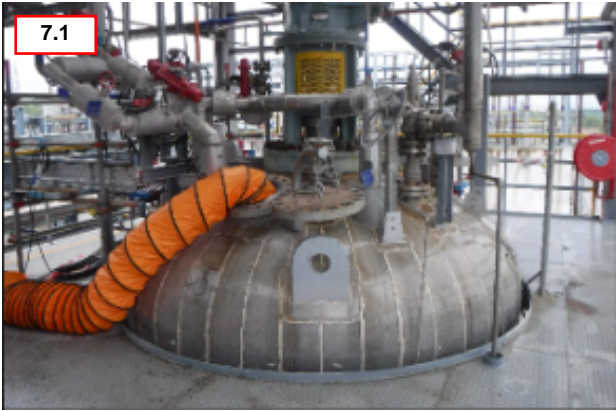
PHOTOS REPORT	
<div>Photo 7</div> <div> <div>7.1</div>

</div>	<p>Finding: 7.1 Top dish head observed in satisfactory profile with no sign of damage on insulation.</p> <p>Recommendation: 7.1 Nil.</p>
