<b>MAJOR TURNAROUND 2025</b> <b>PRESSURE VESSEL INSPECTION REPORT</b>	Report no.: <b>PLANT1/VI/HX-301/TA2025</b> Report date: 19 Nov 2025 Plant/Unit/Area: Plant 1
--	--	--

Equipment tag no: HX-301

Equipment description: Shell and Tube Heat Exchanger

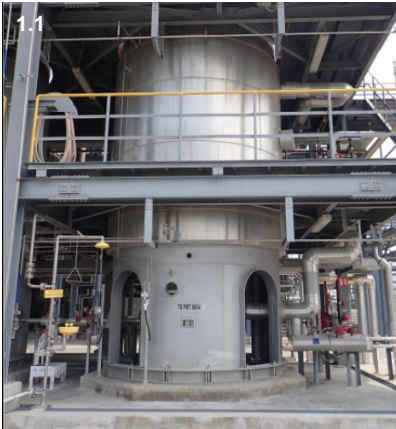
Photo 1

- Finding:
- 1.1 1.1 Severe corrosion with significant metal loss exceeding 3mm depth
  - 1.2 General corrosion observed with pitting depth up to 2mm across affected area
  - 1.3 External corrosion detected on shell surface, localized area approximately 50mm x 50mm with minimal metal loss
- Recommendation:
- 1.1 1.1 Plan repair for next major turnaround
  - 1.2 Schedule repair during next planned shutdown within 30 days
  - 1.3 Engineering assessment required to determine repair methodology

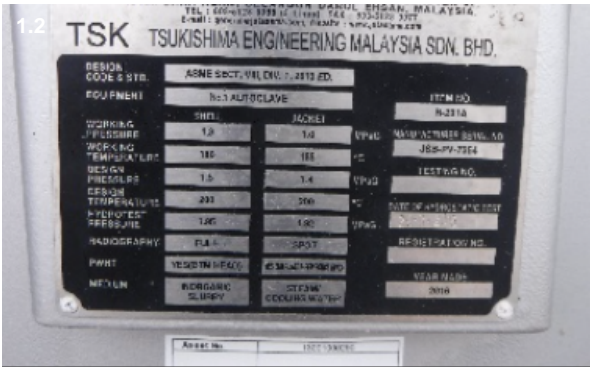
- Finding:
- 1.2 1.1 Severe corrosion with significant metal loss exceeding 3mm depth
  - 1.2 General corrosion observed with pitting depth up to 2mm across affected area
  - 1.3 External corrosion detected on shell surface, localized area approximately 50mm x 50mm with minimal metal loss
- Recommendation:
- 1.2 1.1 Plan repair for next major turnaround
  - 1.2 Schedule repair during next planned shutdown within 30 days
  - 1.3 Engineering assessment required to determine repair methodology

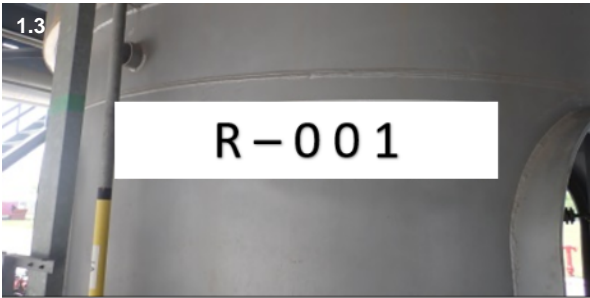
- Finding:
- 1.3 1.1 Severe corrosion with significant metal loss exceeding 3mm depth
  - 1.2 General corrosion observed with pitting depth up to 2mm across affected area
  - 1.3 External corrosion detected on shell surface, localized area approximately 50mm x 50mm with minimal metal loss
- Recommendation:
- 1.3 1.1 Plan repair for next major turnaround
  - 1.2 Schedule repair during next planned shutdown within 30 days
  - 1.3 Engineering assessment required to determine repair methodology
