STRUCTURAL AUDIT REPORT
FOR
“VISHAL SAHYADRI CO – OP HSG. SOC. LTD”,
“C12 – WING”
SITUATED AT
SAHYADRI NAGAR, CHARKOP,
KANDIVALI (W) MUMBAI – 400 067

978/B1/LSS/2021

JUNE 21, 2021

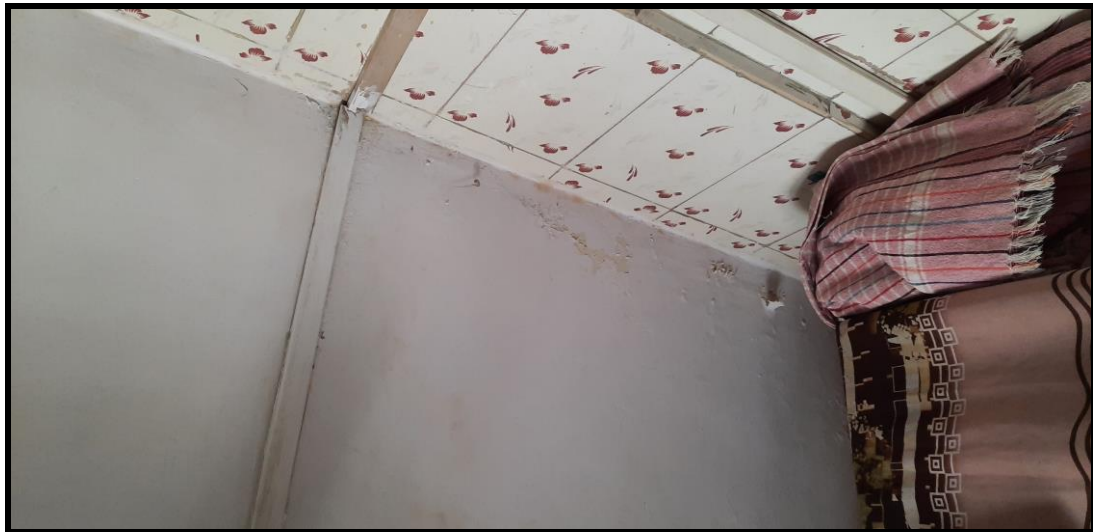
FLAT NO – 03

- ❖ **HALL** – O.K.
- ❖ **KITCHEN** – Leakage mark observed on ceiling.
- ❖ **PASSAGE** – O.K.
- ❖ **TOILET & BATH ROOM** – O.K.

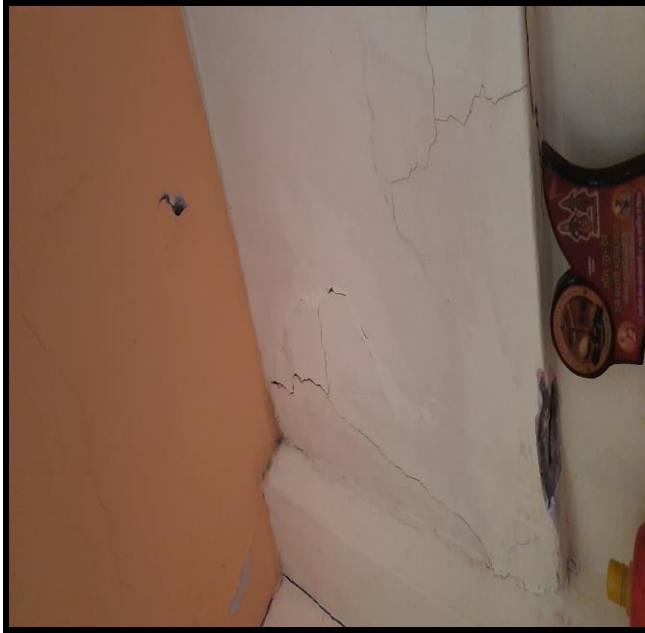
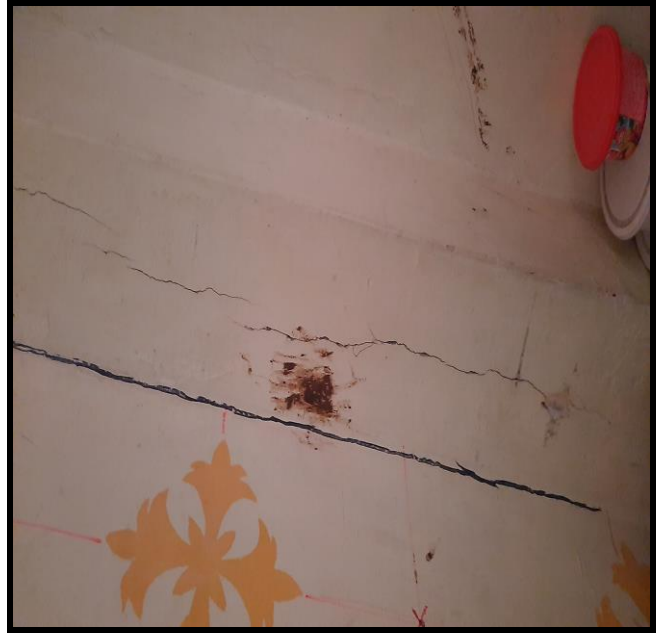
FLAT NO – 08

- ❖ **HALL** – Structural crack observed on beam.
- ❖ **KITCHEN** – O.K.
- ❖ **PASSAGE** – O.K.
- ❖ **TOILET & BATH ROOM** – O.K.

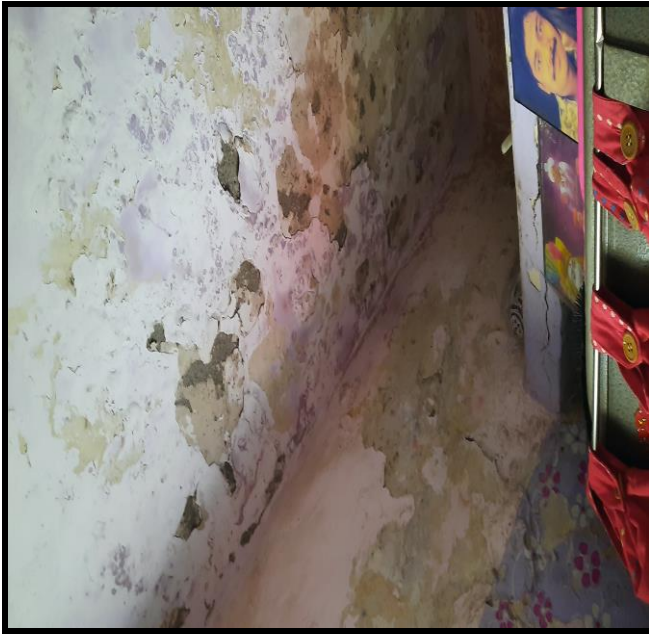
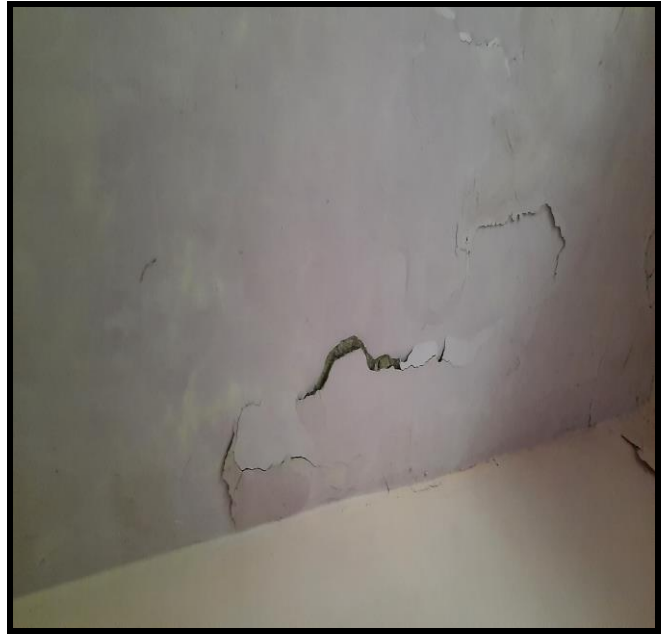
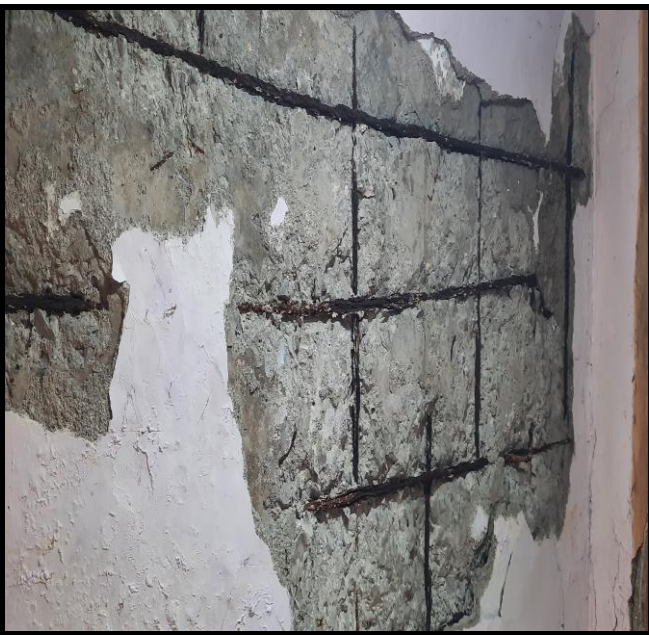
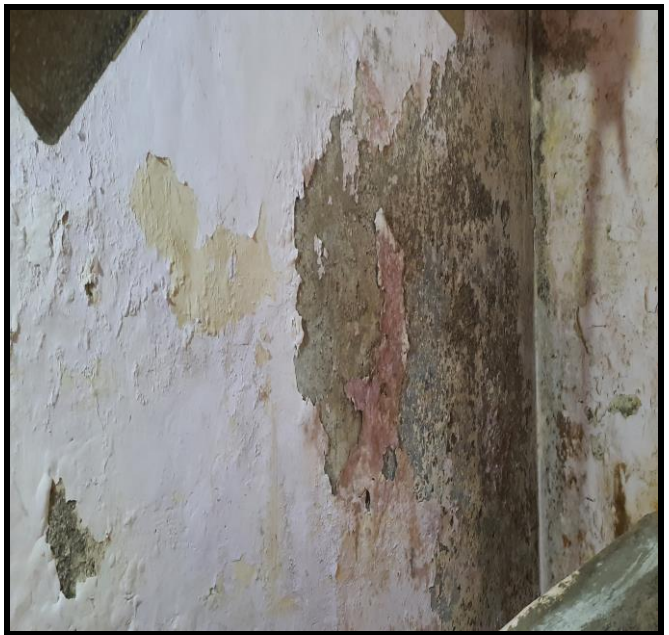
FLAT NO – 31

- ❖ **HALL** – Leakage mark observed on wall & ceiling.
 - Structural damage observed on ceiling.
- ❖ **KITCHEN** – Leakage mark observed on ceiling.
 - Ceiling plaster get damaged & steel get exposed & corroded.
- ❖ **PASSAGE** – O.K.
- ❖ **TOILET & BATH ROOM** – O.K.

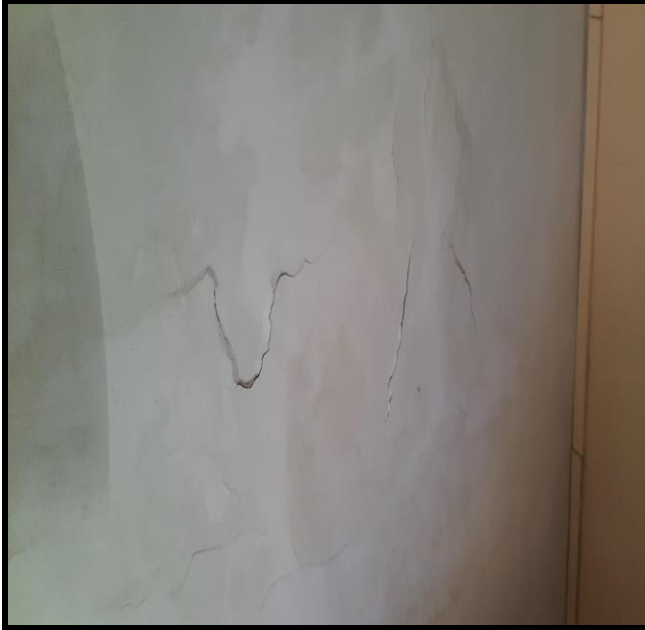
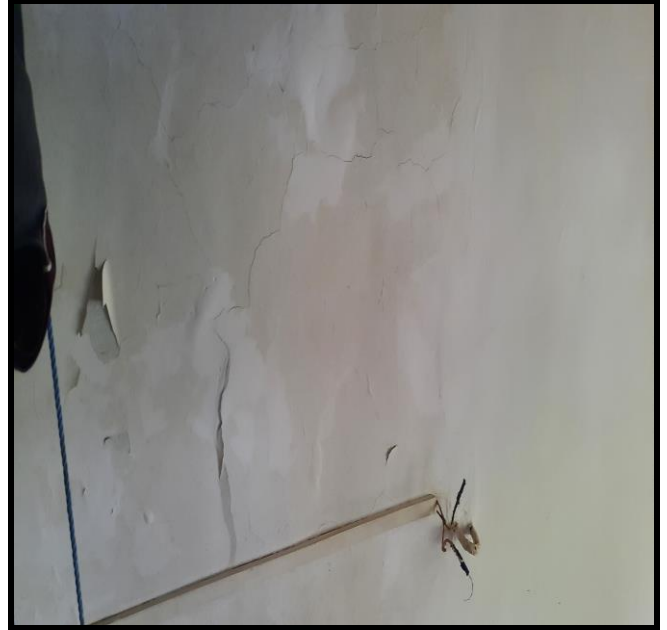
FLAT NO – 34

- ❖ **HALL** – Structural damage observed on ceiling.
- ❖ **KITCHEN** – Structural damage observed on ceiling.
- ❖ **PASSAGE** – O.K.
- ❖ **TOILET & BATH ROOM** – O.K.

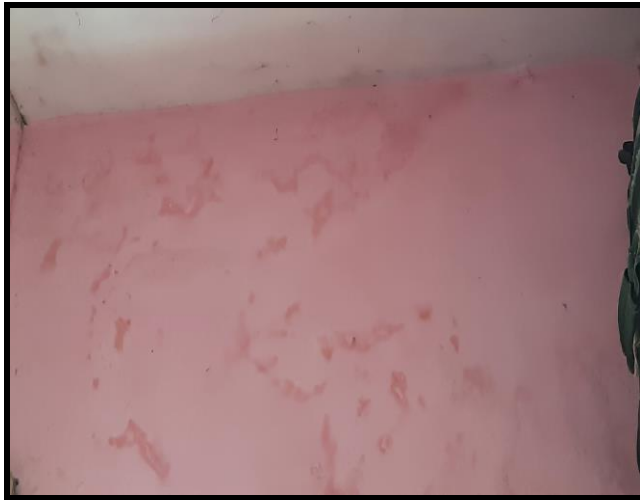
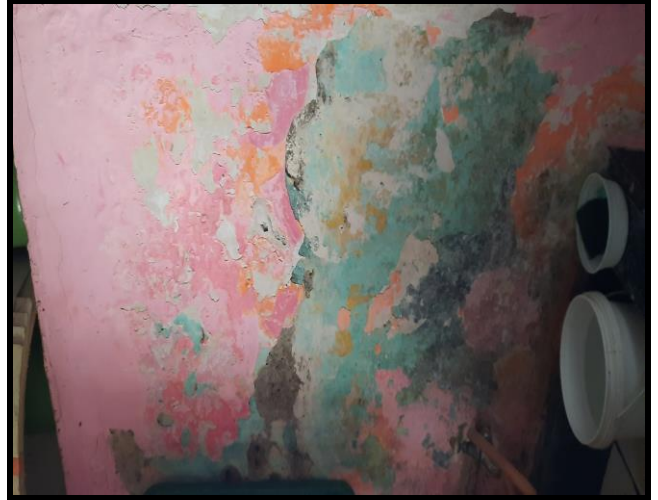
FLAT NO – 37

- ❖ **HALL** – Leakage mark observed on wall.
- ❖ **KITCHEN** – Leakage mark observed on wall.
- ❖ **PASSAGE** – O.K.
- ❖ **TOILET & BATH ROOM** – O.K.

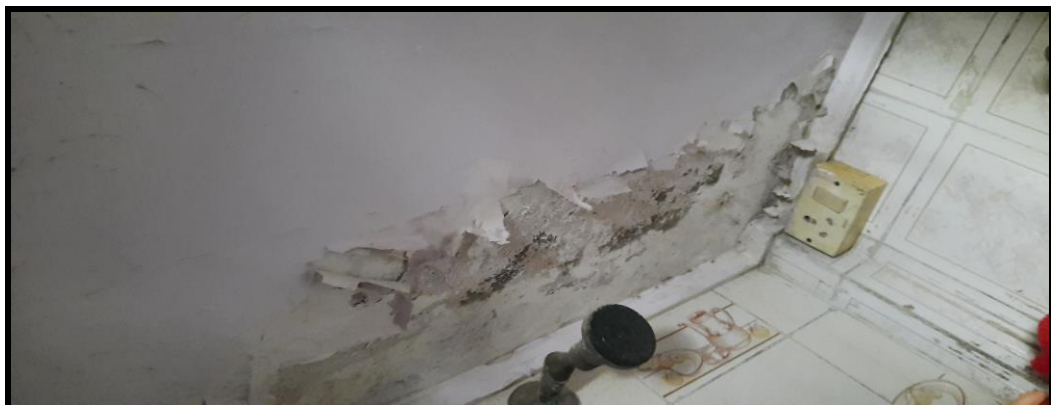
FLAT NO – 39

- ❖ **HALL** – O.K.
- ❖ **KITCHEN** – O.K.
- ❖ **PASSAGE** – O.K.
- ❖ **TOILET & BATH ROOM** – Leakage mark observed on ceiling.

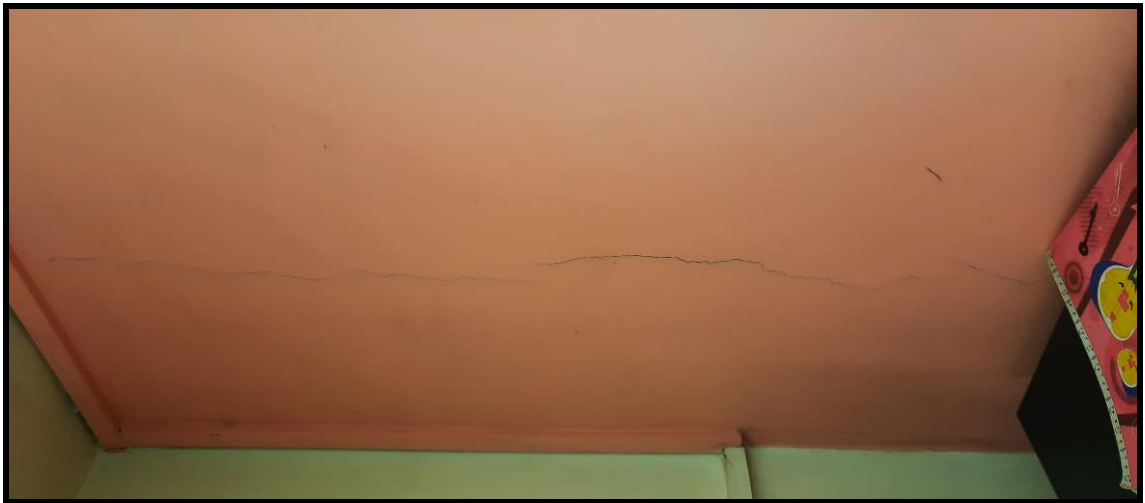
FLAT NO – 42

- ❖ **HALL** – Structural crack observed on column.
- ❖ **KITCHEN** – O.K.
- ❖ **PASSAGE** – O.K.
- ❖ **TOILET & BATH ROOM** – O.K.

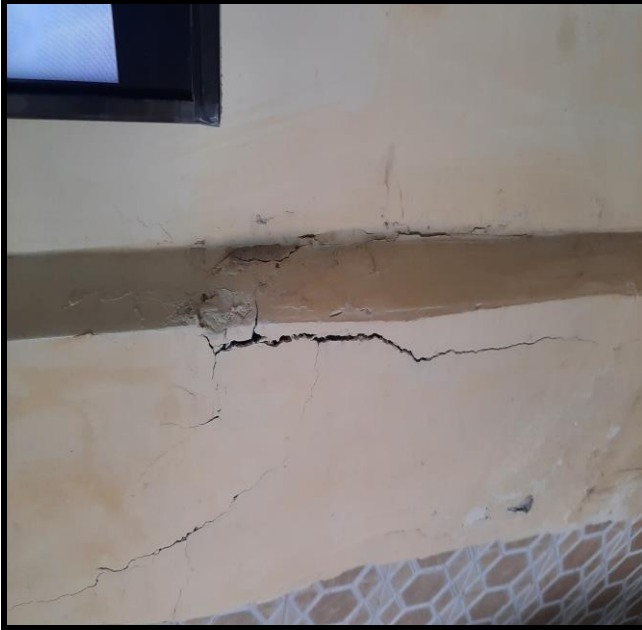
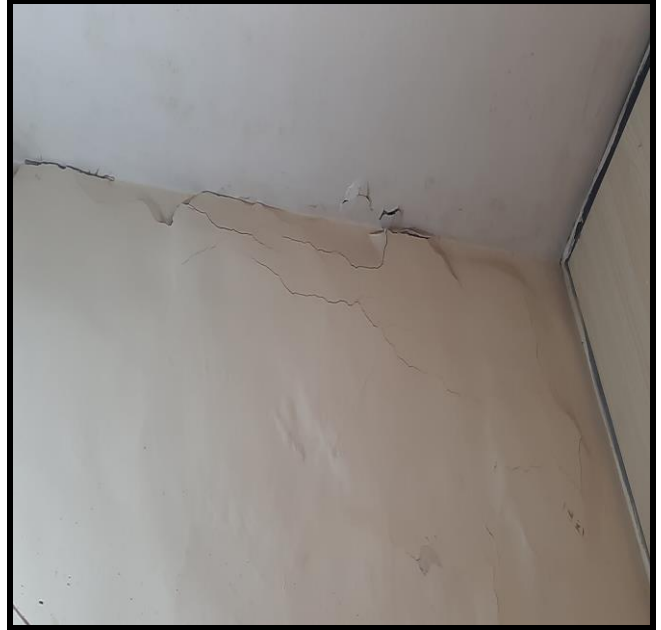
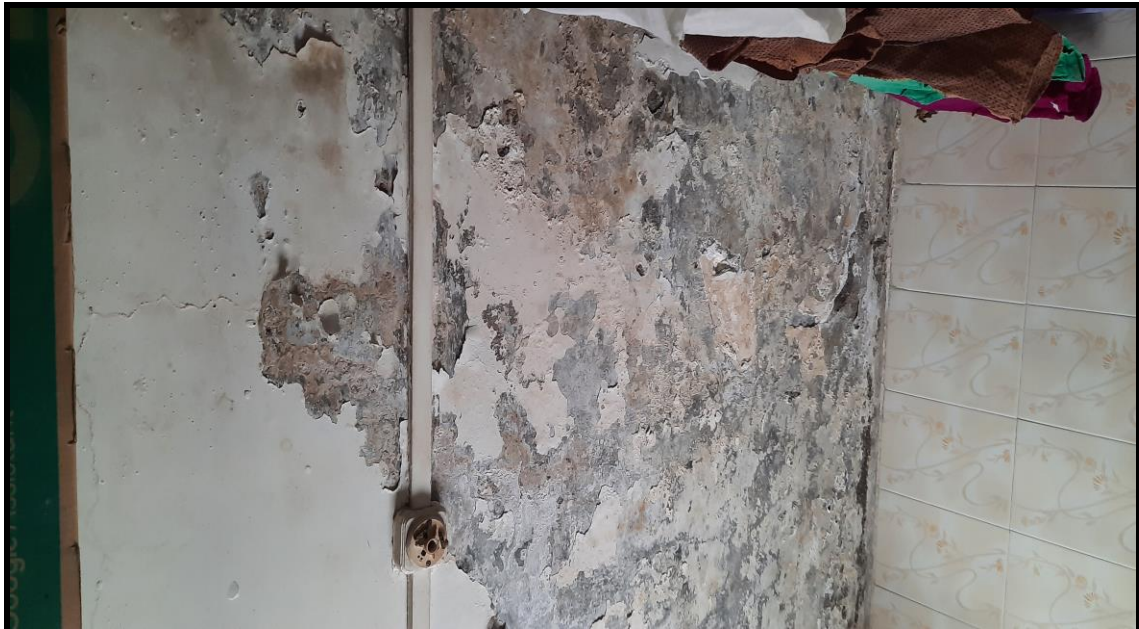
FLAT NO – 50

- ❖ **HALL** – Structural crack observed on column & beam.
- ❖ **KITCHEN** – Leakage mark observed on ceiling.
- ❖ **PASSAGE** – O.K.
- ❖ **TOILET & BATH ROOM** – O.K.

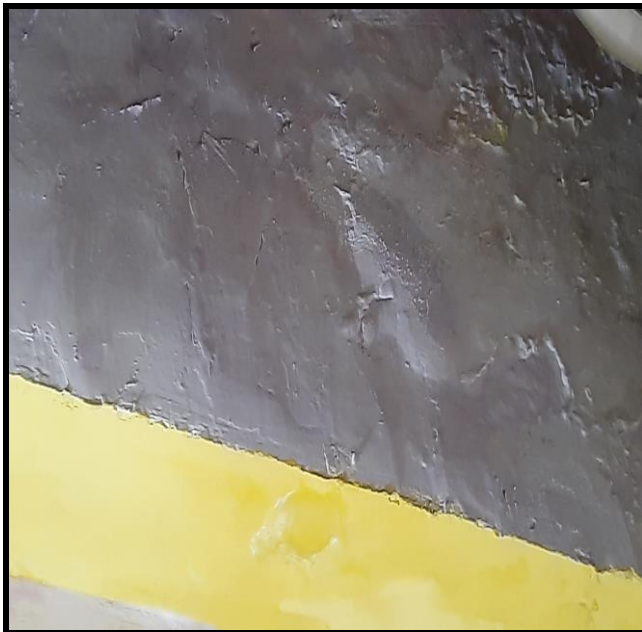
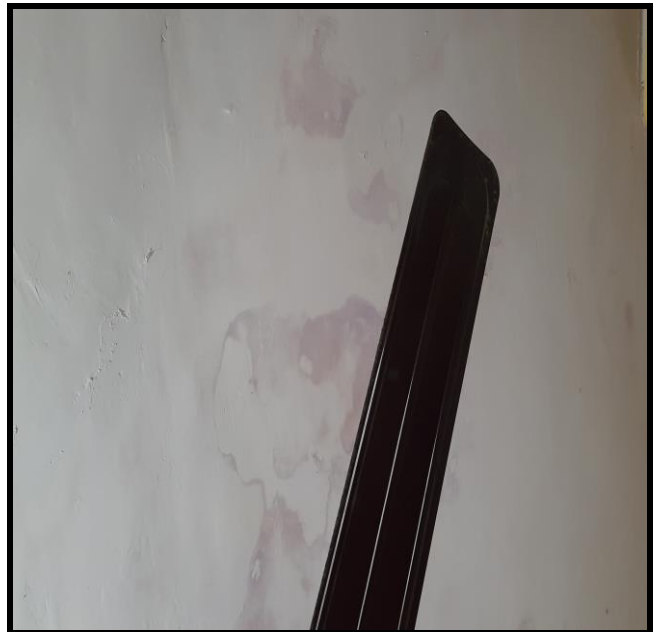
FLAT NO – 54

- ❖ HALL – O.K.
- ❖ KITCHEN – Leakage mark observed on ceiling & wall.
- ❖ PASSAGE – O.K.
- ❖ TOILET & BATH ROOM – O.K.

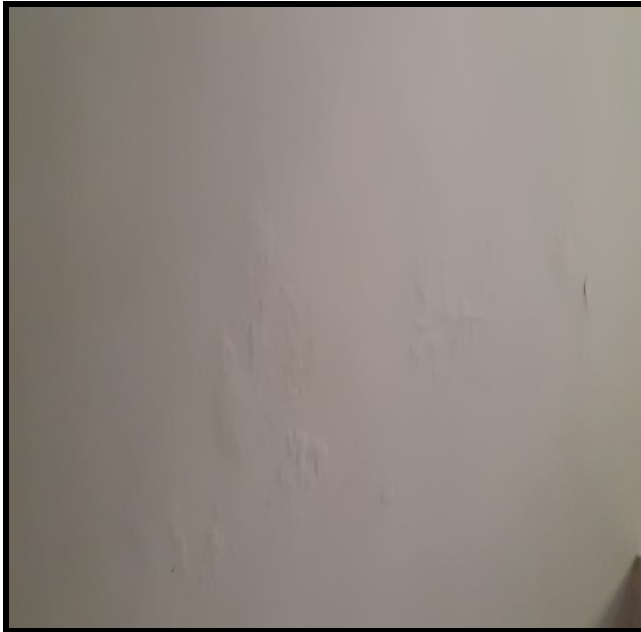
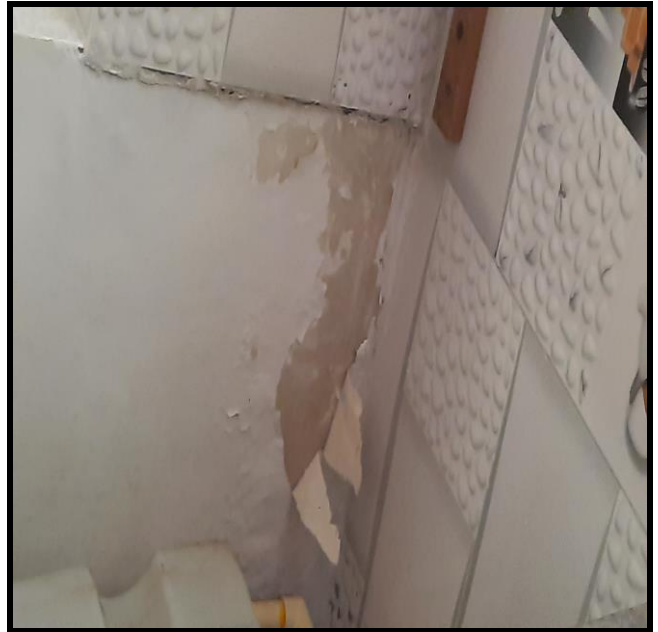
FLAT NO – 67

- ❖ **HALL** – O.K.
- ❖ **KITCHEN** – Leakage mark observed on ceiling.
- ❖ **PASSAGE** – O.K.
- ❖ **TOILET & BATH ROOM** – O.K.

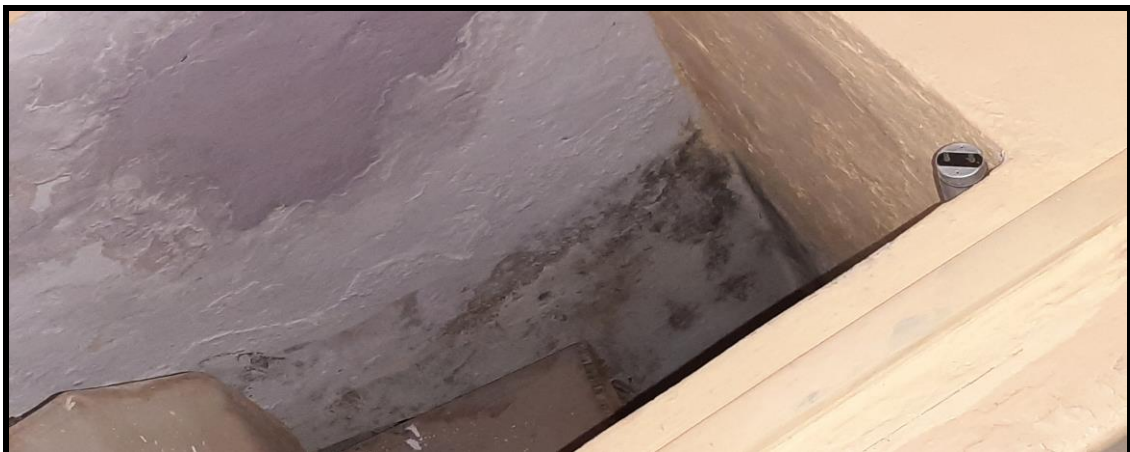
FLAT NO – 68

- ❖ **HALL** – Dampness observed on wall.
- ❖ **KITCHEN** – Leakage mark observed on ceiling.
- ❖ **PASSAGE** – O.K.
- ❖ **TOILET & BATH ROOM** – O.K.

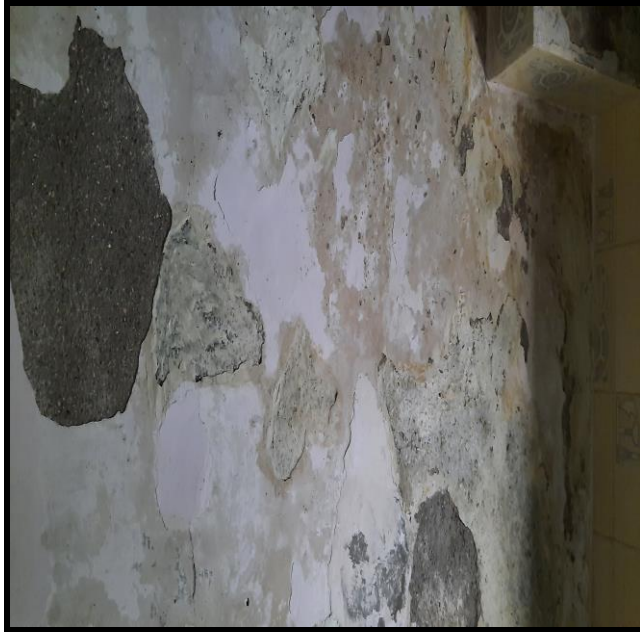
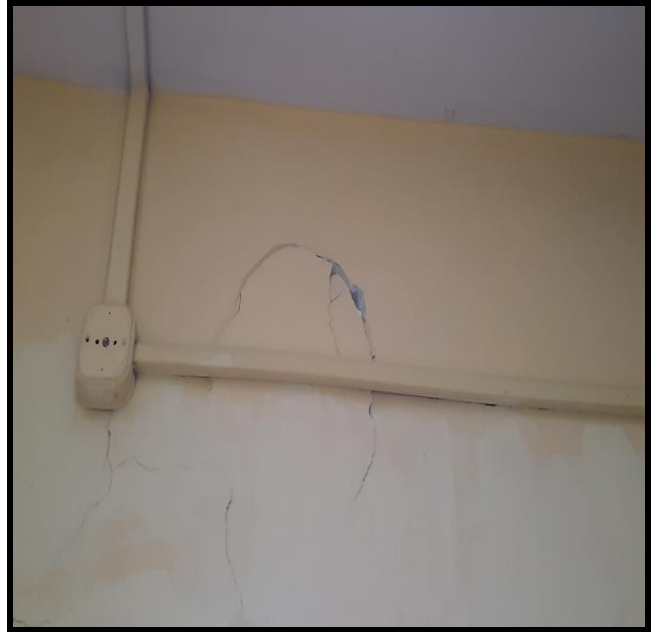
FLAT NO – 70

- ❖ **HALL** – O.K.
- ❖ **KITCHEN** – Leakage mark observed on ceiling.
 - Beam plaster get damaged & steel get exposed & corroded.
- ❖ **PASSAGE** – O.K.
- ❖ **TOILET & BATH ROOM** – Leakage mark observed on ceiling.

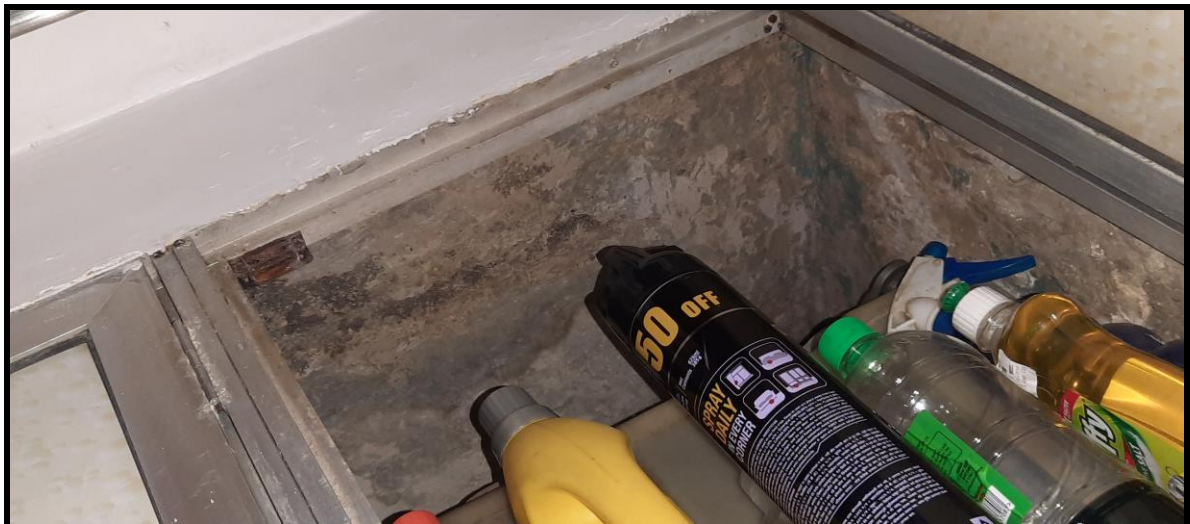
FLAT NO – 71

- ❖ **HALL** – O.K.
- ❖ **KITCHEN** – Leakage mark observed on ceiling.
- ❖ **PASSAGE** – O.K.
- ❖ **TOILET & BATH ROOM** – O.K.

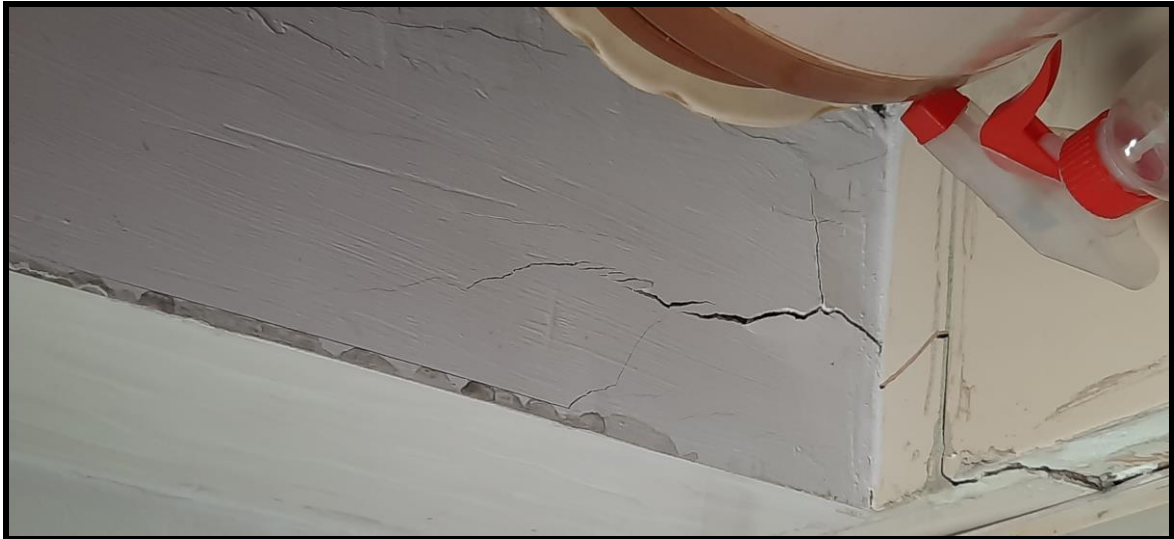
FLAT NO – 75

- ❖ HALL – O.K.
- ❖ KITCHEN – Structural crack observed on beam.
- ❖ PASSAGE – O.K.
- ❖ TOILET & BATH ROOM – O.K.

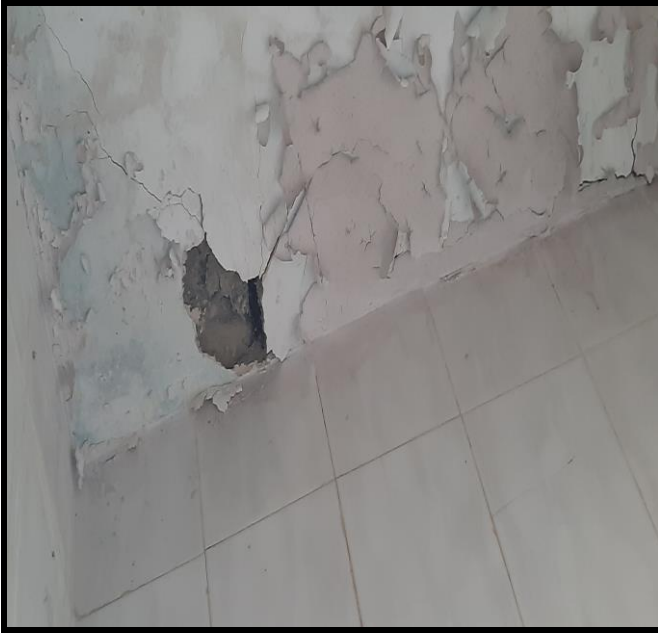
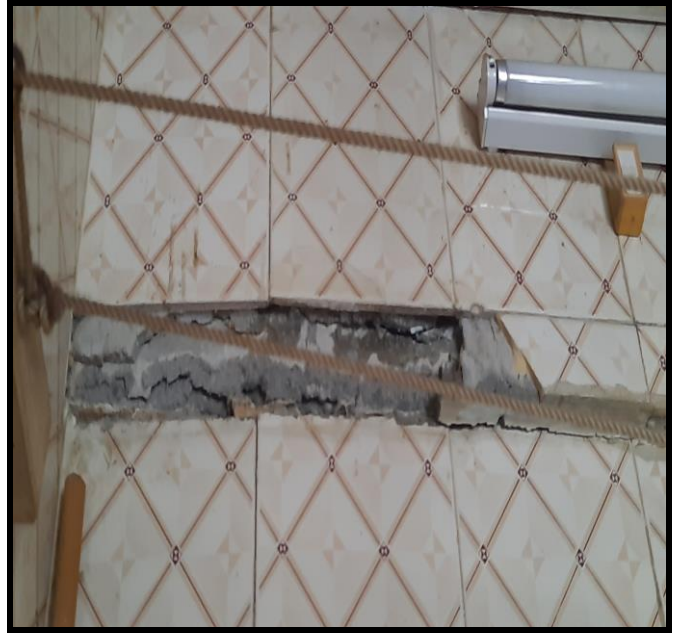
FLAT NO – 78

- ❖ **HALL** – O.K.
- ❖ **KITCHEN** – Structural damage observed on beam.
- ❖ **PASSAGE** – O.K.
- ❖ **TOILET & BATH ROOM** – ceiling plaster get damaged & steel get exposed & corroded.

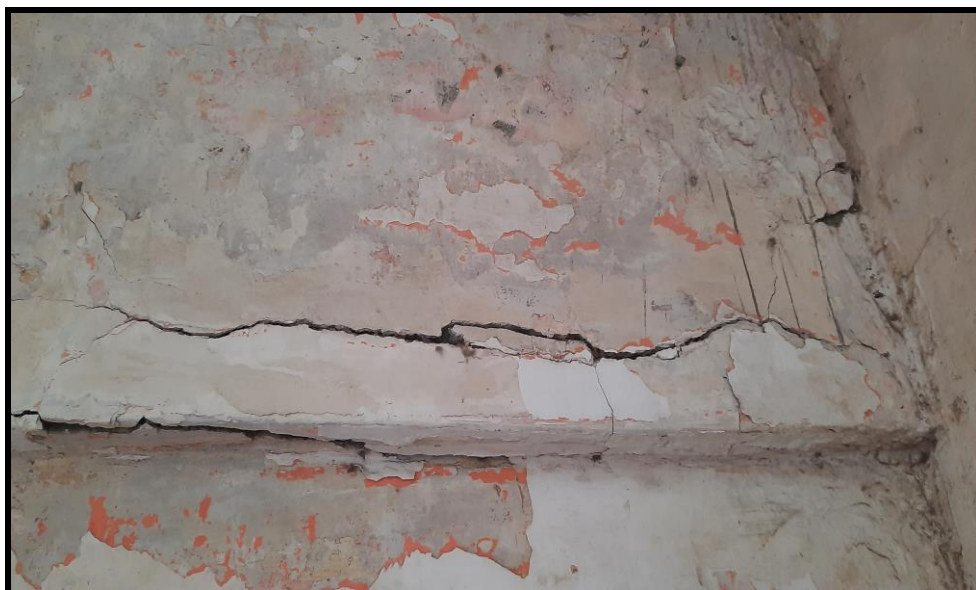
FLAT NO – 80

- ❖ **HALL** – Structural crack observed on ceiling.
- ❖ **KITCHEN** – Structural crack observed on beam.
- ❖ **PASSAGE** – O.K.
- ❖ **TOILET & BATH ROOM** – O.K.
