STRUCTURAL AUDIT REPORT  
FOR  
“VISHAL SAHYADRI CO – OP HSG. SOC. LTD”,  
“C10 – WING”  
SITUATED AT  
SAHYADRI NAGAR, CHARKOP,  
KANDIVALI (W) MUMBAI – 400 067

978/B1/LSS/2021

JUNE 21, 2021

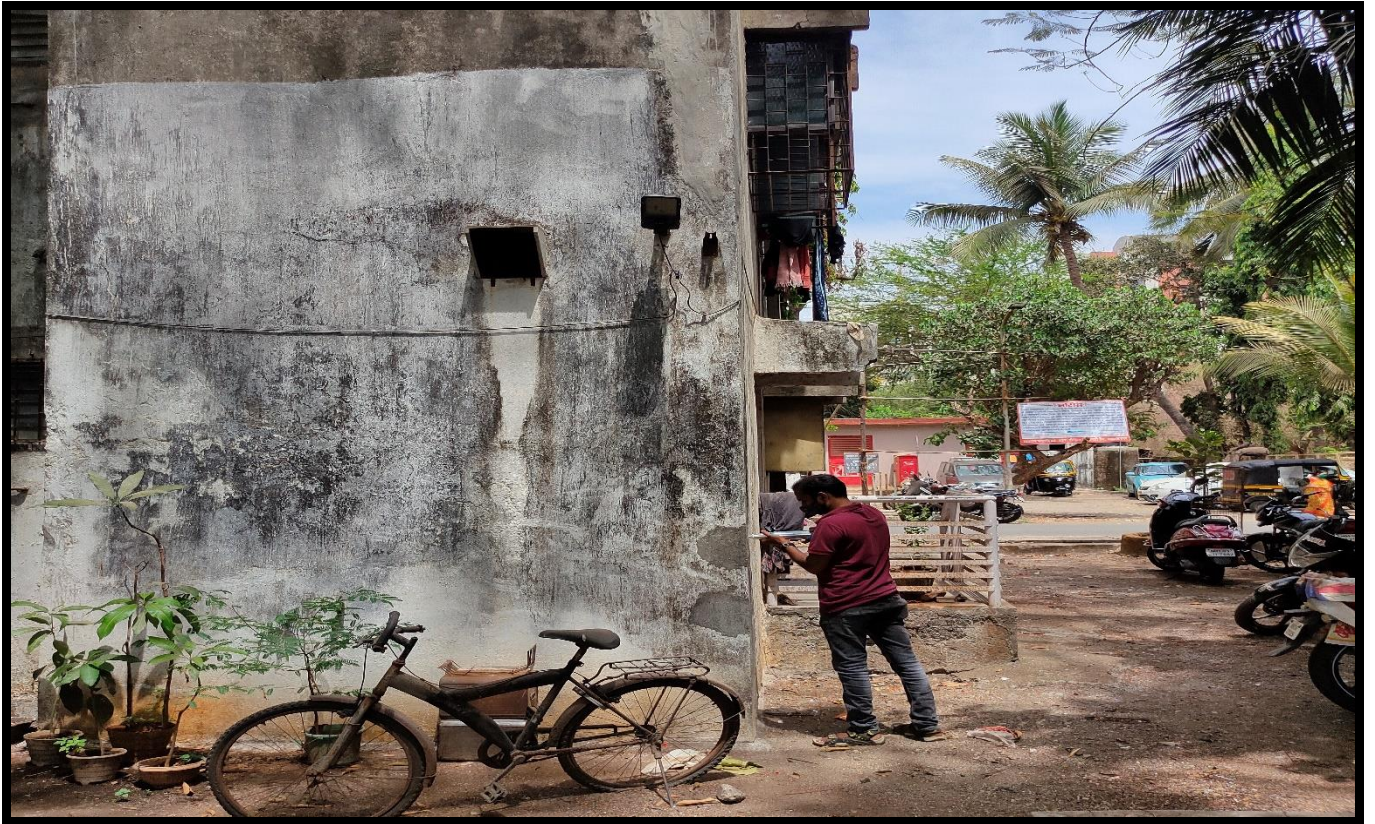
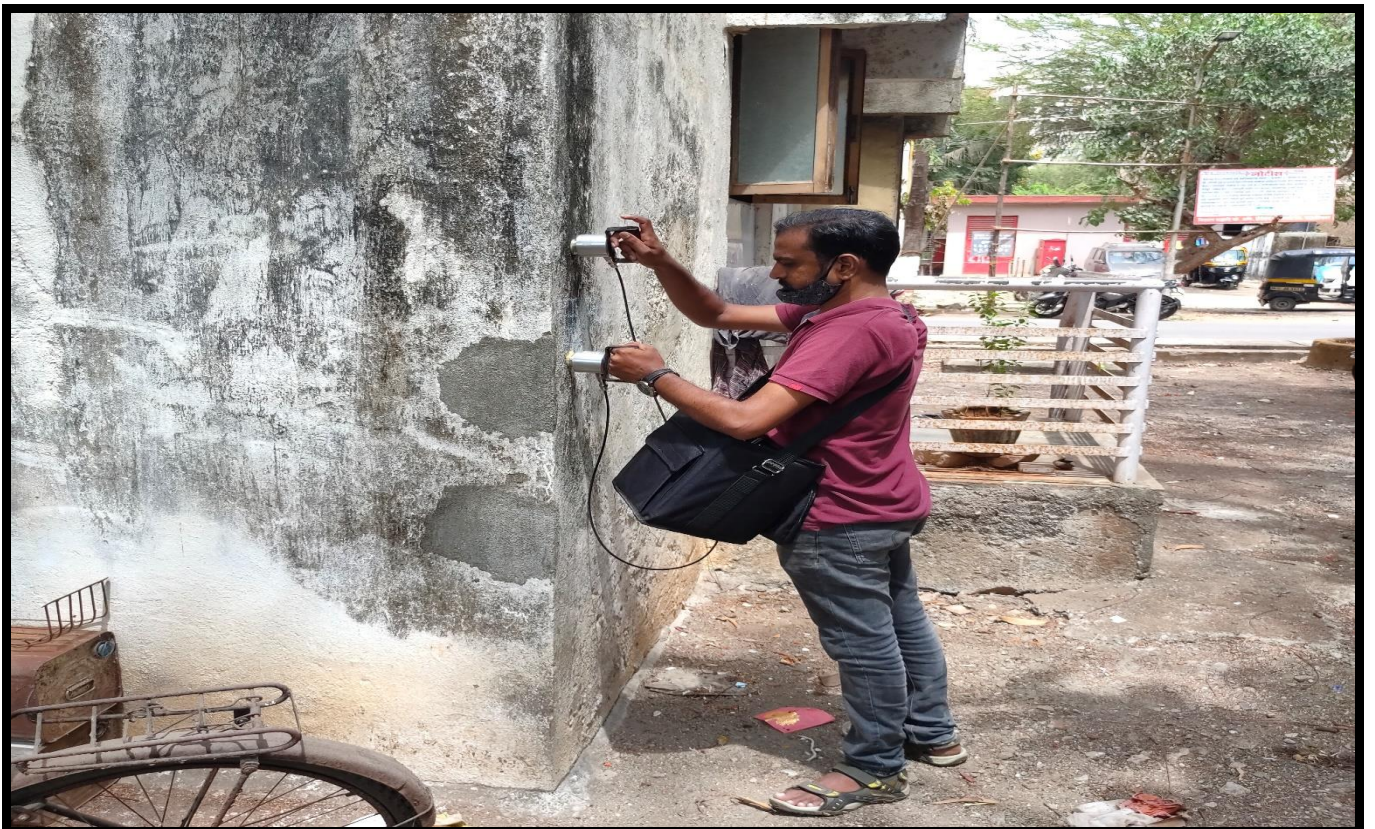
## **NON –DESTRUCTIVE TEST PHOTO**

Rebound Hammer was tested for compressive strength at surface by Schmidt rebound hammer. Results indicate the compressive strength at surface of the RCC columns & beam in is ranging between 20.30 MPa to 26.50 MPa.

The UPV values are ranging between 3.0 Km/Sec to 3.50 Km/Sec.

Half Cell Potential tested for corrosion activity by half – cell potential tests. Value is taken on Column. The result on tested column is – 325 mV.

Carbonation test was conducted to assess carbonation depth. Readings are taken on Column. Result indicates the carbonation penetration depth is 40.00 mm. Carbonation depths have reached to the reinforcement level in all of the RCC elements. It is essential to give a suitable anti-corrosion treatment to all the RCC members to stop further carbonation and corrosion of concrete.

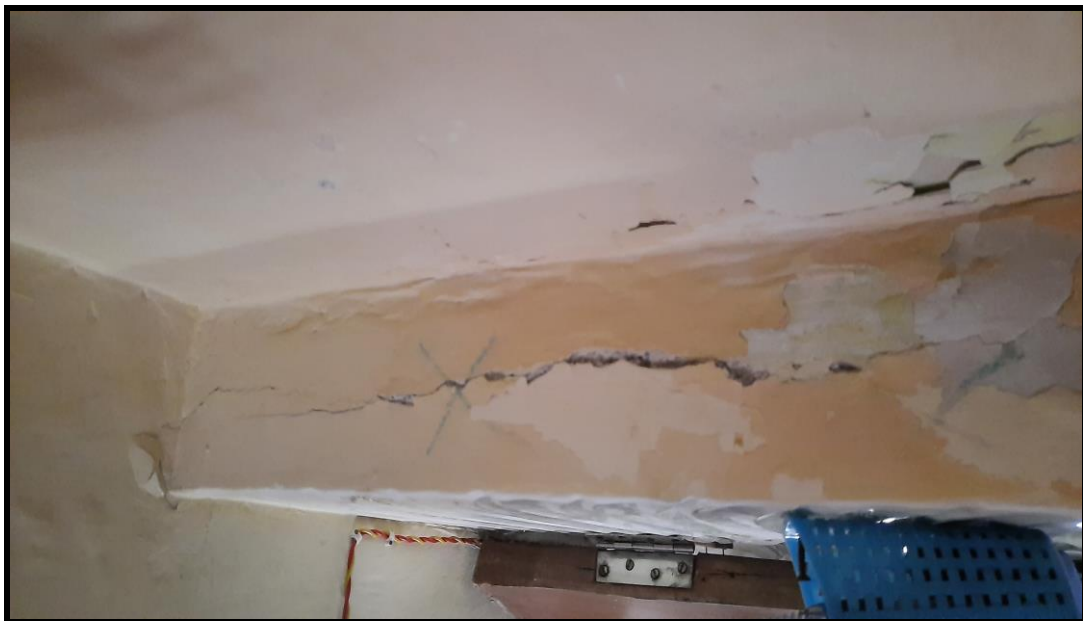
#### **FLAT NO – 03**

- ❖ **HALL** – Structural crack observed on column.
- ❖ **KITCHEN** – O.K.
- ❖ **PASSAGE** – O.K.
- ❖ **TOILET & BATH ROOM** – O.K.

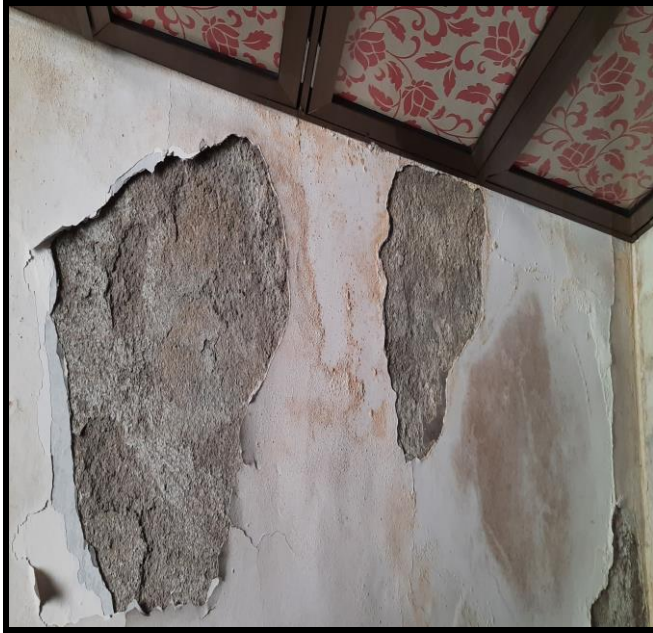
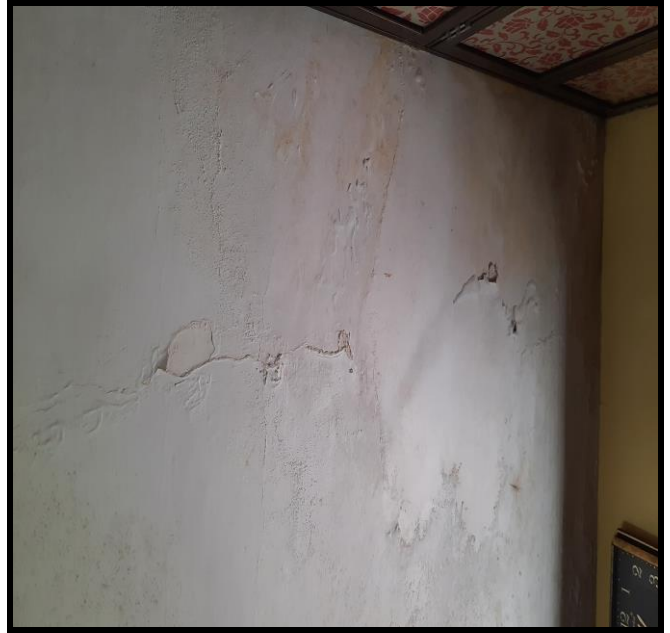
## FLAT NO – 07

- ❖ **HALL** – Leakage mark observed on ceiling.
- ❖ **KITCHEN** – Leakage mark observed on ceiling.
- ❖ **PASSAGE** – O.K.
- ❖ **TOILET & BATH ROOM** – O.K.

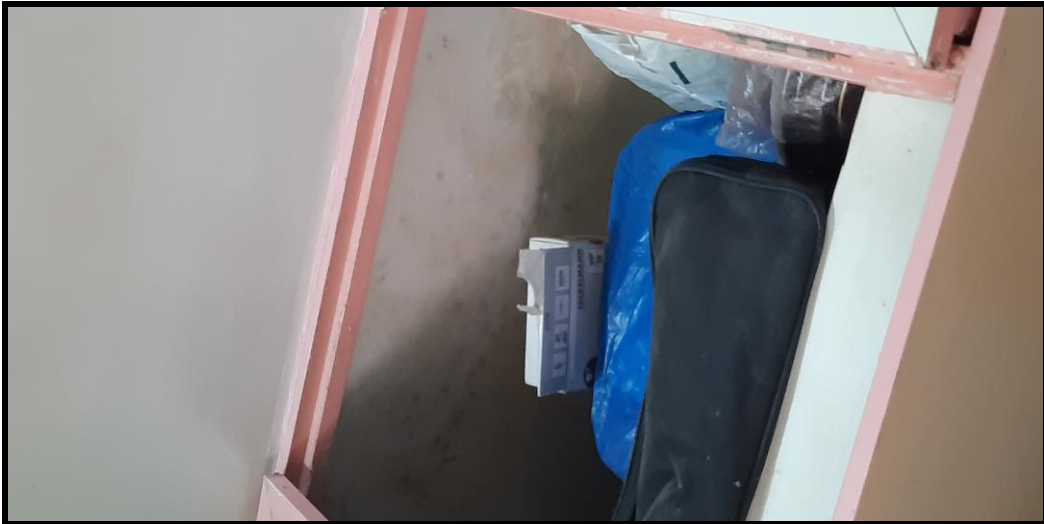
### FLAT NO – 9

- ❖ **HALL** – Leakage mark observed on ceiling.
- ❖ **KITCHEN** – O.K.
- ❖ **PASSAGE** – O.K.
- ❖ **TOILET & BATH ROOM** – O.K.

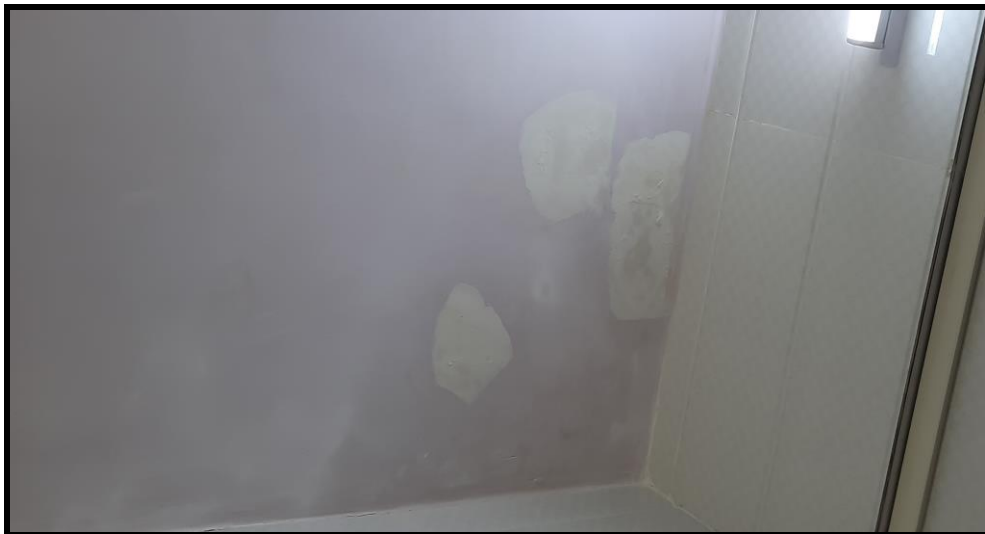
### FLAT NO – 11

- ❖ **HALL** – Dampness observed on ceiling.
- ❖ **KITCHEN** – Leakage observed on ceiling.
- ❖ **PASSAGE** – O.K.
- ❖ **TOILET & BATH ROOM** – O.K.

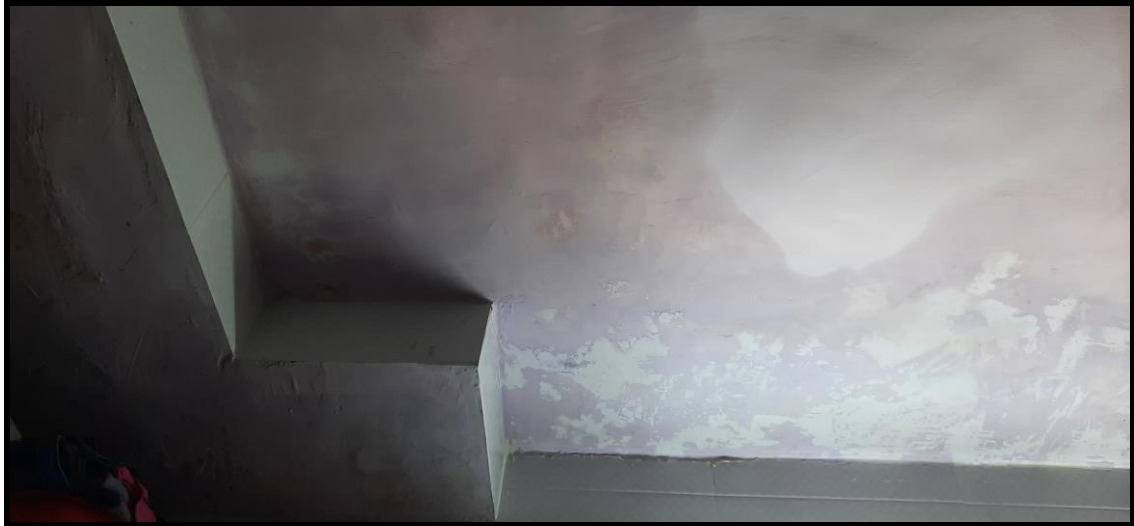
## FLAT NO – 12

- ❖ **HALL** – Dampness observed on ceiling in monsoon.
- ❖ **KITCHEN** – Dampness observed on ceiling.
- ❖ **PASSAGE** – O.K.
- ❖ **TOILET & BATH ROOM** – O.K.

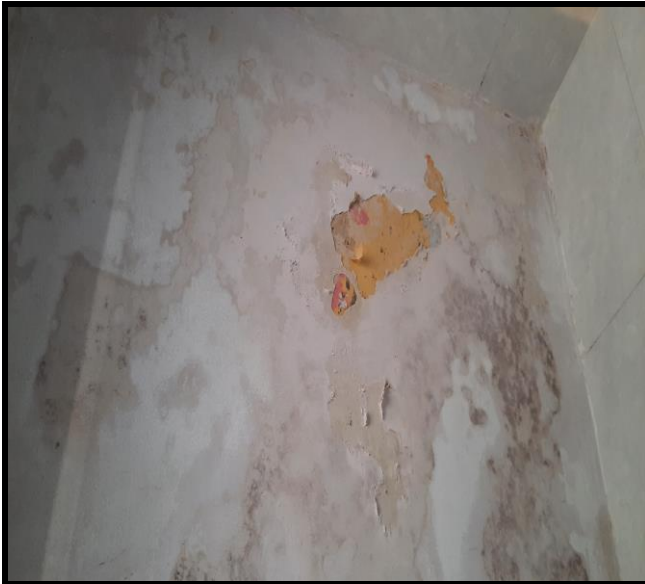
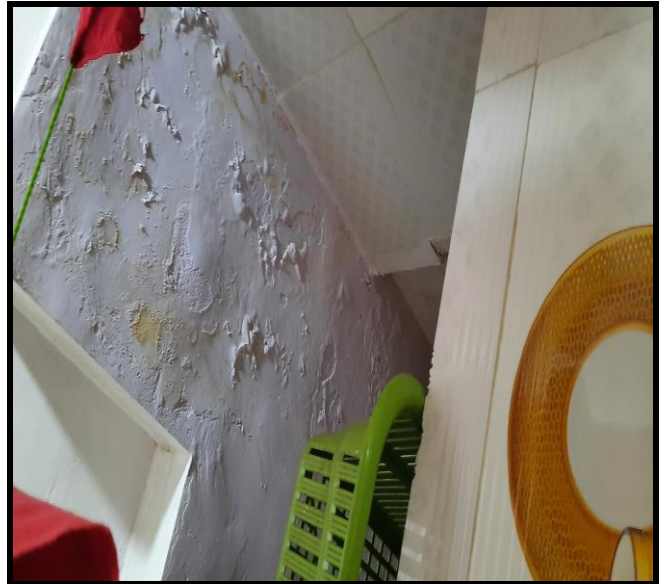
### FLAT NO – 20

- ❖ **HALL** – Dampness observed on ceiling.
- ❖ **KITCHEN** – Dampness observed on ceiling.
- ❖ **PASSAGE** – O.K.
- ❖ **TOILET & BATH ROOM** – Dampness observed on ceiling.

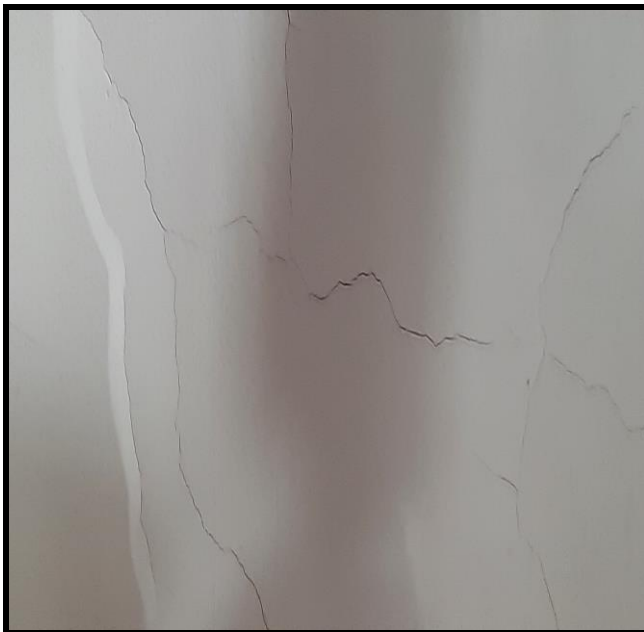
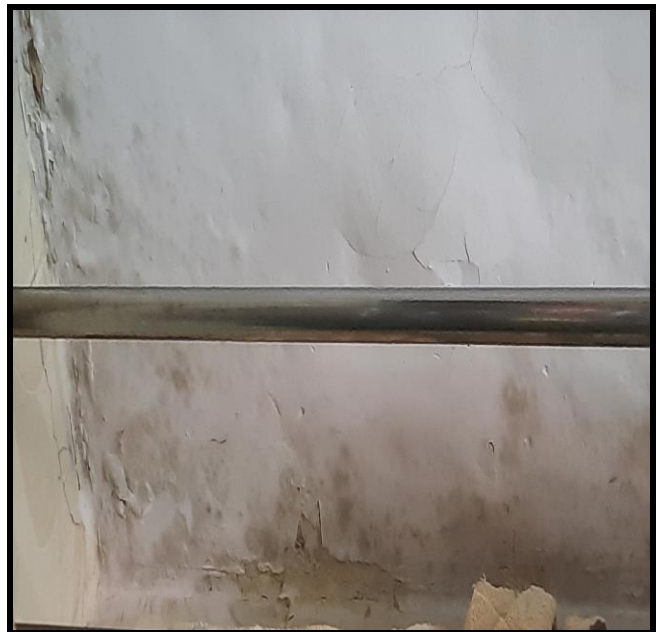
### FLAT NO – 28

- ❖ **HALL** – O.K.
- ❖ **KITCHEN** – Leakage mark observed on ceiling.
  - Structural crack observed on ceiling.
- ❖ **PASSAGE** – O.K.
- ❖ **TOILET & BATH ROOM** – O.K.

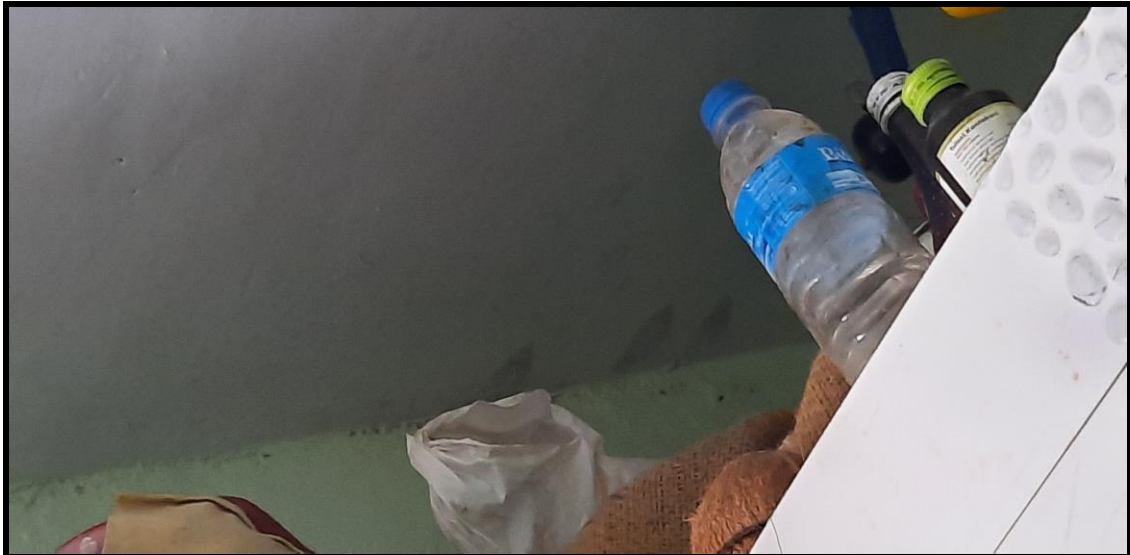
### FLAT NO – 35

- ❖ **HALL** – O.K.
- ❖ **KITCHEN** – Leakage observed on ceiling in monsoon.
- ❖ **PASSAGE** – O.K.
- ❖ **TOILET & BATH ROOM** – O.K.

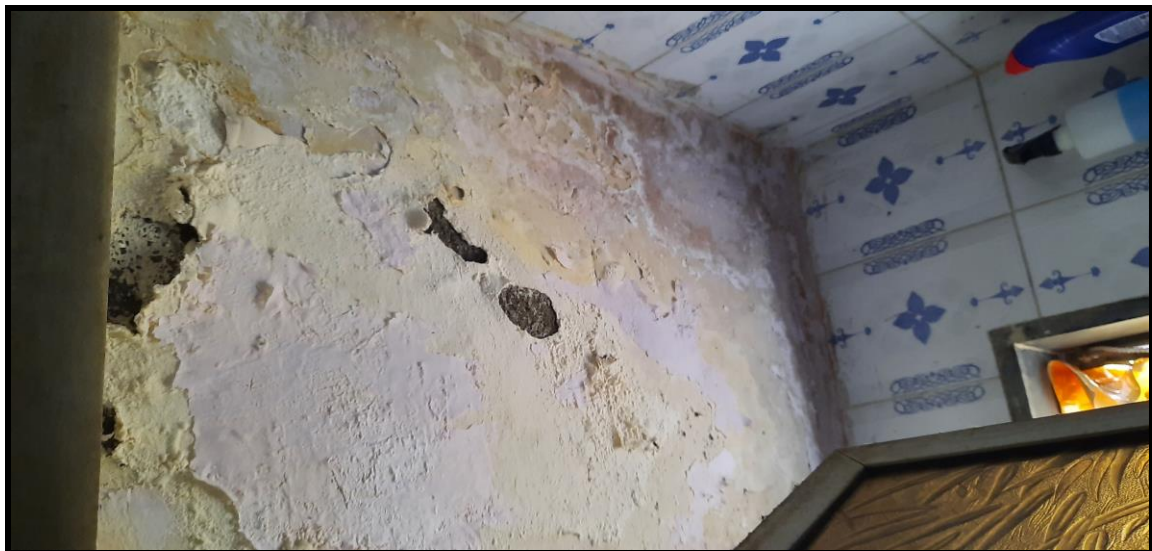
### FLAT NO – 61

- ❖ HALL – O.K.
- ❖ KITCHEN – O.K.
- ❖ PASSAGE – O.K.
- ❖ TOILET & BATH ROOM – Leakage mark observed on ceiling.

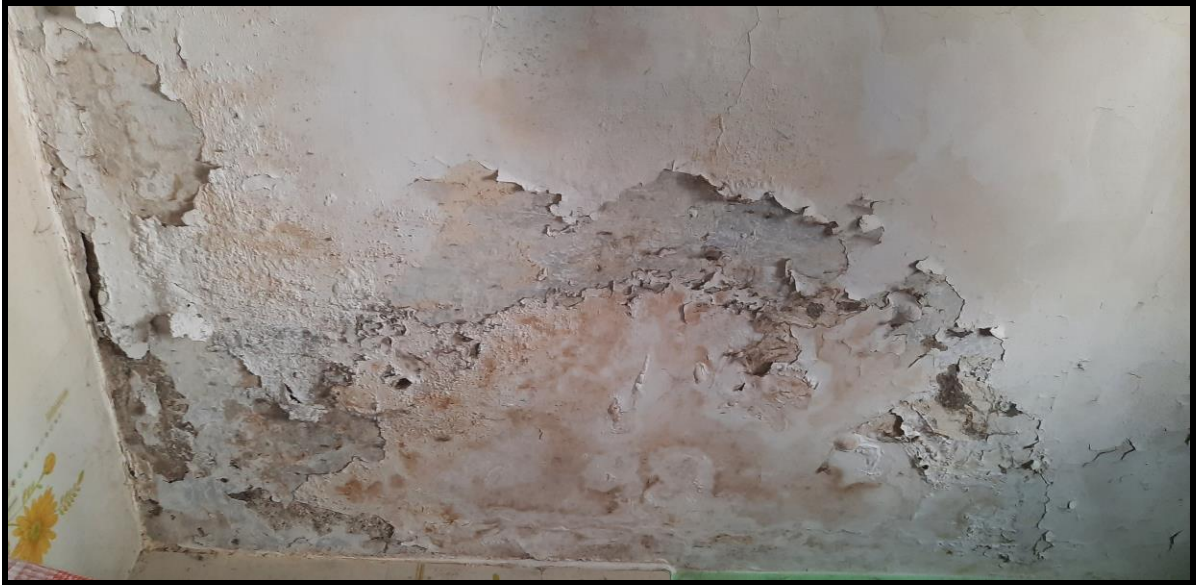
## FLAT NO – 62

- ❖ **HALL** – Leakage mark observed on ceiling.
- ❖ **KITCHEN** – Leakage mark observed on ceiling.
- ❖ **PASSAGE** – O.K.
- ❖ **TOILET & BATH ROOM** – O.K.

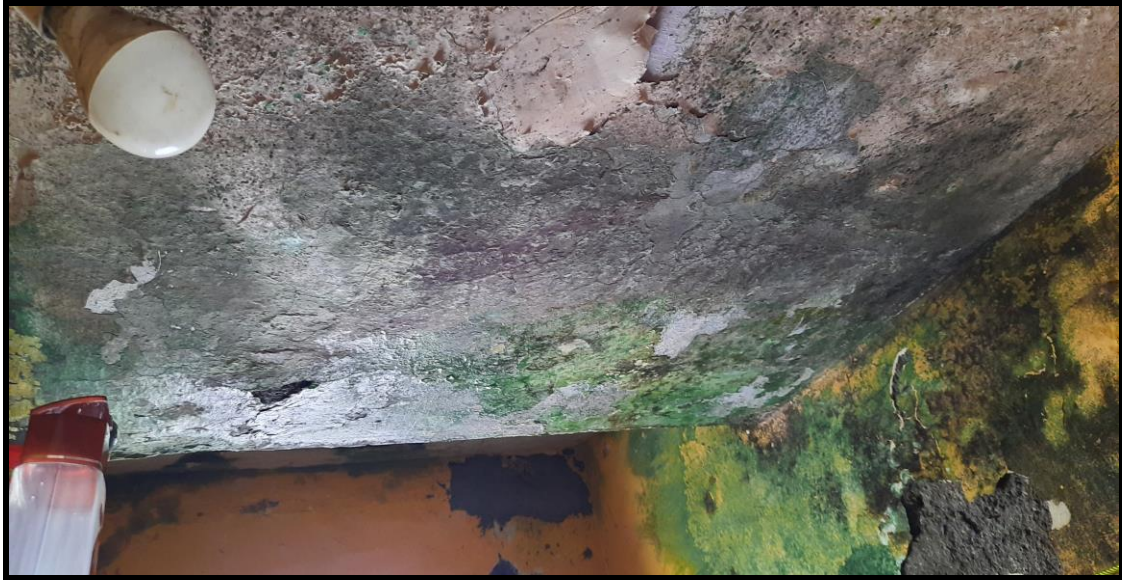
## FLAT NO – 71

- ❖ **HALL** – O.K.
- ❖ **KITCHEN** – O.K.
- ❖ **PASSAGE** – O.K.
- ❖ **TOILET & BATH ROOM** – Leakage observed on ceiling.
