STRUCTURAL AUDIT REPORT  
FOR  
“VISHAL SAHYADRI CO – OP HSG. SOC. LTD”,  
“D3 – A WING”  
SITUATED AT  
SAHYADRI NAGAR, CHARKOP,  
KANDIVALI (W) MUMBAI – 400 067

978/D3/LSS/2021

JULY 16, 2021

"Vishal Sahyadri Co – Operative Housing Soc. Ltd", "D3 – A WING" Regi. No. BOM/HSG/5697/1979 Situated at Sahyadri Nagar, Charkop, Kandivali (W) Mumbai – 400 067 had requested to **Latesh S. Sanklecha, Consulting Structural Engineer** to inspect the structures.

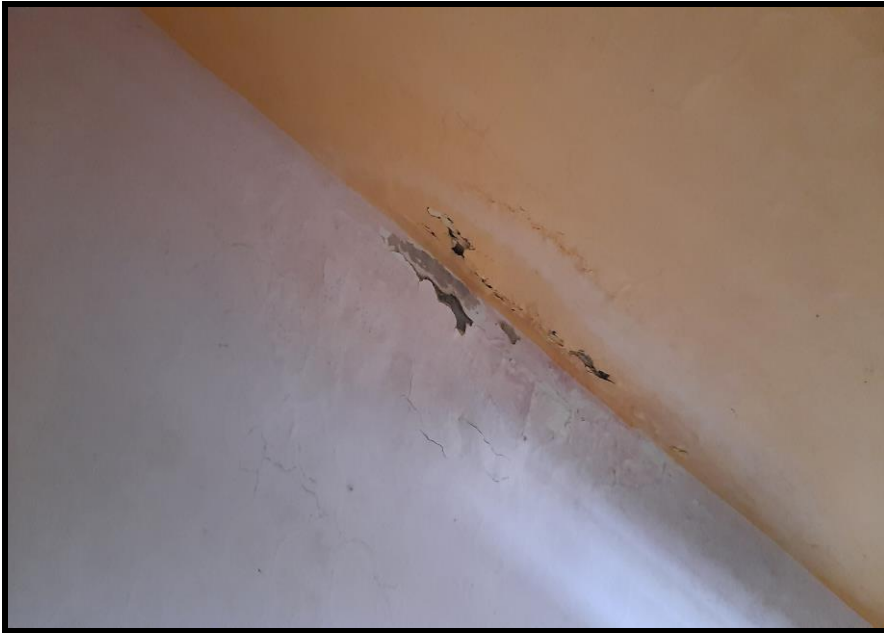
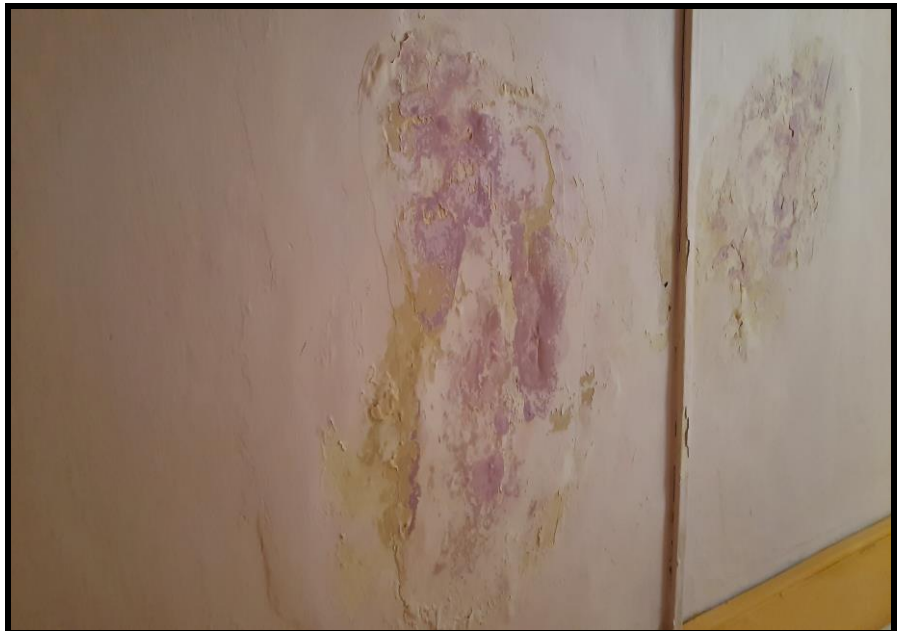
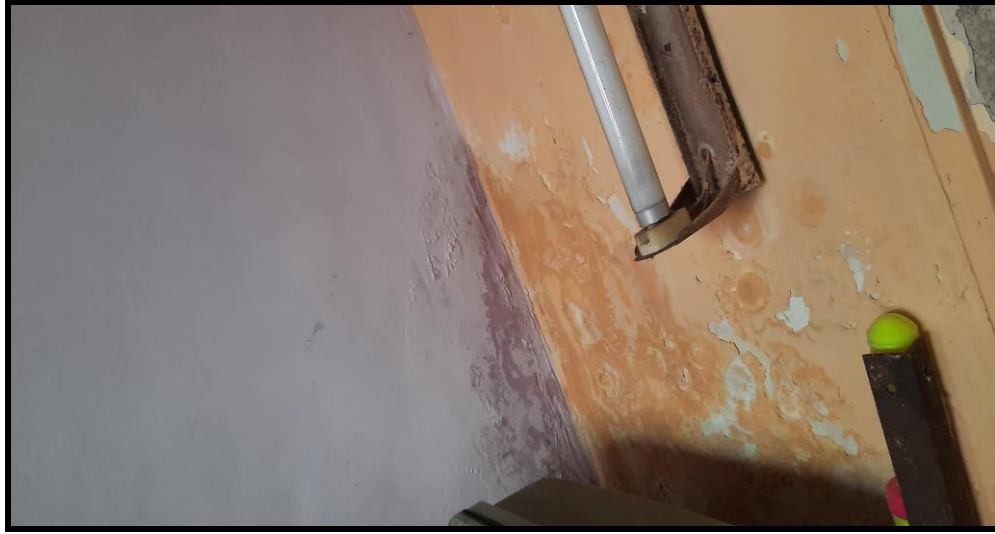
### FLAT NO – 14

- ❖ **HALL** – Leakage mark observed on ceiling.
- ❖ **KITCHEN** – Leakage mark observed on ceiling & wall.
- ❖ **PASSAGE** – O.K.
- ❖ **TOILET & BATH ROOM** – O.K.

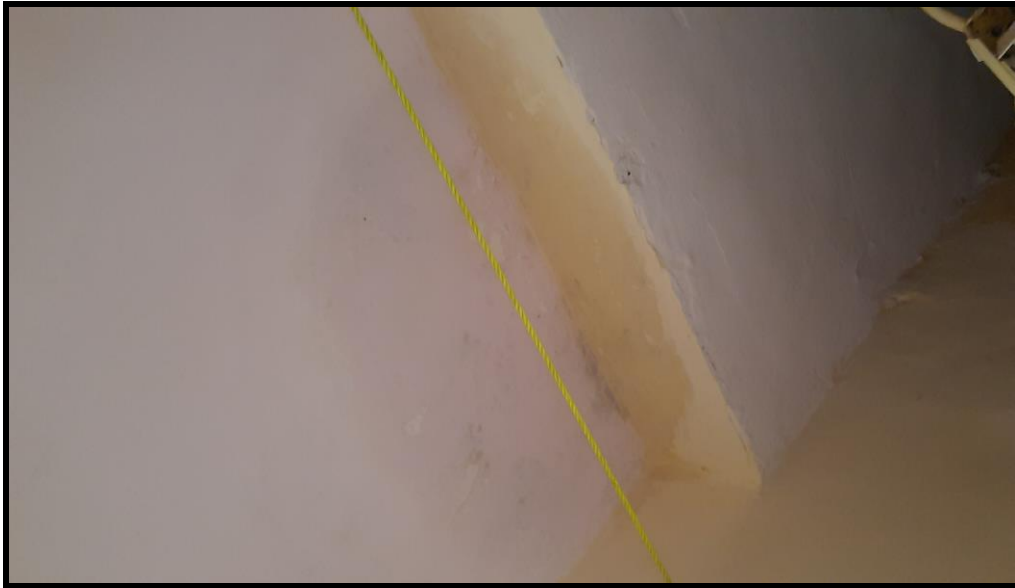
### FLAT NO – 25

- ❖ **HALL** – O.K.
- ❖ **KITCHEN** – O.K.
- ❖ **PASSAGE** – Leakage mark observed on ceiling.
- ❖ **TOILET & BATH ROOM** – O.K.

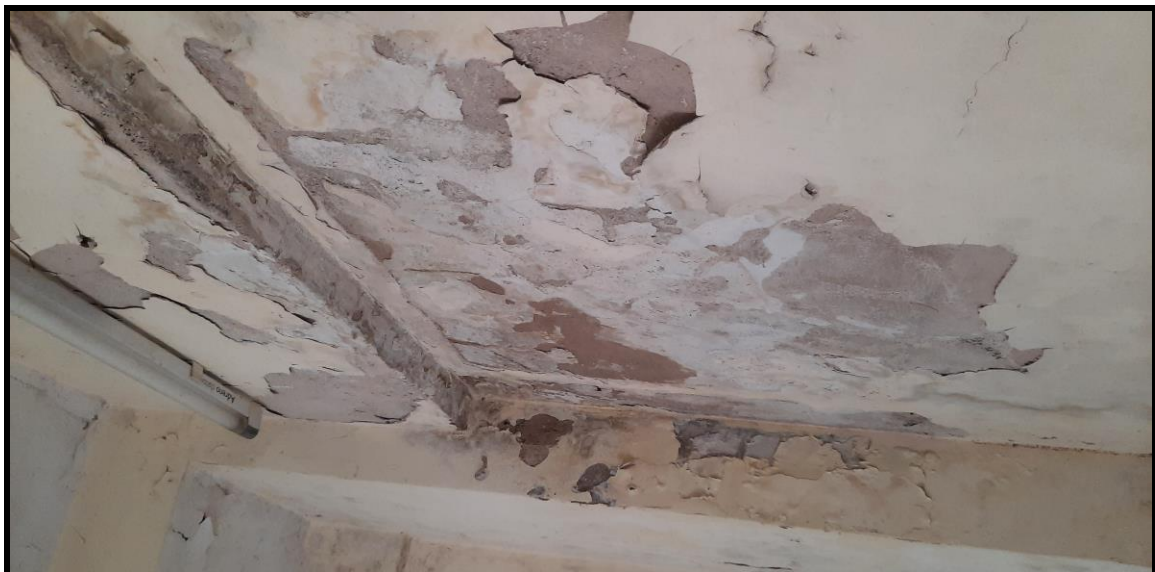
### FLAT NO – 27

- ❖ **HALL** – O.K.
- ❖ **KITCHEN** – Leakage mark observed on wall.
- ❖ **PASSAGE** – O.K.
- ❖ **TOILET & BATH ROOM** – O.K.

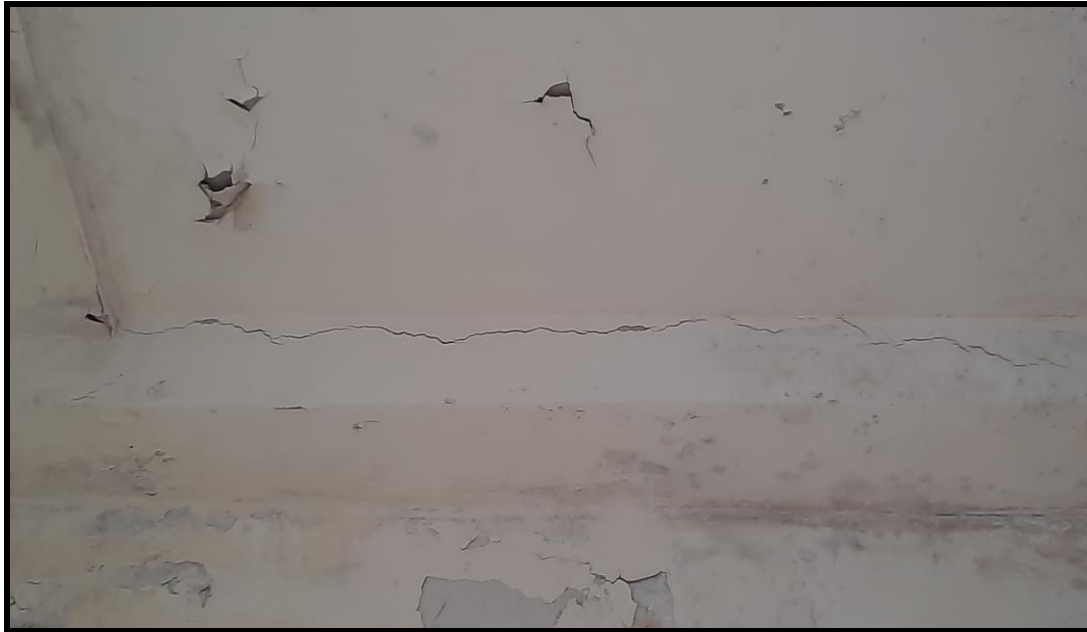
## FLAT NO – 28

- ❖ **HALL** – O.K.
- ❖ **KITCHEN** – Leakage mark observed on wall.
  - Structural crack observed on column.
- ❖ **PASSAGE** – O.K.
- ❖ **TOILET & BATH ROOM** – O.K.
