STRUCTURAL AUDIT REPORT  
FOR  
“VISHAL SAHYADRI CO – OP HSG. SOC. LTD”,  
“B14 – WING”  
SITUATED AT  
SAHYADRI NAGAR, CHARKOP,  
KANDIVALI (W) MUMBAI – 400 067

978/B14/LSS/2021

JULY 24, 2021

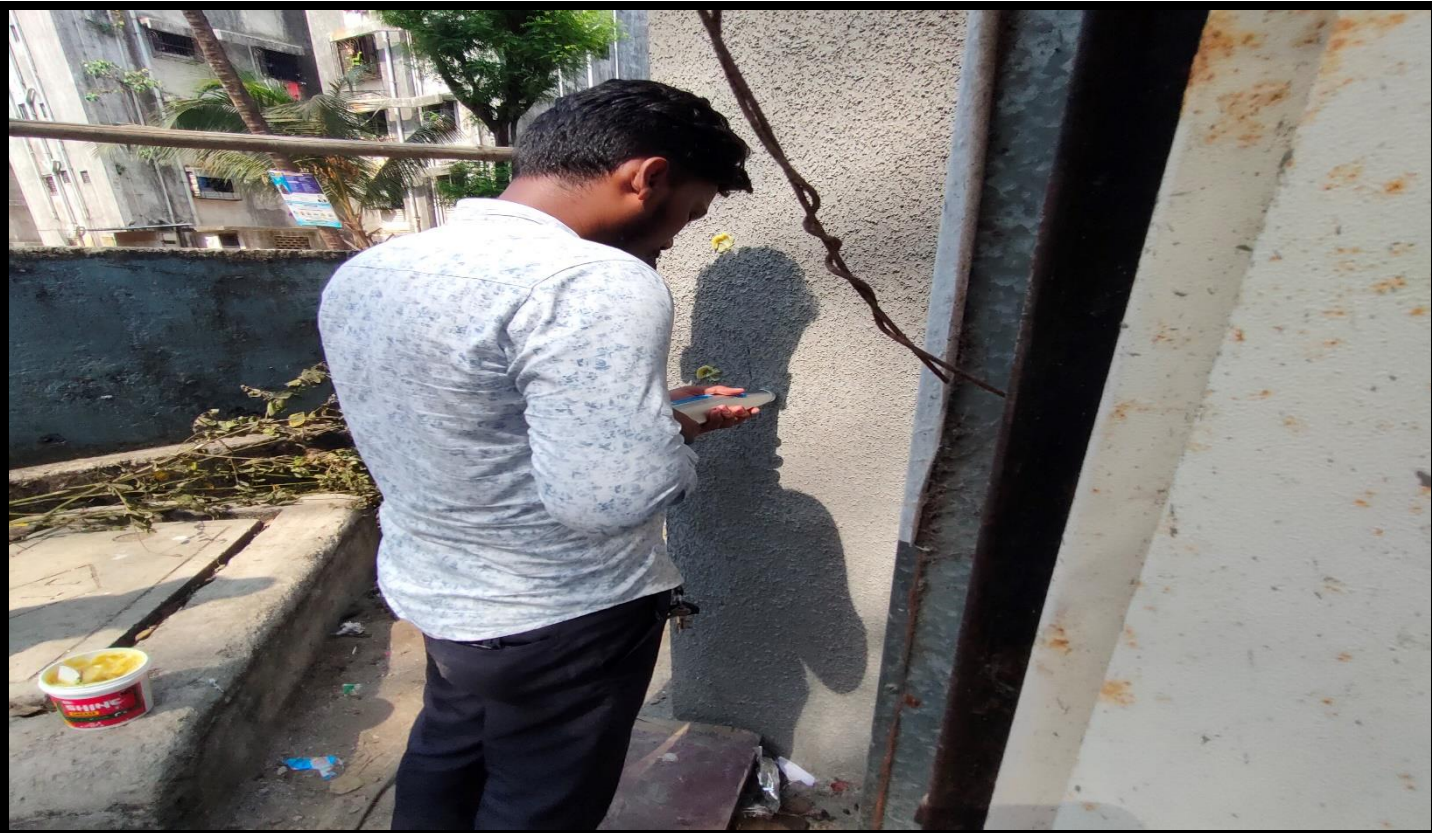
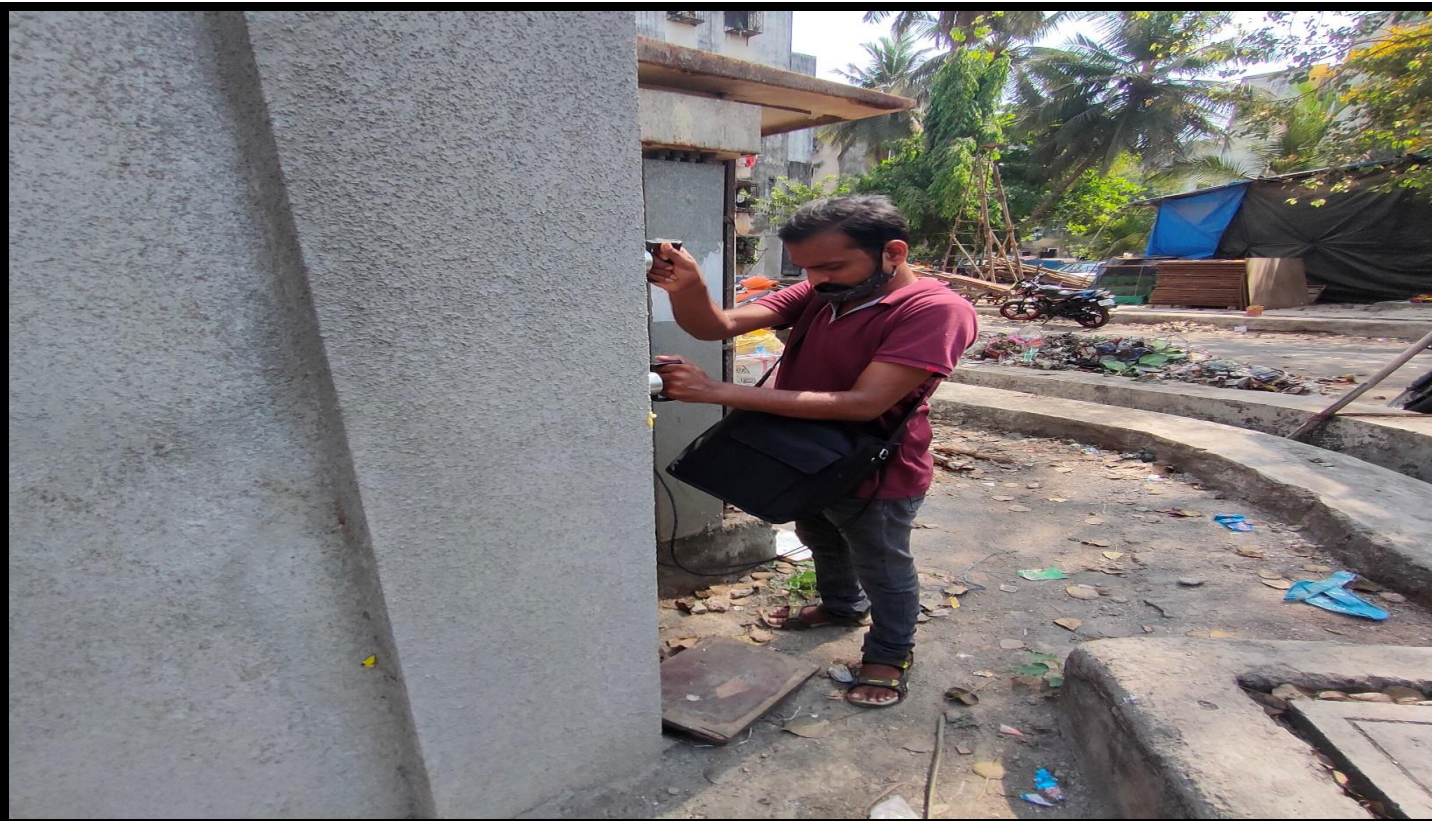
## **NON –DESTRUCTIVE TEST PHOTO**

Rebound Hammer was tested for compressive strength at surface by Schmidt rebound hammer. Results indicate the compressive strength at surface of all the RCC columns in is ranging between 17.50 MPa to 23.30 MPa.

Out of 4 locations 1 location was below 3.0 Km/Sec means concrete quality is poor and 3 locations ranging between 3.0 to 3.75 Km/Sec means concrete quality is doubtful.

This indicates there are progressive internal cracks in the RCC members due to corrosion of reinforced steel. These members are under distress condition.

This indicates the probability of corrosion is 50% on tested column steel reinforcement.

Carbonation test was conducted to assess carbonation depth. Readings are taken on Column. Result indicates the carbonation penetration depth is 35.00 mm. Carbonation depths have reached to the reinforcement level in all of the RCC elements. It is essential to give a suitable anti-corrosion treatment to all the RCC members to stop further carbonation and corrosion of concrete.

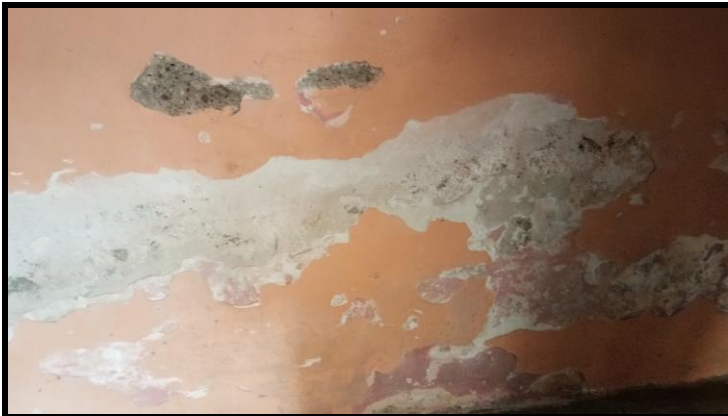
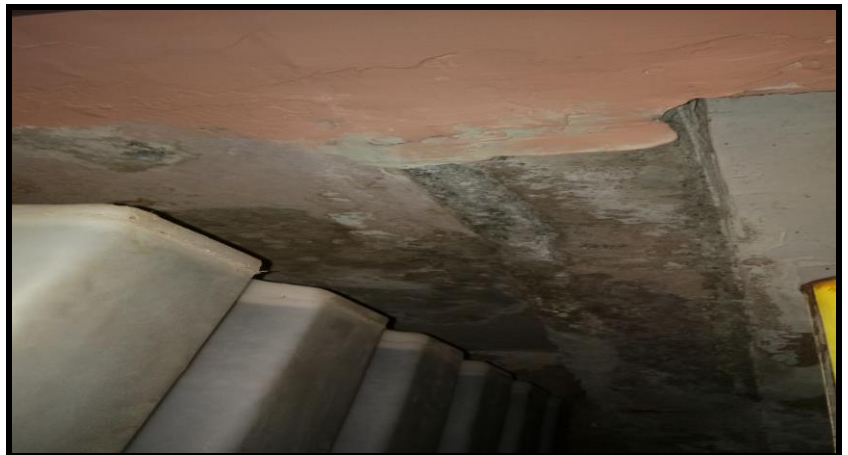
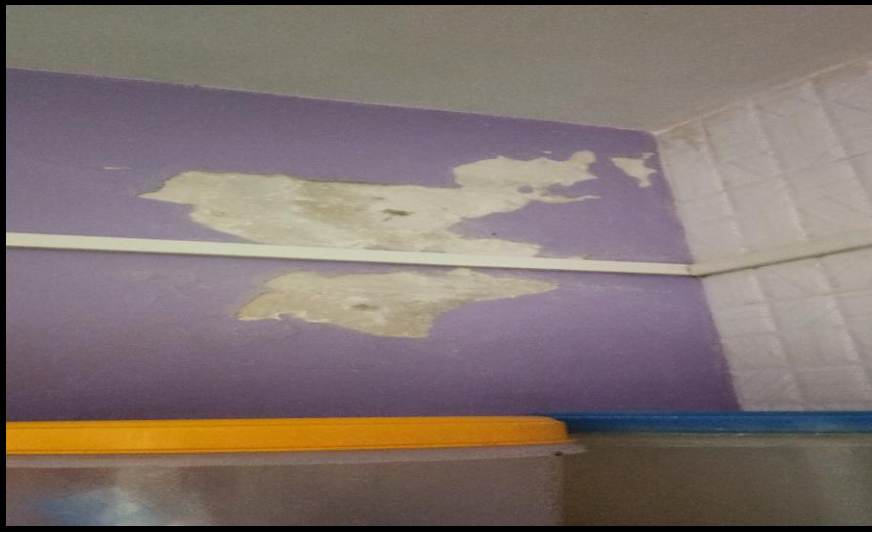
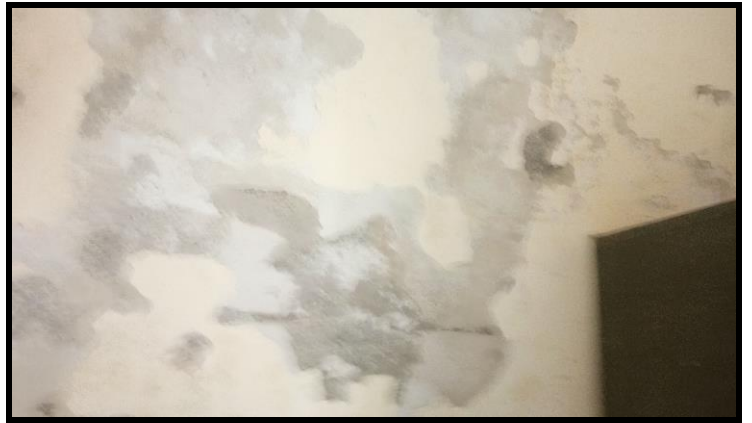
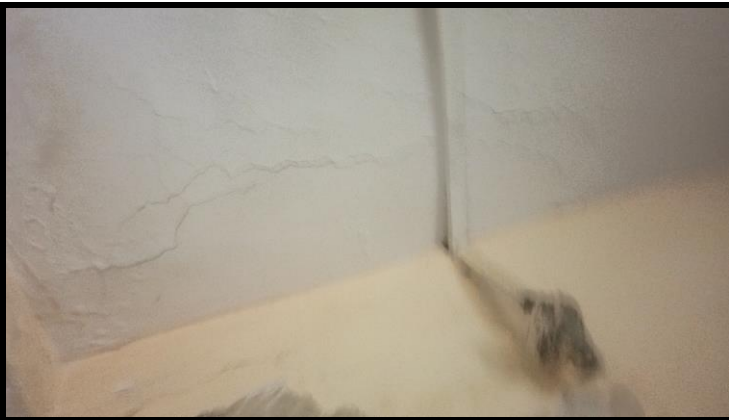
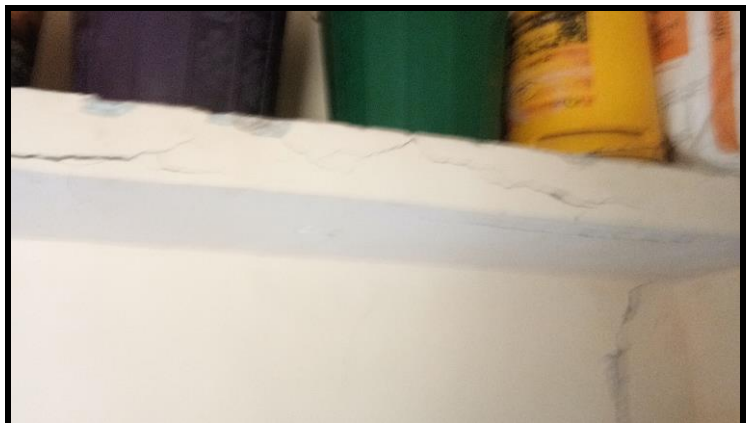
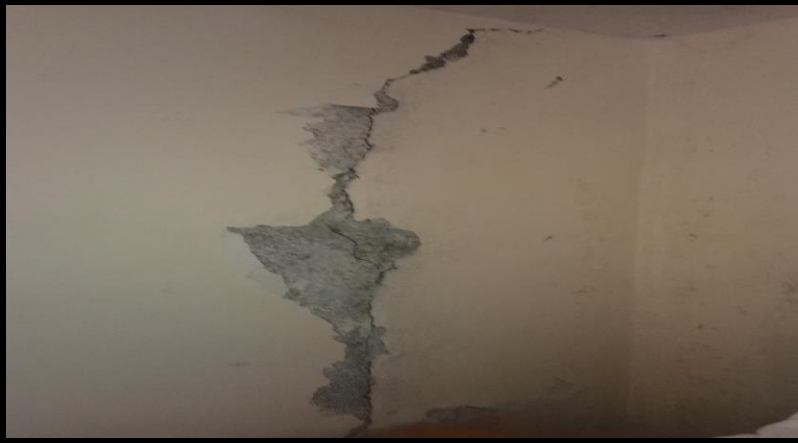
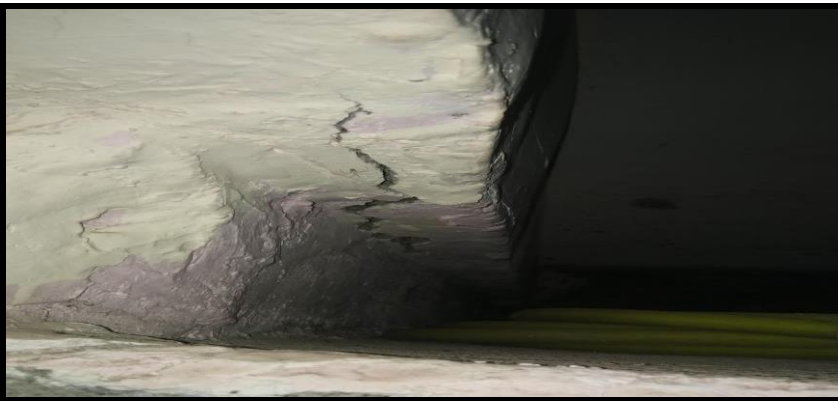
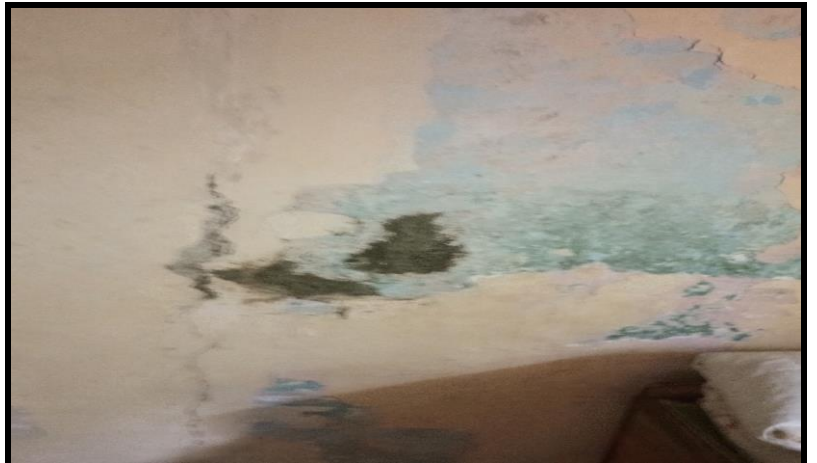
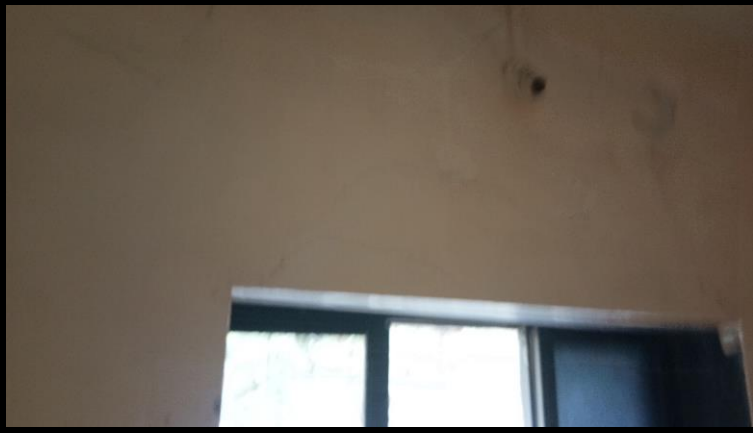
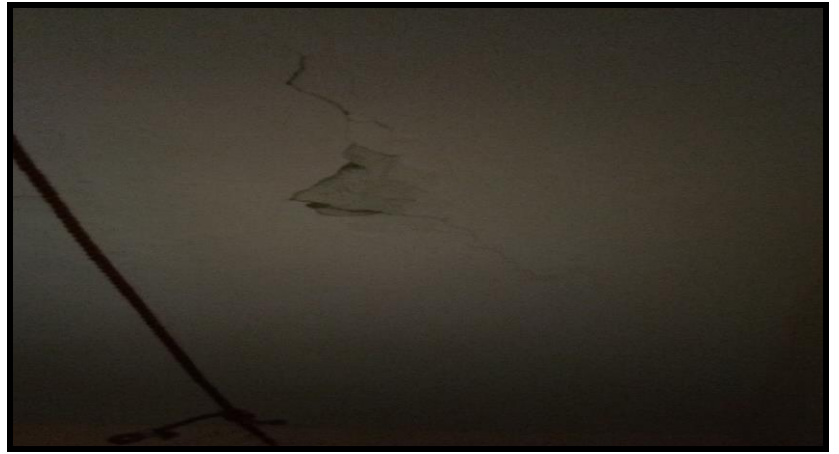
### FLAT NO – 07, 08

- ❖ **HALL** – Peeling of paint observed on wall.
  - Major structural crack observed on beam.
- ❖ **KITCHEN** – Seepage mark observed on wall.
  - Peeling of paint observed on ceiling.
- ❖ **PASSAGE NO. 01** – Major crack observed on wall.
  - Peeling of paint observed on column.
  - Seepage mark observed on beam.
- ❖ **PASSAGE NO. 02** – Seepage mark observed on ceiling.
- ❖ **BEDROOM NO. 01** – Major structural crack observed on beam.
  - Major structural crack observed on column.
  - Leakage mark observed on ceiling.
- ❖ **BEDROOM NO. 02** – Seepage mark observed on wall.
- ❖ **TOILET & BATH ROOM** – Seepage mark observed on window side wall.

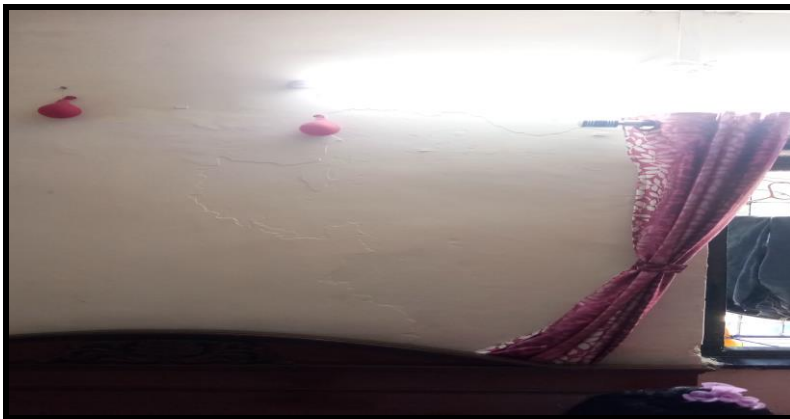
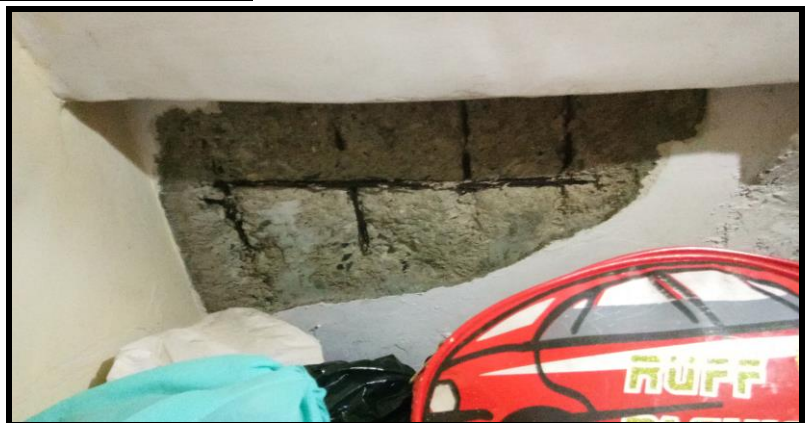
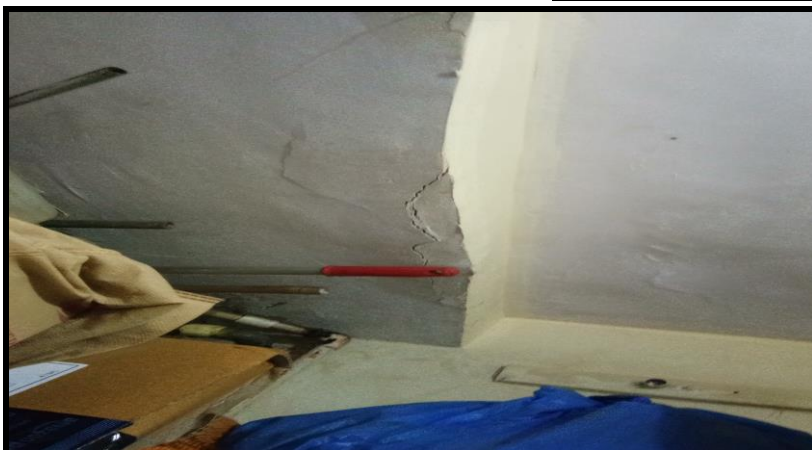
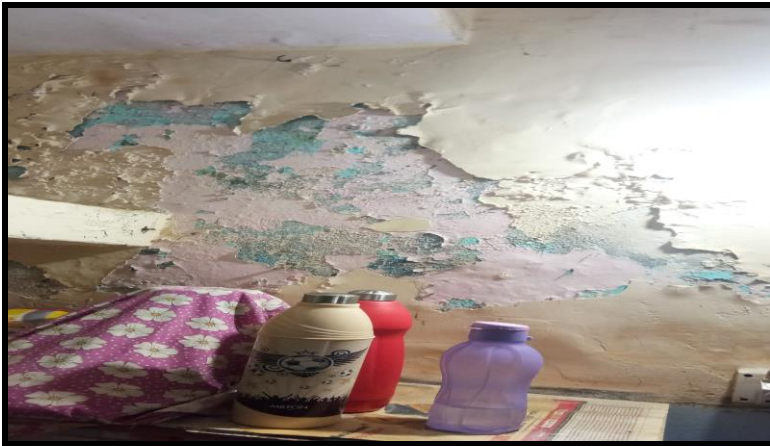
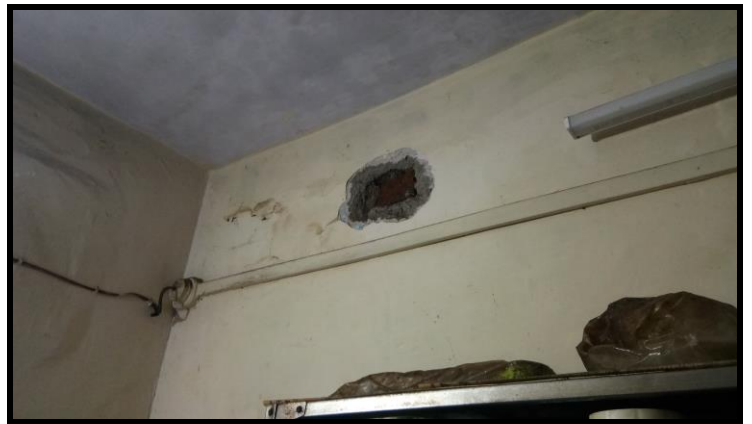
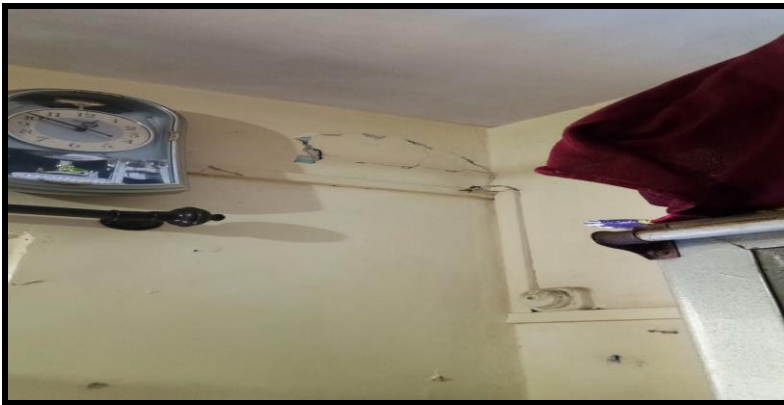
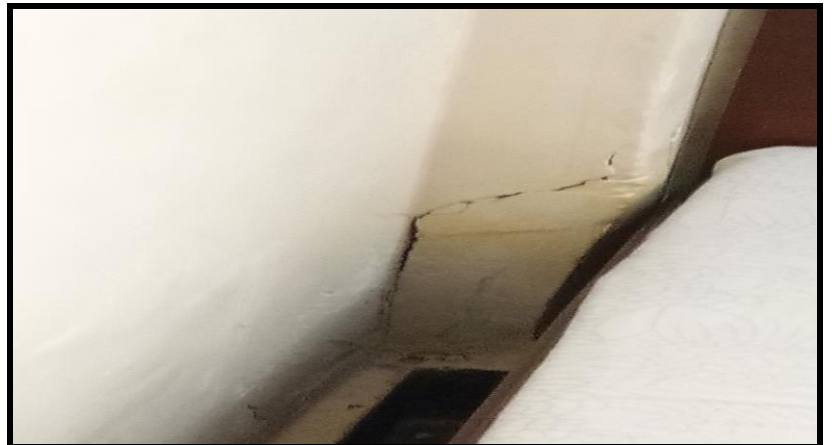
### FLAT NO – 15

- ❖ **HALL** – Major structural crack observed on beam.
  - Seepage mark observed on wall.
- ❖ **KITCHEN** – Major crack observed on wall.
  - Peeling of paint observed on ceiling.
- ❖ **PASSAGE** – Plaster gets exposed and steel gets corroded.
  - Major crack observed on wall.
- ❖ **TOILET & BATH ROOM** – Seepage mark observed on wall.

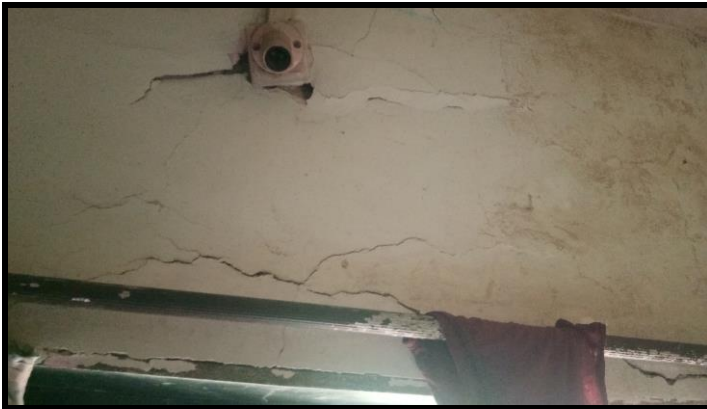
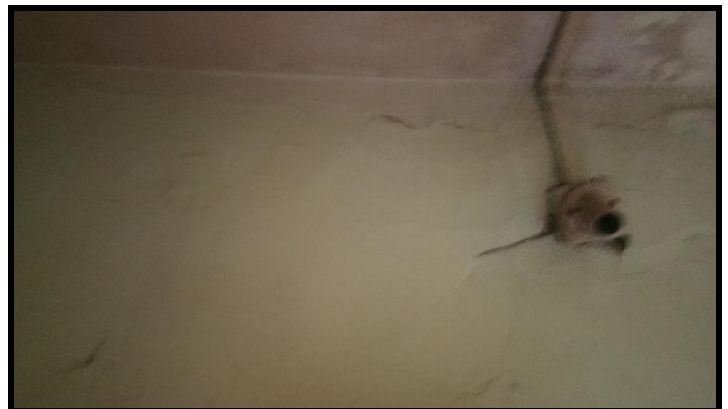
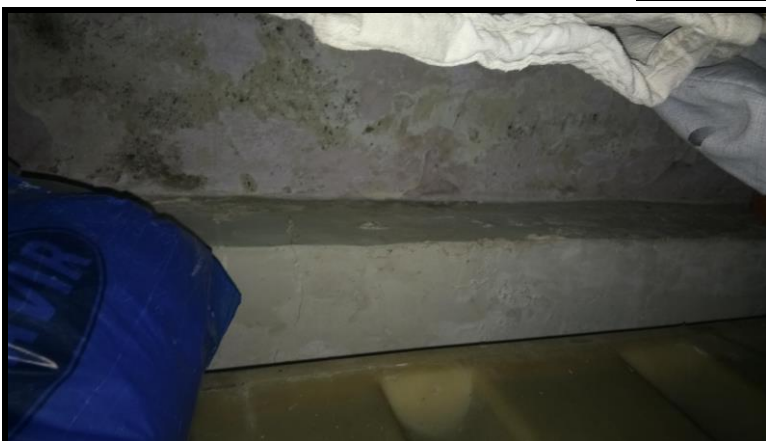
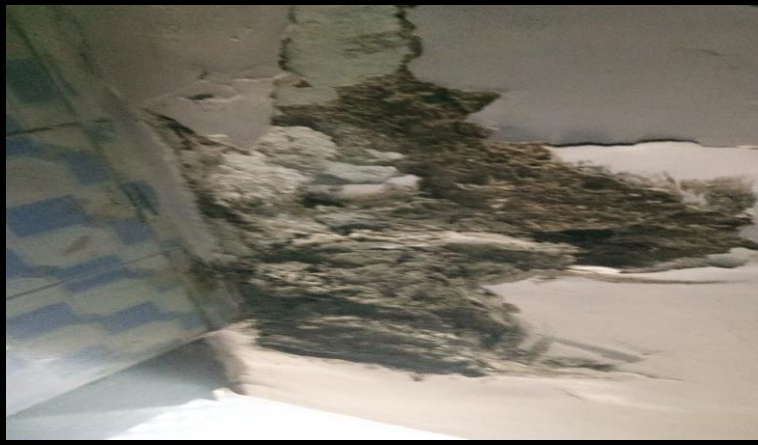
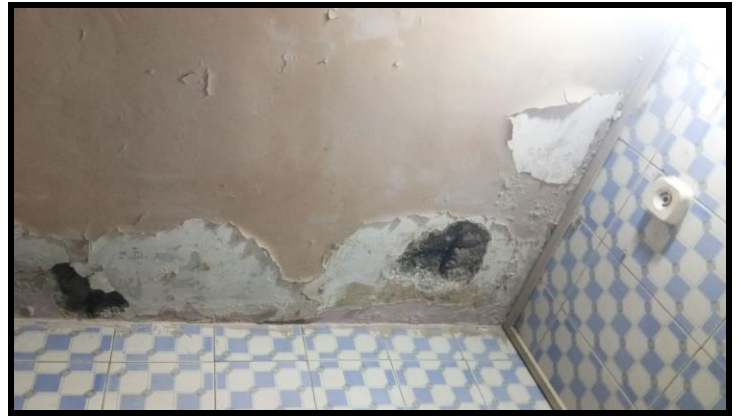
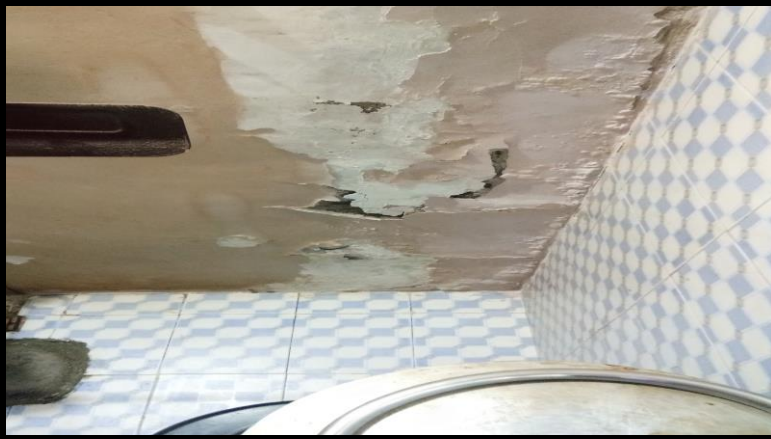
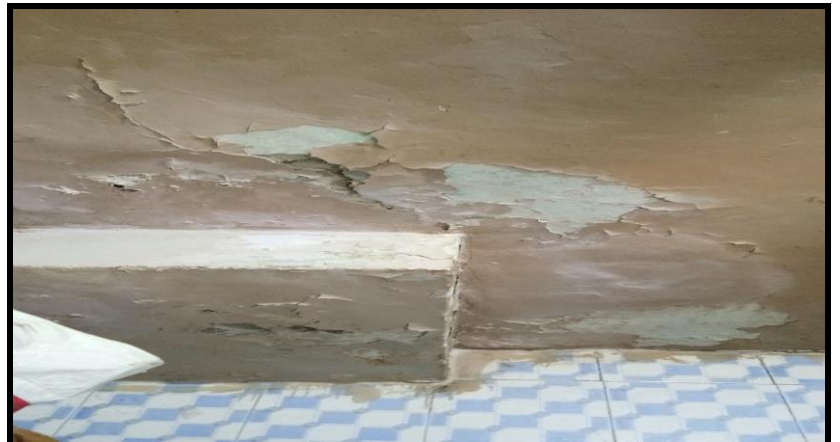
## FLAT NO – 17

- ❖ **HALL** – Major structural crack observed on beam.
  - Peeling of paint observed on ceiling.
- ❖ **KITCHEN** – Major structural crack observed on beam.
  - Ceiling gets damage.
  - Plaster gets exposed and steel gets corroded.
- ❖ **PASSAGE** – Peeling of paint observed on wall.
  - Major structural crack observed on beam.
- ❖ **TOILET & BATH ROOM** – Seepage mark observed on wall.

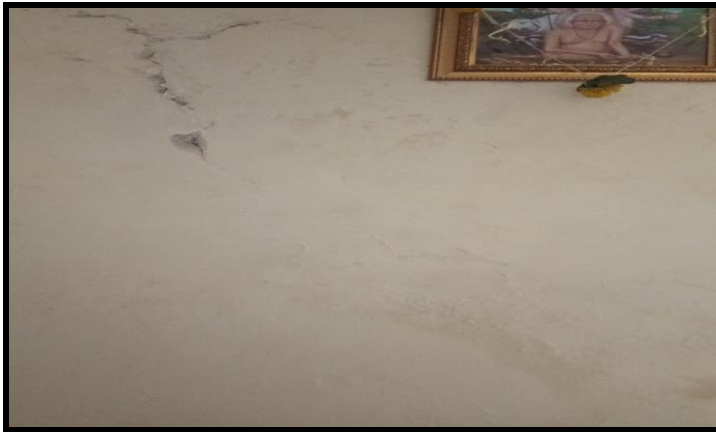
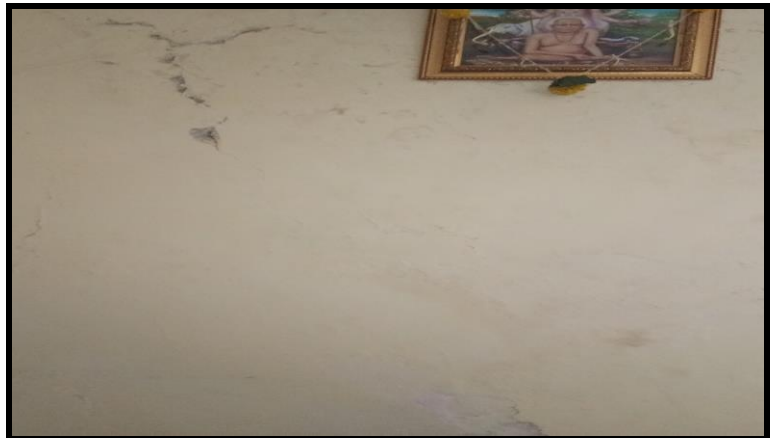
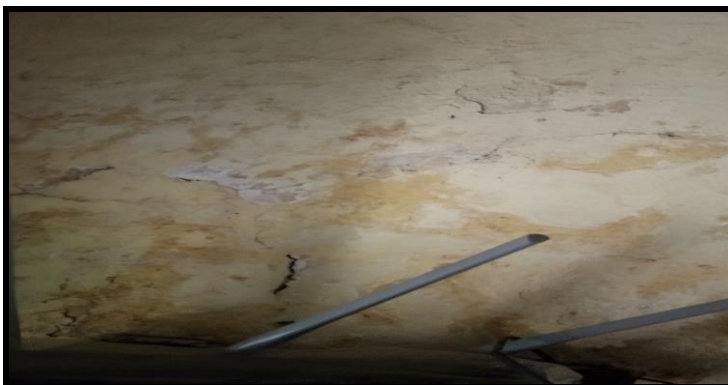
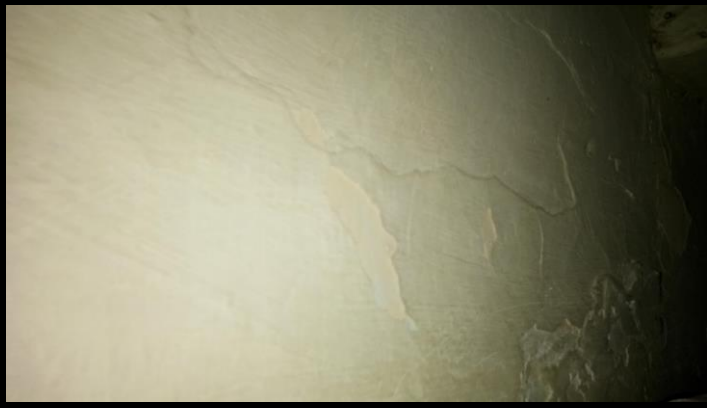
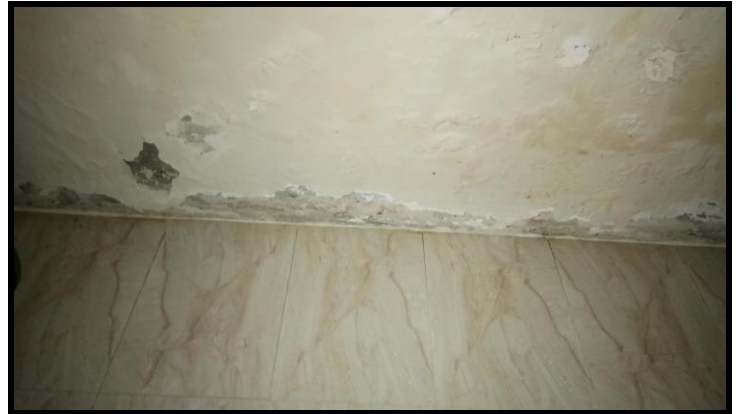
### FLAT NO – 27

- ❖ **HALL** – Major structural crack observed on beam.
  - Peeling of paint observed on ceiling.
- ❖ **KITCHEN** – Peeling of paint observed on wall.
  - Seepage mark observed on wall.
- ❖ **PASSAGE** – Seepage mark observed on ceiling.
- ❖ **TOILET & BATH ROOM** – Seepage mark observed on ceiling.

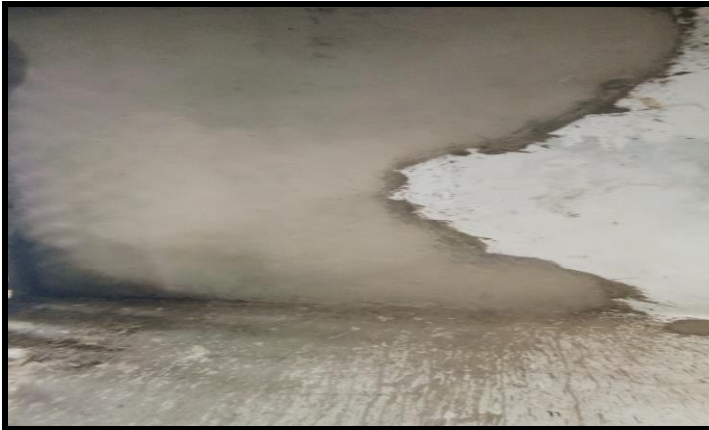
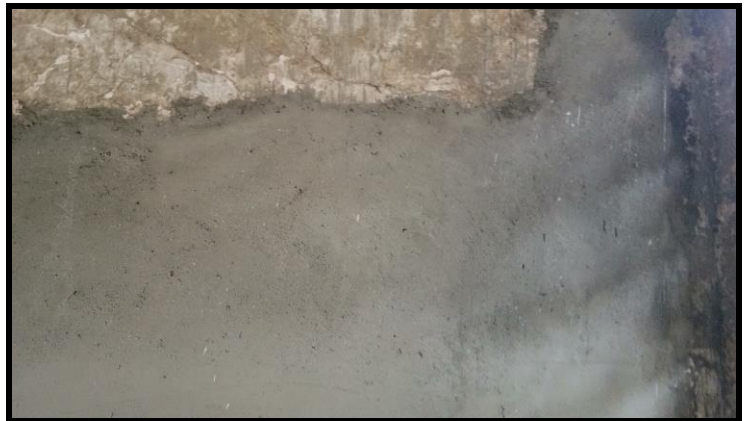
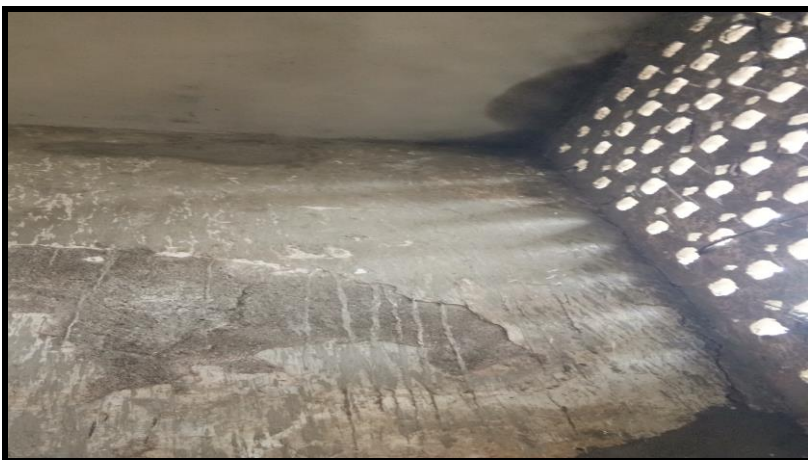
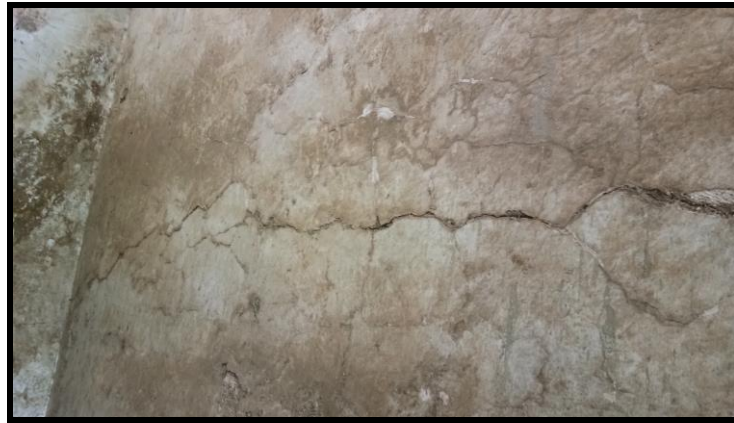
### **Terrace to Fourth floor:-**

- ❖ Plaster gets removed.
- ❖ Patch work observed on wall.
- ❖ Peeling of paint observed on wall.

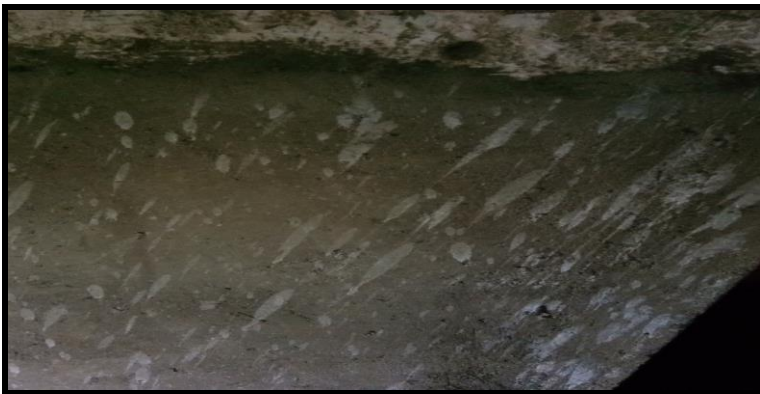
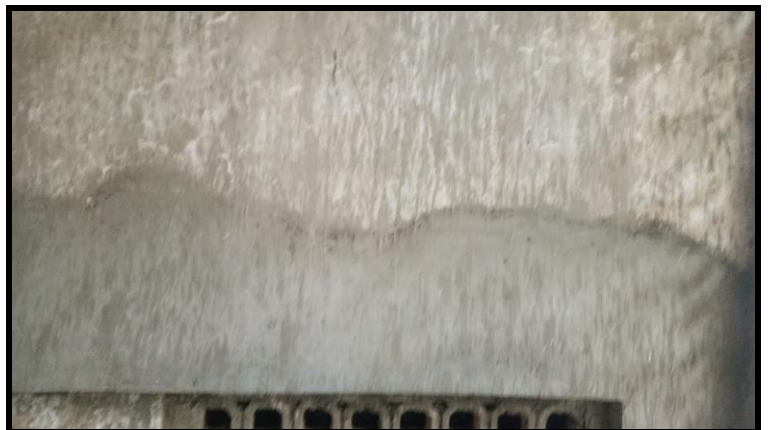
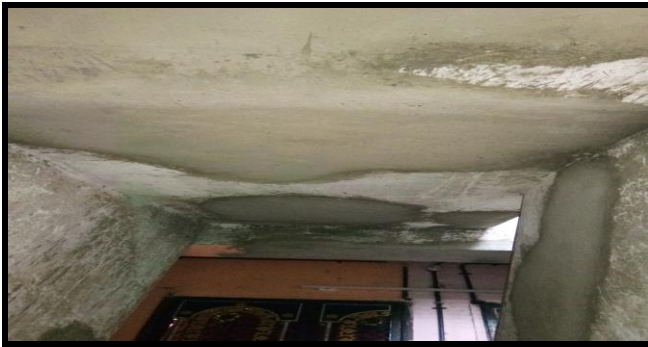
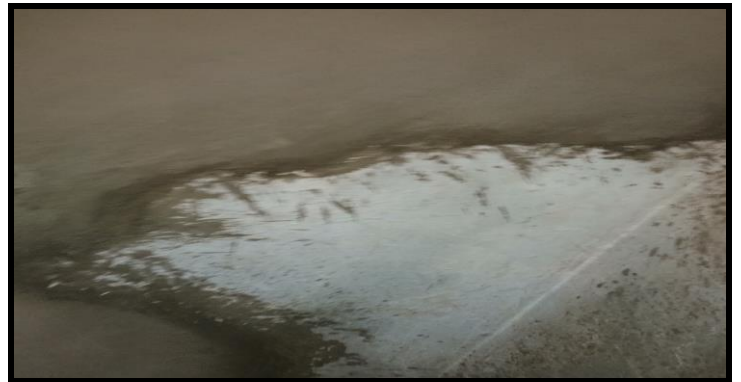
#### **Fourth floor to Third floor:-**

- ❖ Plaster gets removed.
- ❖ Patch work observed on wall.

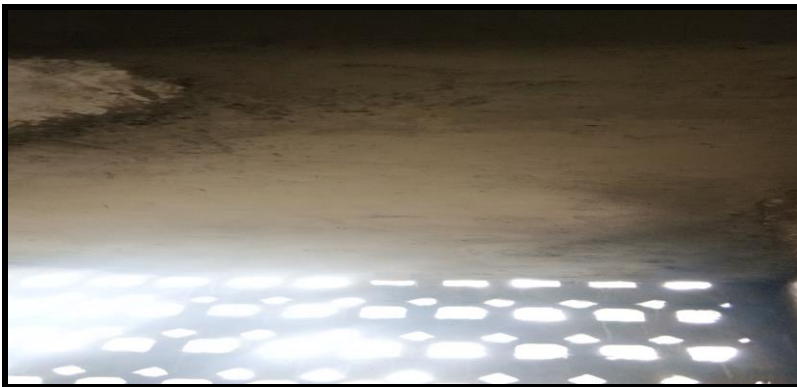
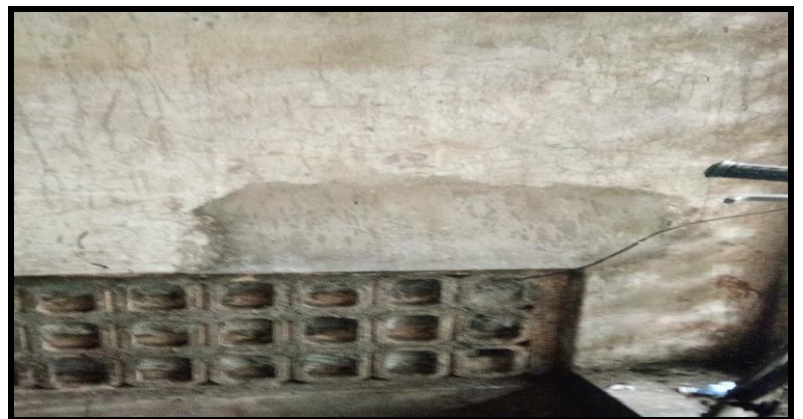
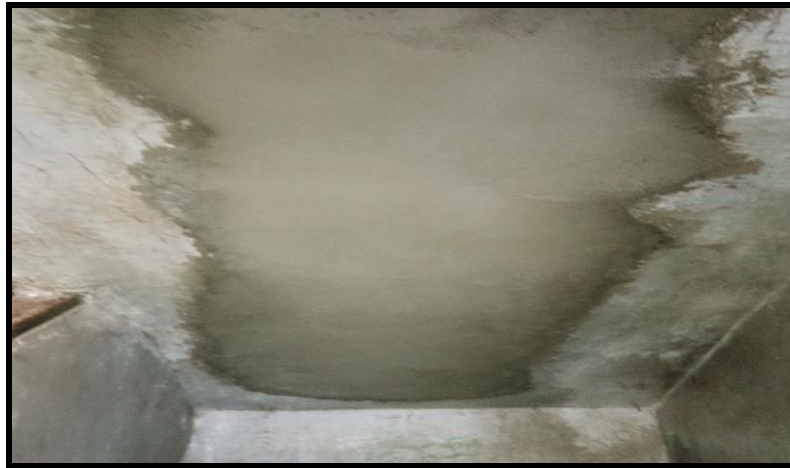
### Third floor to Second floor:-

- ❖ Plaster gets removed.
- ❖ Patch work observed on wall.

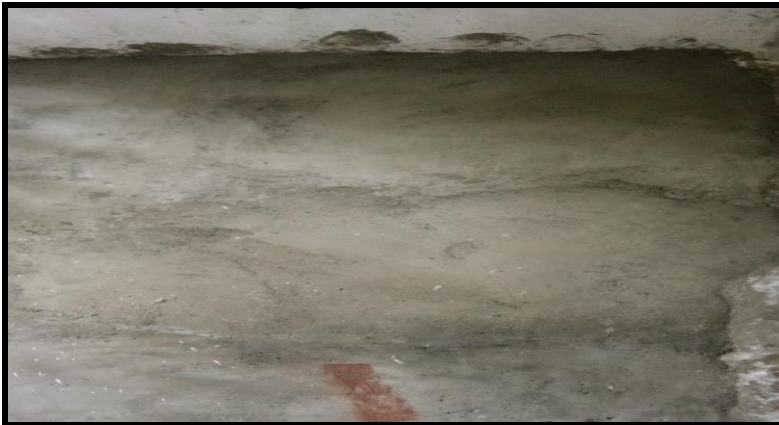
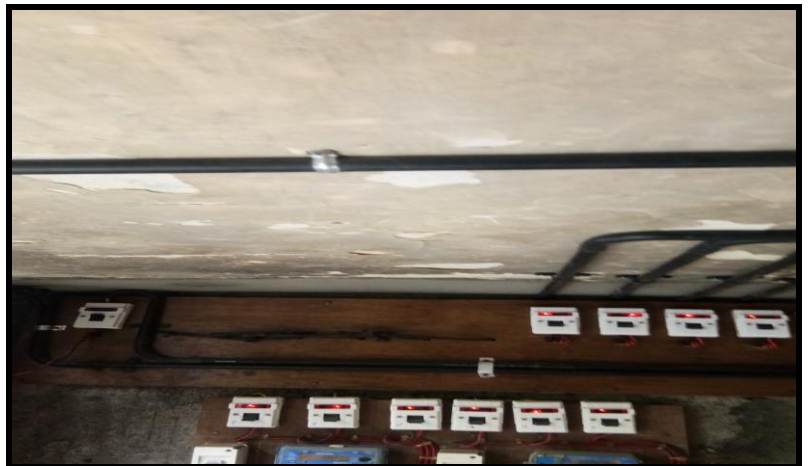
## First floor to Ground floor:-

- ❖ Patch work observed on wall.
- ❖ Peeling of paint observed on wall.
