## Field Biologist Site Inspection for Family Mart

FamilyMart Mayang Mall / 21 Jul 2025

Document No.	000148
Audit Title	Post-Opening Site Inspection
Site Name	FamilyMart Mayang Mall
Location	Lower Ground Mayang Mall, 20000 Kuala Terengganu, Terengganu, Malaysia (5.3370937, 103.14438159999999)
Contractor Present	Yes
Name	Adam IDZire
Project PIC Present	Yes
Name	Sim Hant Shen
Inspected by	Naim Yusuf
Inspection Date	21.07.2025
Prepared by	Naim Yusuf

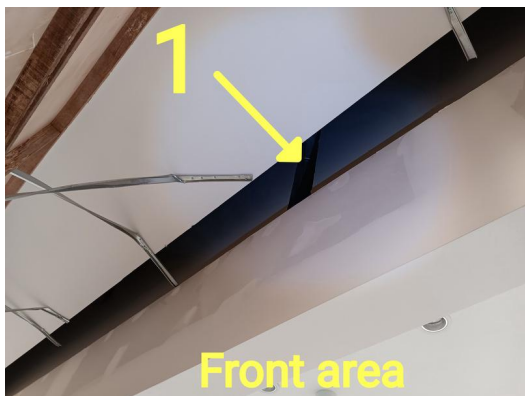
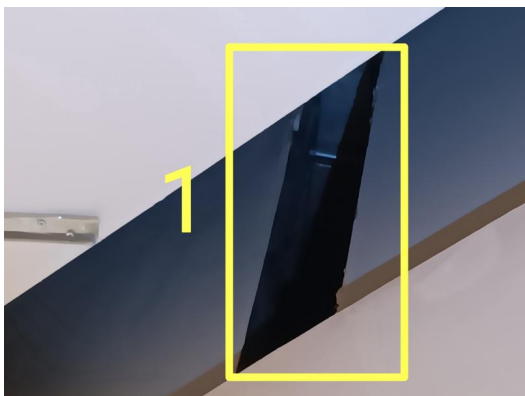
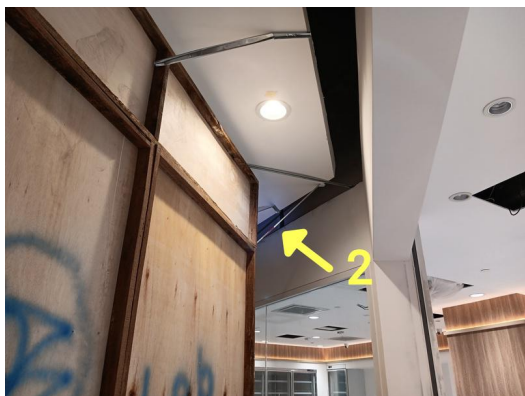
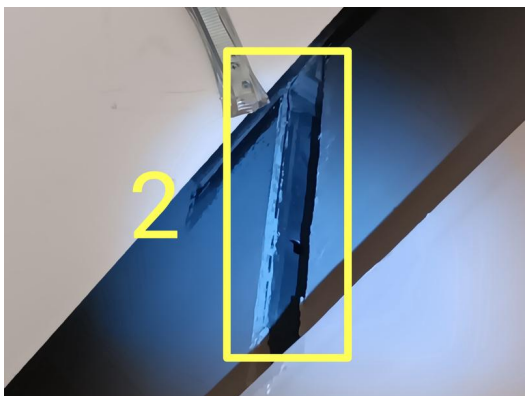
Gaps found above ceiling at front area connecting to internal ceiling.

- 1. Completed ☒
- 2. Completed ☒

Please close the gaps securely.

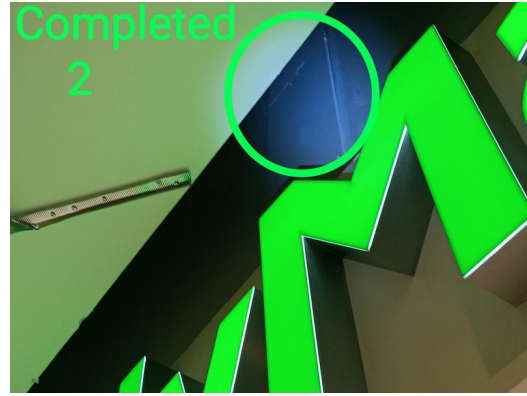
Photo 6

New finding 15, 16, 17, 18: Project manager clarify that area above front ceiling unable to be closed due to accessibility issue

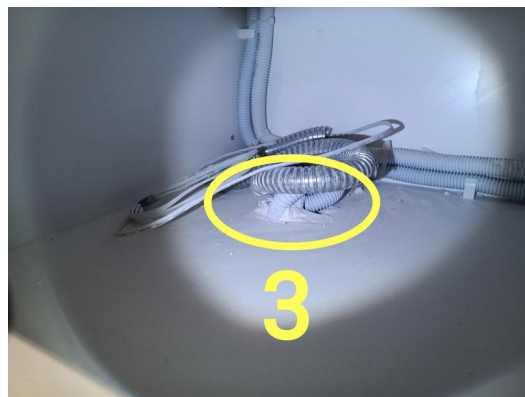
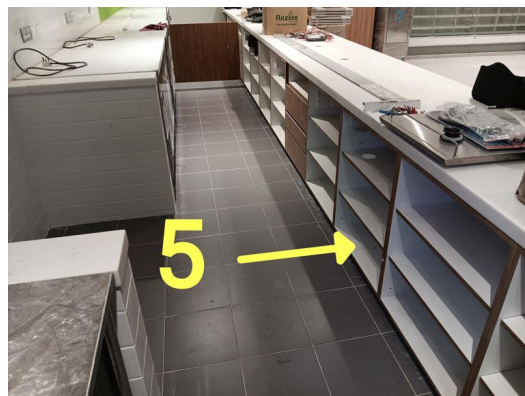
Some gaps found around the conduit. Existing proofing need to be improved.

- 3. Completed ☒
- 4. Completed ☒
- 5. Completed ☒

Fix the proofings and seal the gaps completely.

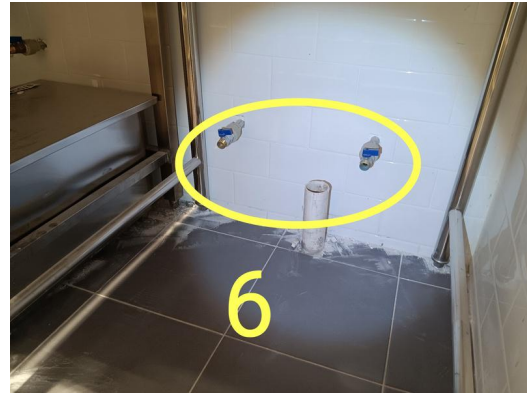
Photo 19

Pipe installation works not done yet and leaving exposed openings at the pipes.

Crevices observed on the floor tiles.

6. Completed ☒

Please do not left any gap after pipe installation done.

Please seal the crevices.

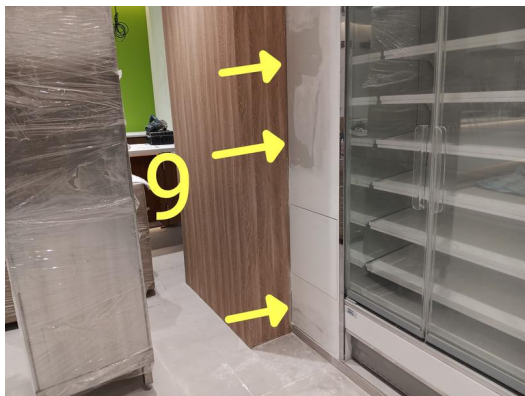
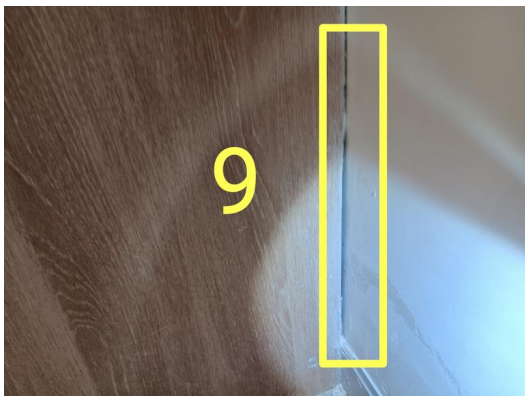
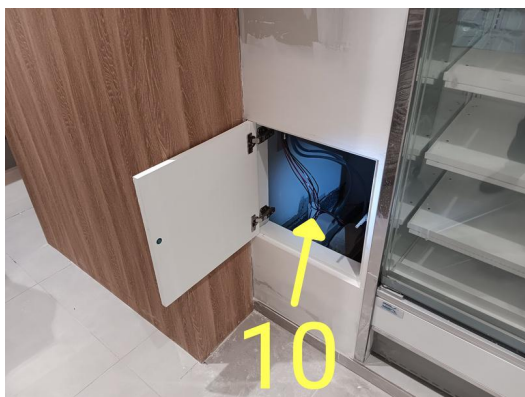
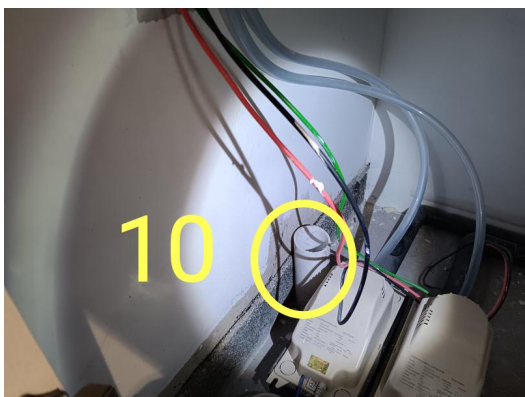
Gaps observe along the wall lining near chiller.

Unseal pipe found near the pump machine.

9. Completed ☒

10. Completed ☒

Please seal the gaps.

Close the pipe with cap if not use.

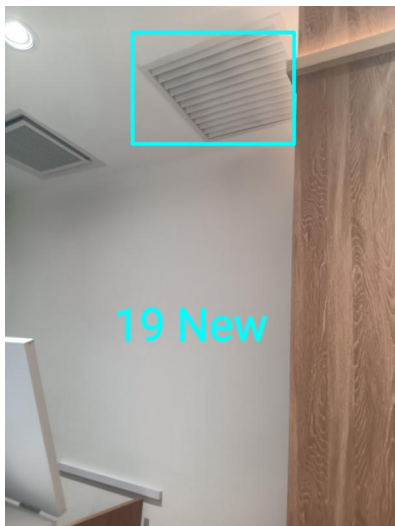
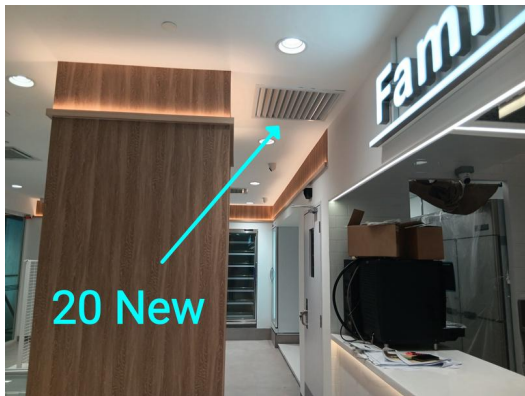
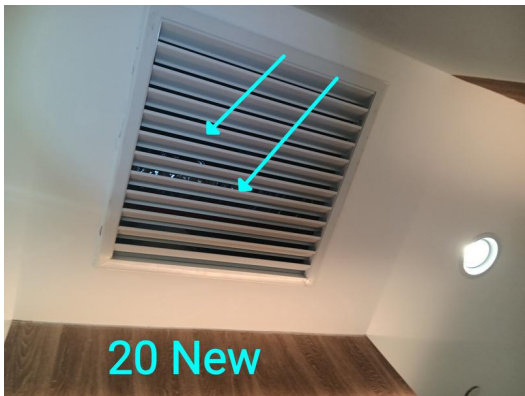
19 & 20, New finding 21st July 2025:

Ventilation grill at the ceiling was observed without net screening, allowing easy pest entry into the floor area.

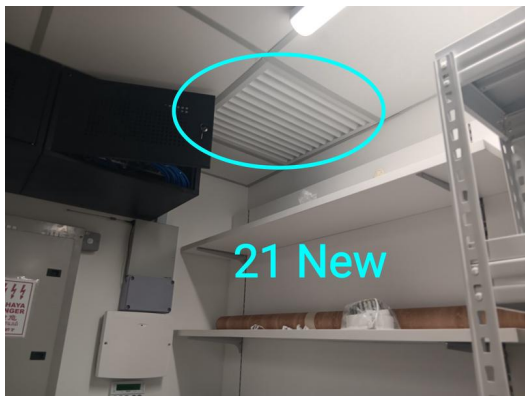
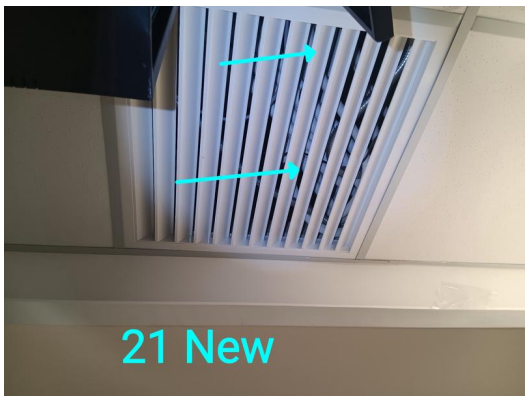
21, New finding 21st July 2025:

Ventilation grill at the ceiling was observed without net screening, allowing easy pest entry into the floor area.

Install screening net.

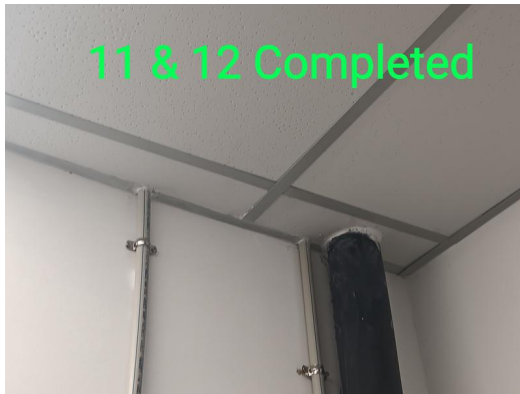
Photo 44

Gaps observed around the ceiling pipes.

Unused pipe with opening found on the floor.

Please seal the gaps and pipe completely.
