Pest Inspection Report

Post-Inspection Report / MFM0131 Porto Historia / 18 Jul 2025

Inspection	Post-Inspection Report
Store ID and Name	MFM0131 Porto Historia
Tracker	Other pest
Inspector	Irshad
Project Team PIC	Faiz
Project Team Present	Yes
Contractor Present	No
Inspection Date	18.07.2025
Report Date	18.07.2025
Handover Date	18.07.2025

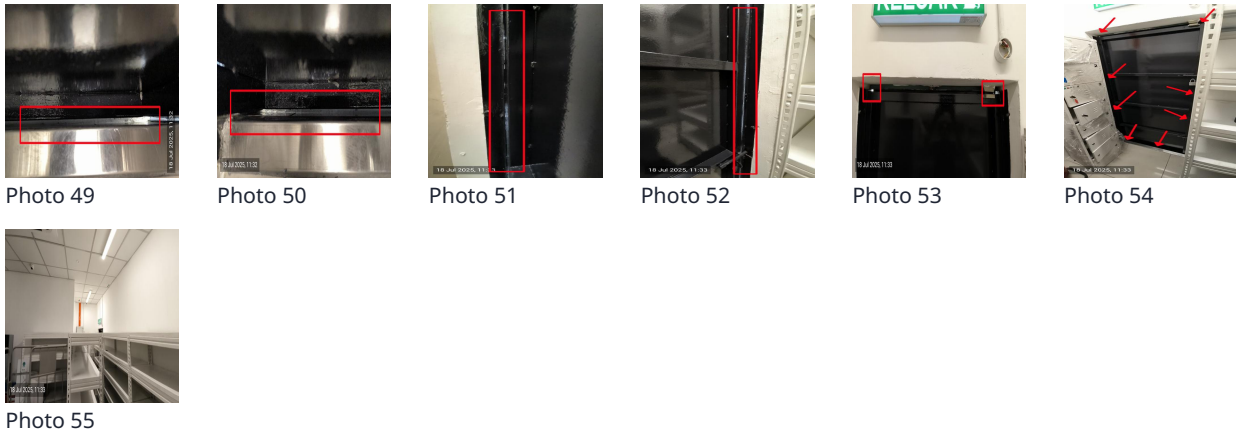
Backroom - Backdoor (Left Side)

Noted with gaps.

Kindly assist to install with bristle strips.

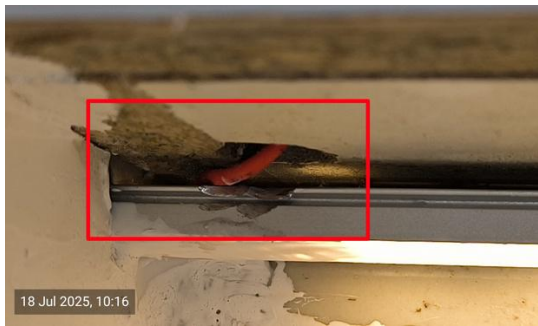
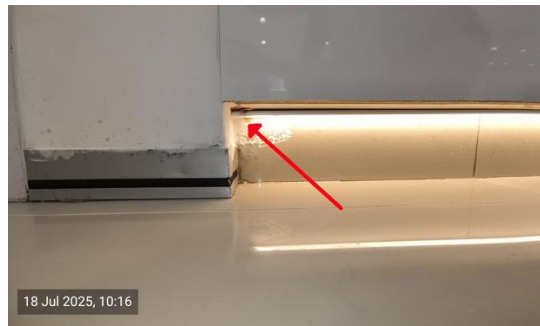
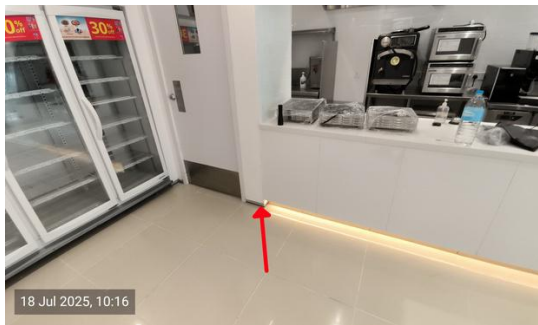
LocationSales Floor - Counter Cabinet

FindingsNoted with a hole.

RecommendationKindly assist to seal.

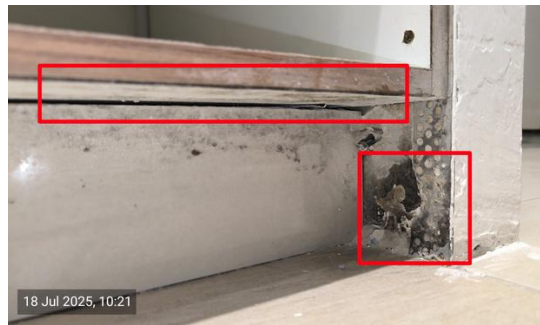
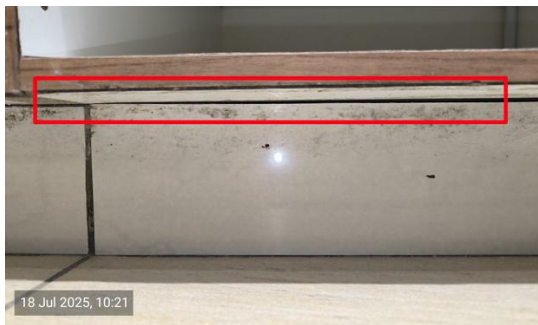
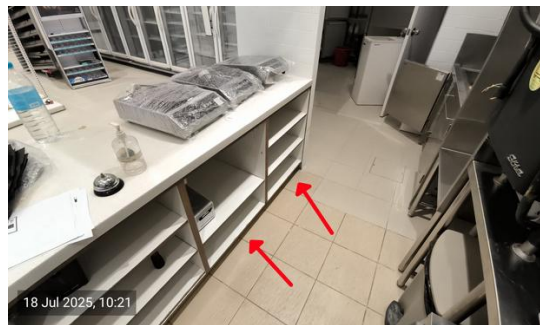
LocationKitchen Area - Underneath Counter Cabinet

FindingsNoted with gaps.

RecommendationKindly assist to seal.

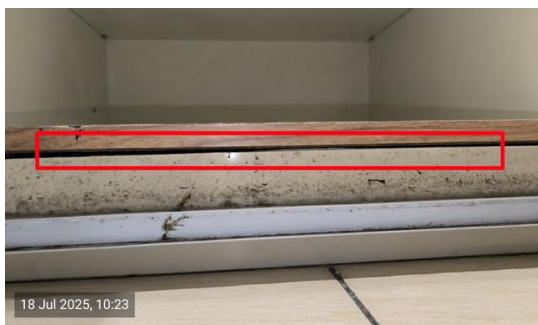
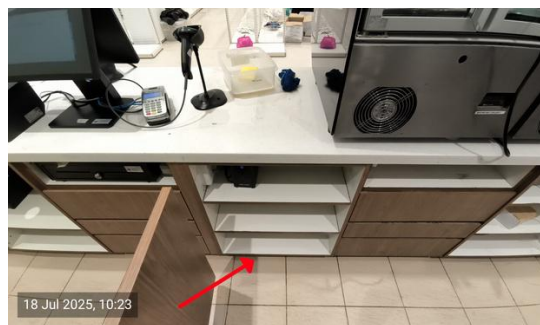
LocationKitchen Area - Underneath Counter Cabinet

Noted with a gap.

Kindly assist to seal.

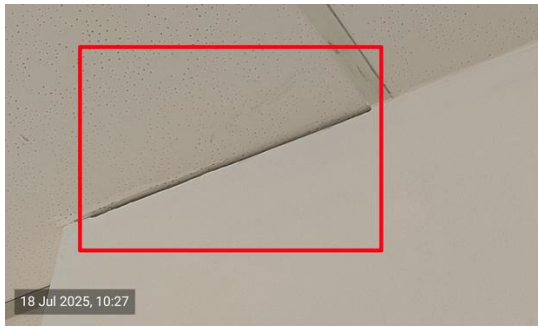
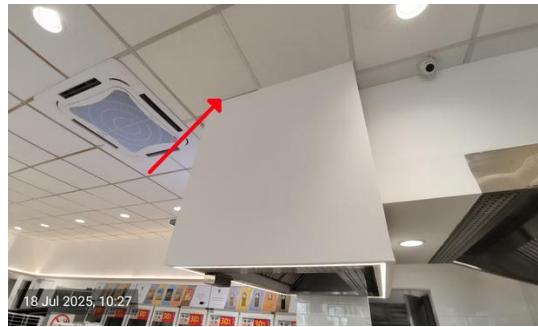
Kitchen Area - Ventilation Hood

Noted with cracks.

Kindly assist to seal.

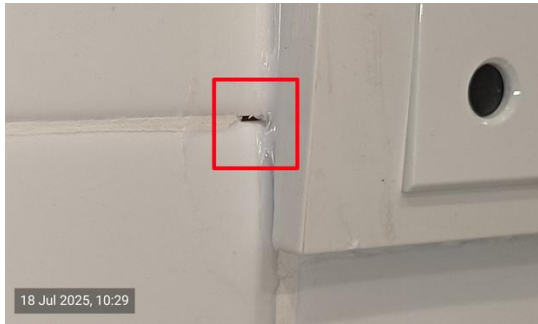
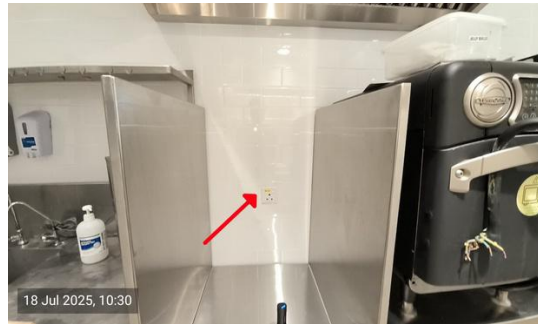
Kitchen Area - Wall

With with a gap.

Kindly assist to seal.

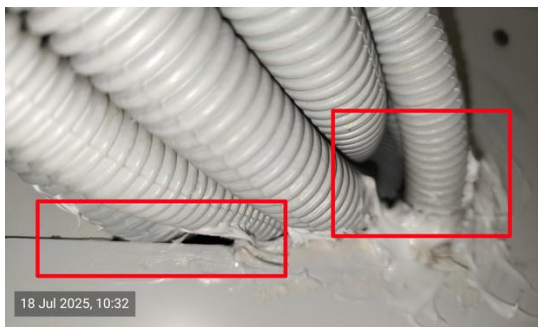
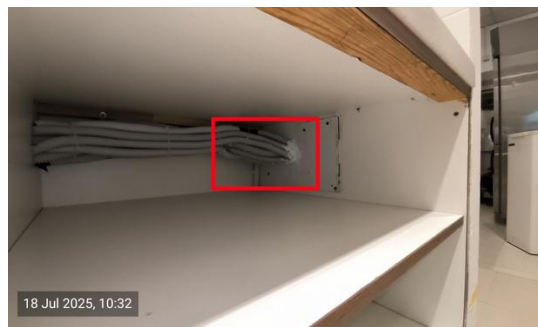
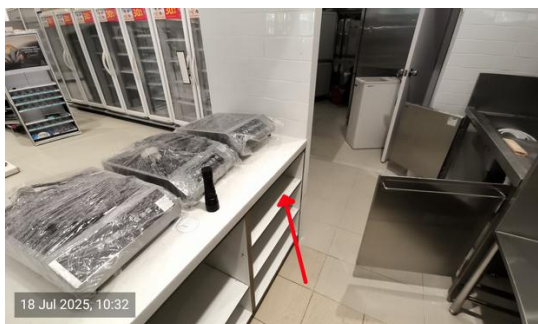
Location Kitchen Area - Counter Cabinet

Findings Wiring connected through the wall with gaps.

Recommendation Kindly assist to seal.

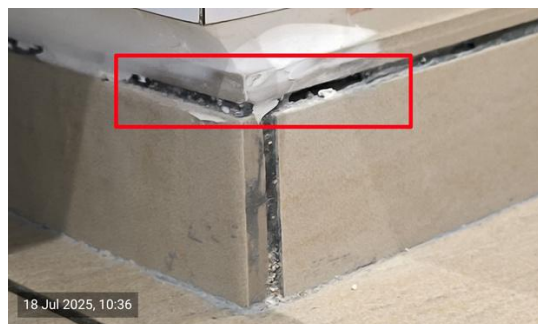
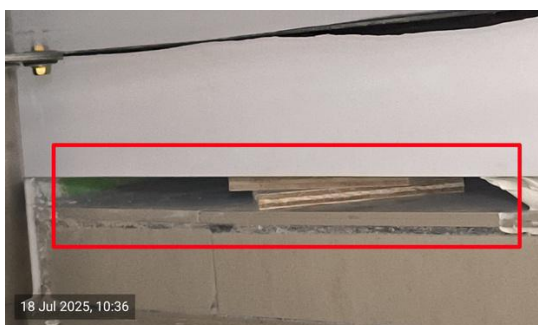
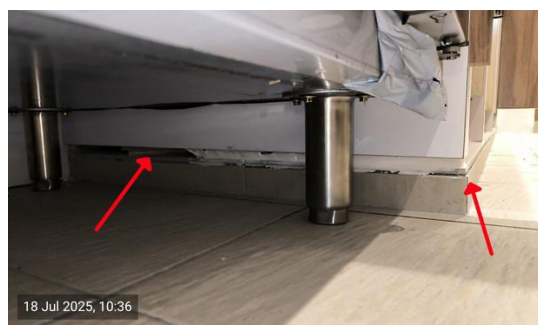
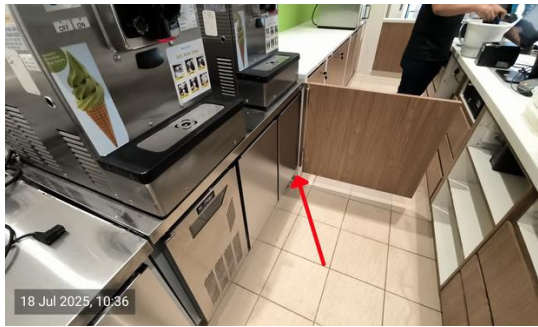
Location Kitchen Area - Counter Cabinet

Findings Noted with gaps.

Recommendation Kindly assist to seal.

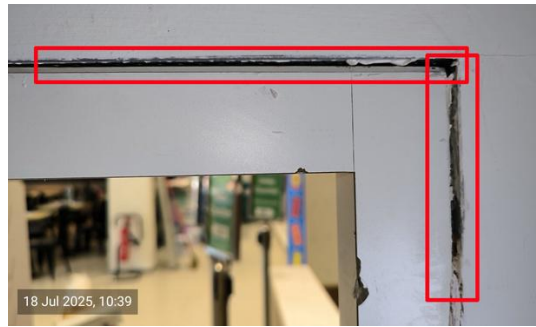
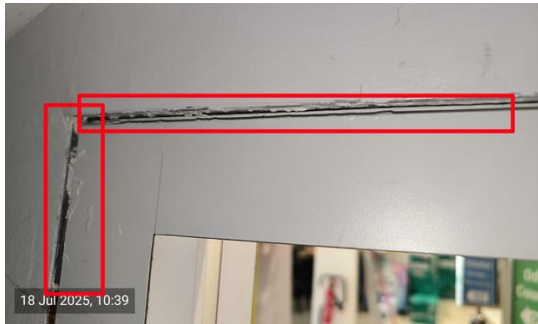
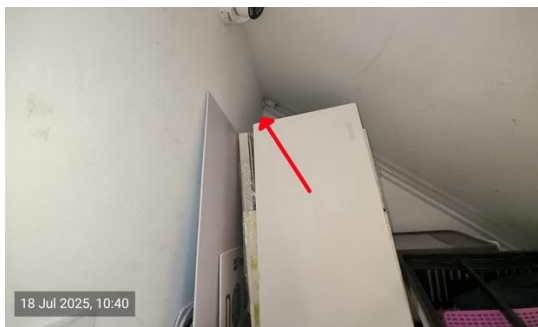
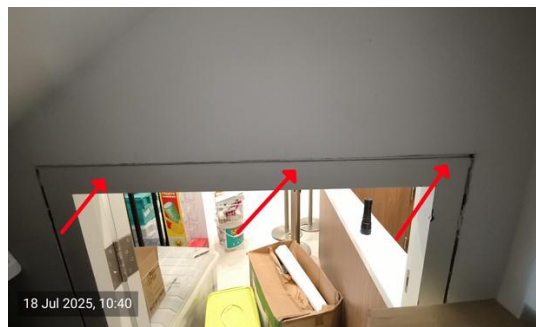
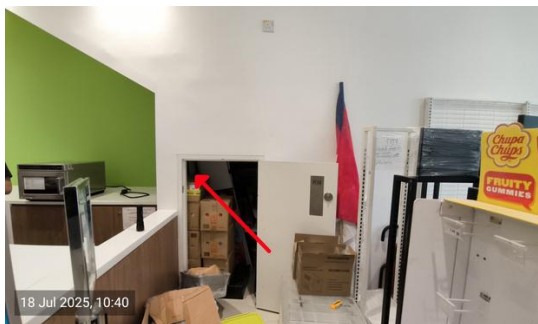
Location Sales Floor - Store Room

Findings	Noted with cracks and a gap.
Recommendation	Kindly assist to seal.
Status	New Findings
Findings #9

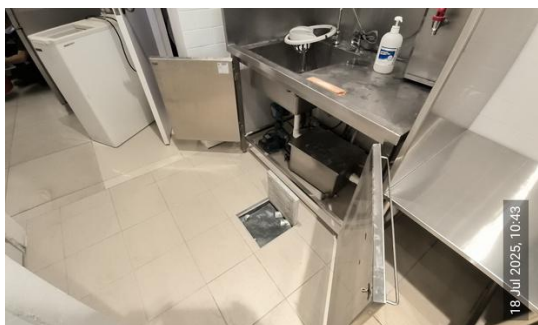
Location	Kitchen Area - Floor Trap
----------	---------------------------

Findings	There is no metal wire mesh net installed.
Recommendation	Kindly assist to install the metal net.
Status	New Findings
Findings #10

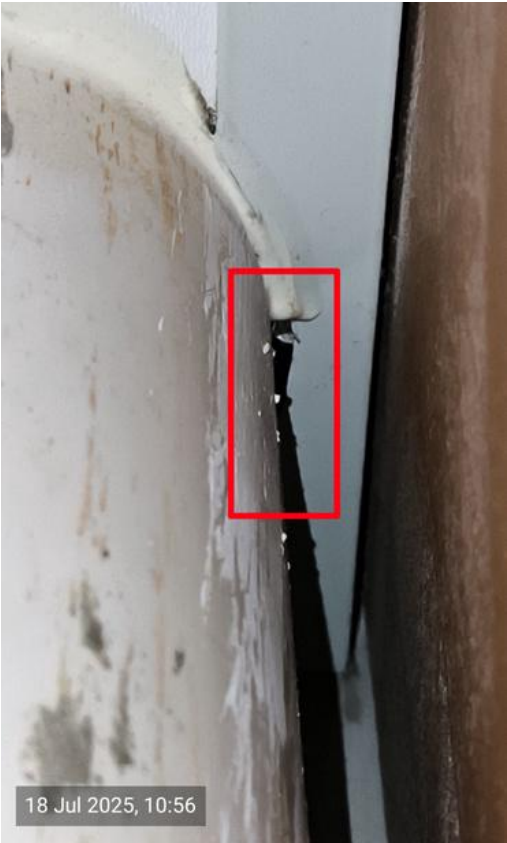
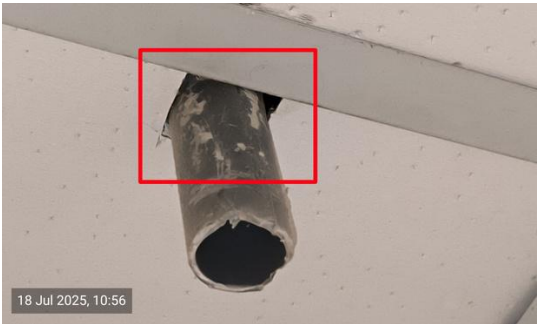
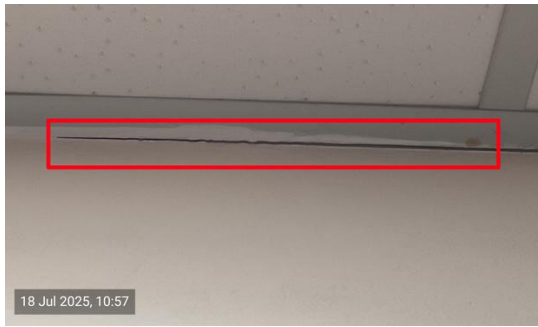
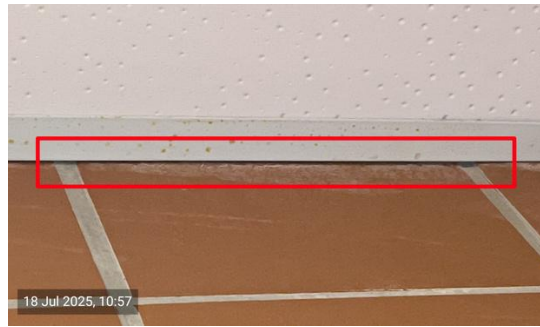
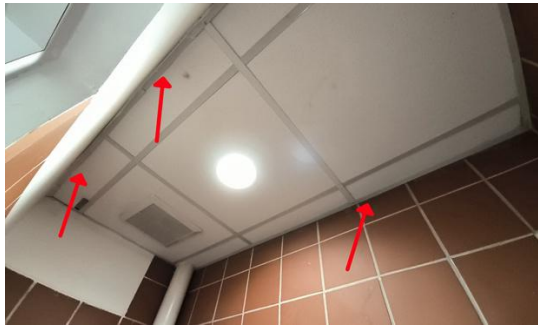
Location	Backroom - Staff Toilet
----------	-------------------------

Findings	Noted with cracks and gaps.
Recommendation	Kindly assist to seal.
Status	New Findings

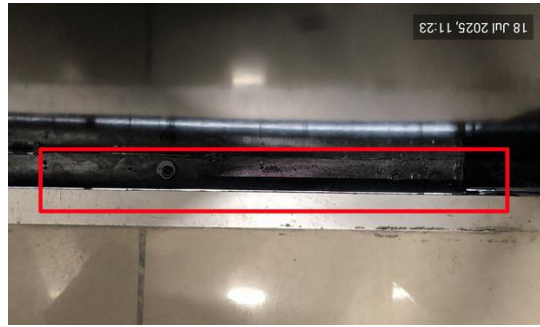
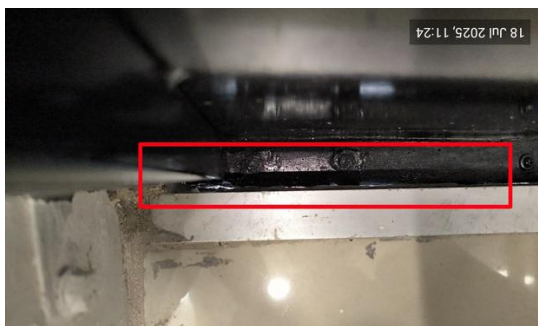
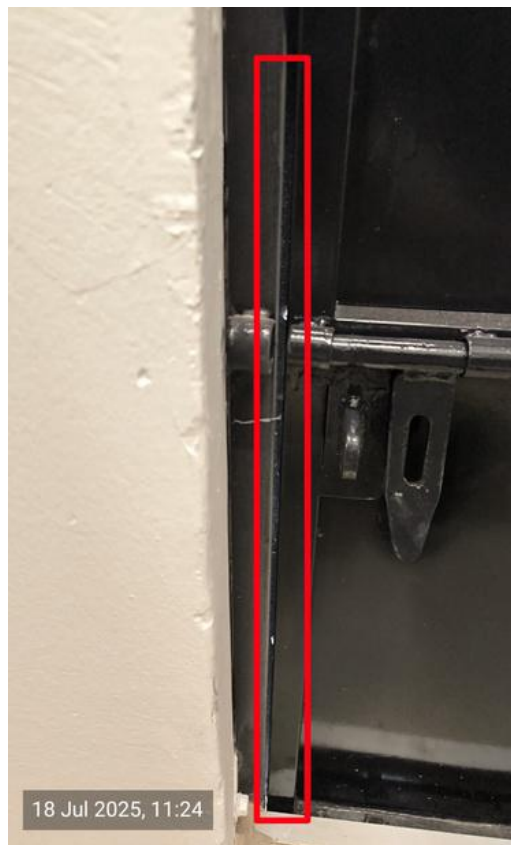
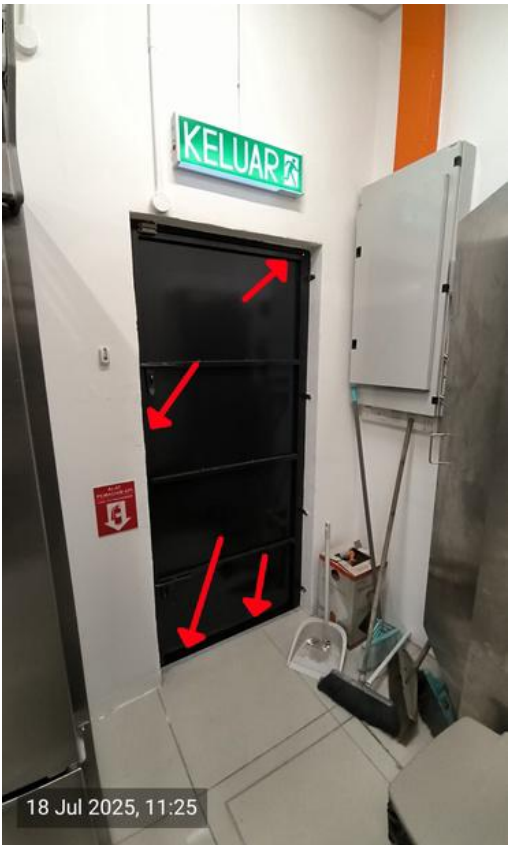
LocationBackroom - Backdoor (Right side)

FindingsNoted external light which indicatong gaps.

RecommendationKindly assist to install bristle strips.

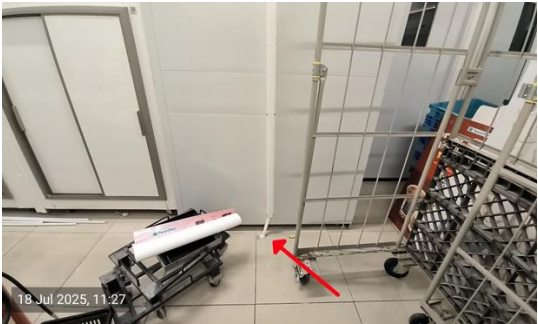
LocationBackroom - Reach-In Freezer

FindingsFloor base with cracks.

RecommendationKindly assist to seal.

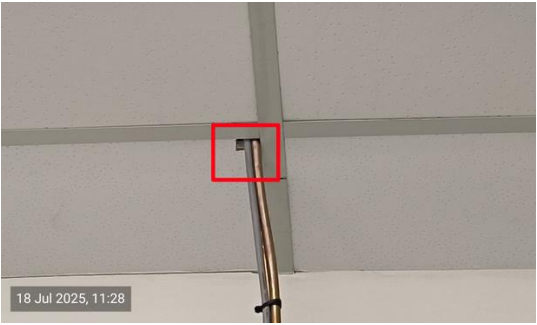
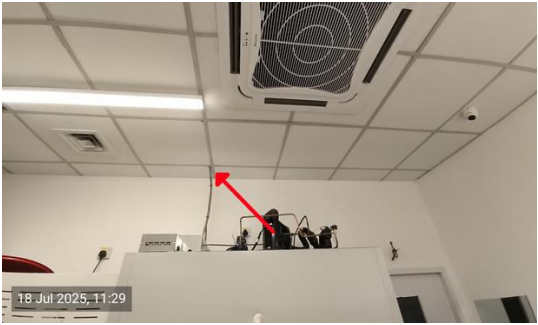
LocationBackroom - Ceiling

Copper piping connected through ceiling with a gap.

Kindly assist to seal.

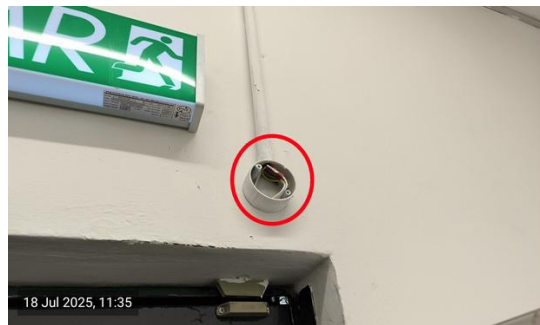
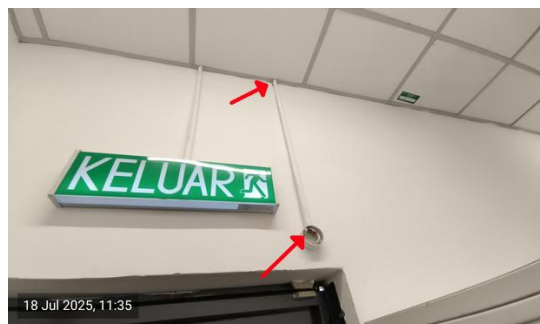
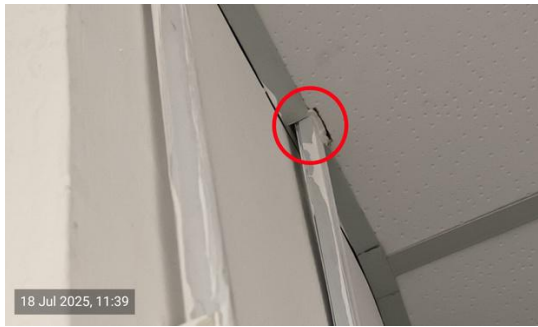
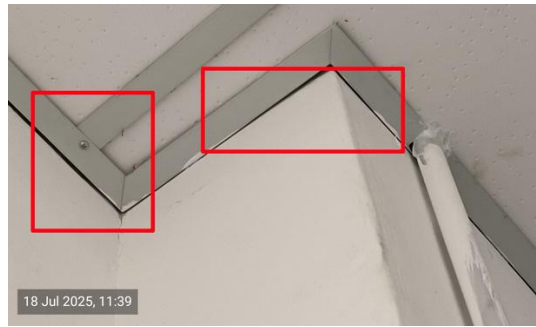
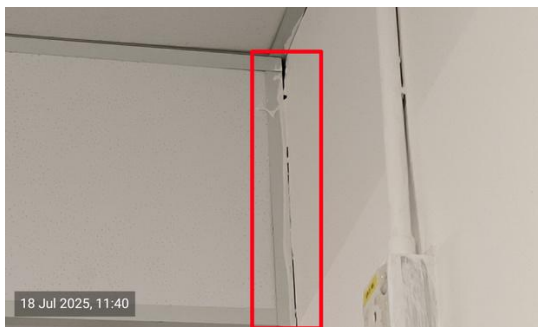
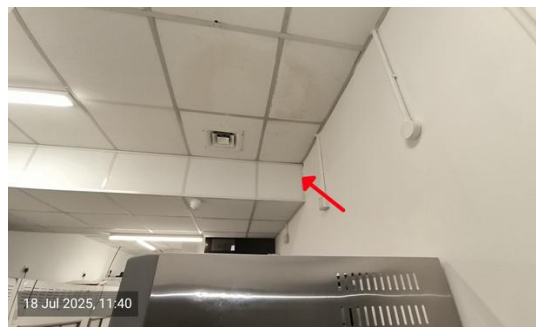
Backroom - Wiring

Noted with gaps.

Kindly assist to seal.

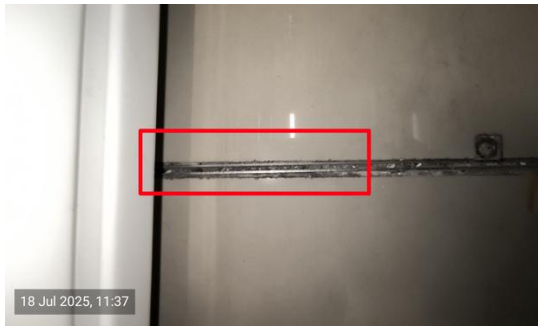
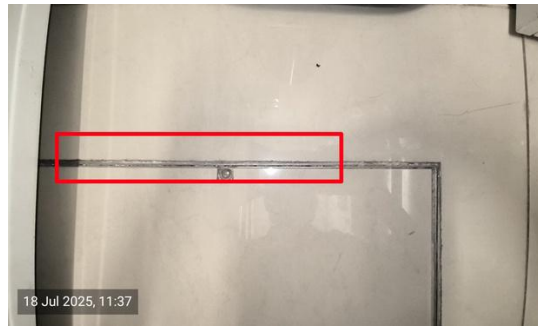
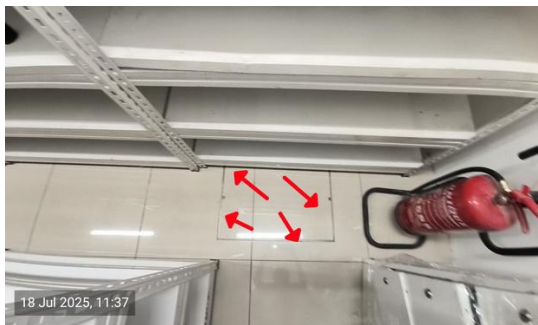
Backroom - Septic Tank

Noted with damaged proofing.

Kindly assist to seal.

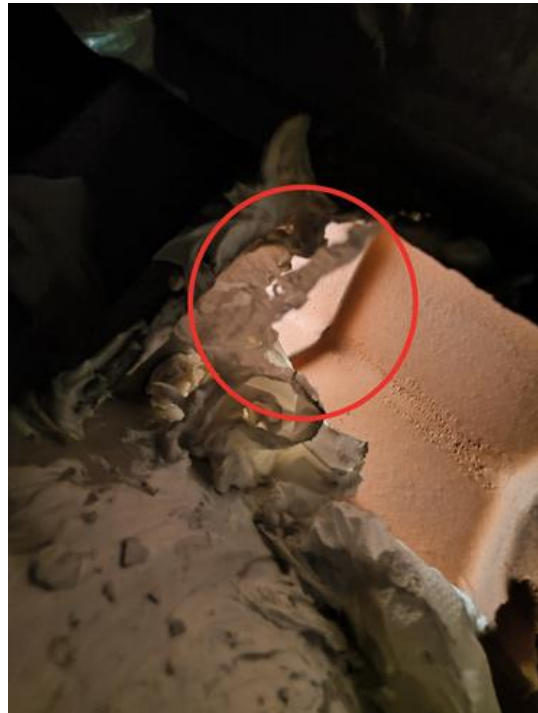
Backroom - Above Ceiling

Findings Noted with gaps.

Recommendation Kindly assist to seal.

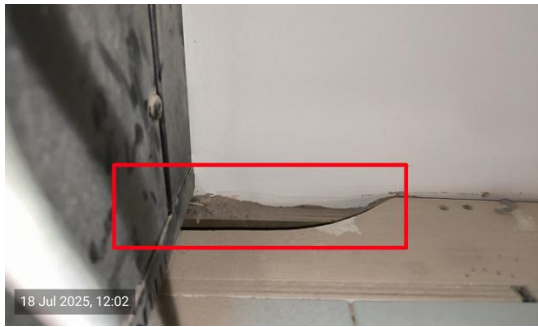
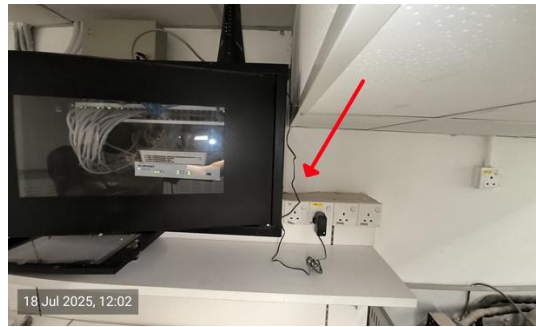
Location Backroom - Server Box

Findings Wiring connected through the ceiling with a gap.

Recommendation Kindly assist to seal.

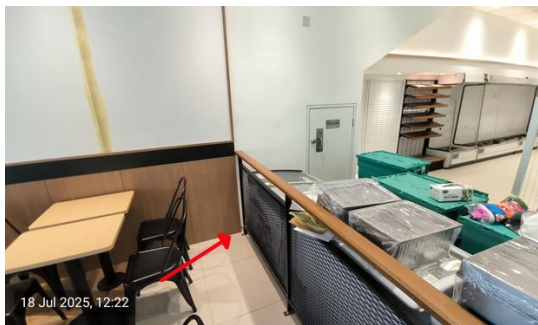
Location Dining Area - Floor Skirting

Findings Noted detached.

Recommendation Kindly assist to rectify.

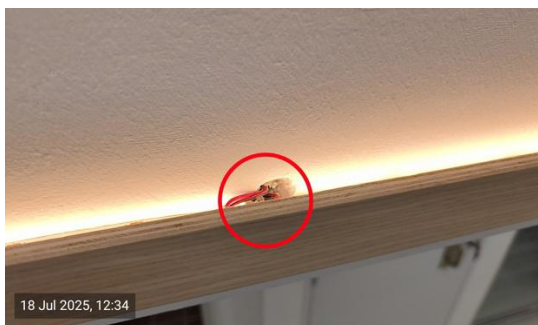
Location Sales Floor - Light Beading

Findings Wiring connected through wall with a gap.

Recommendation Kindly assist to seal.

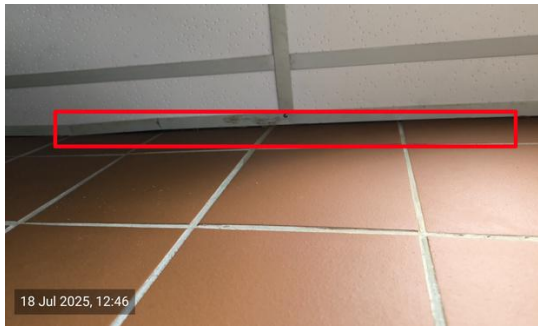
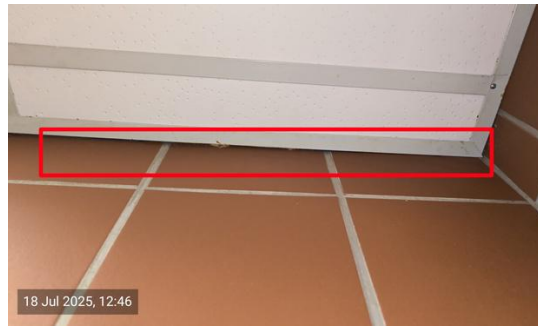
Location Sales Floor - Customer Toilet

Findings	Ceiling skirting with gaps.
Recommendation	Kindly assist to seal.
Status	New Findings
Findings #24	
Location	Backroom - Backdoor

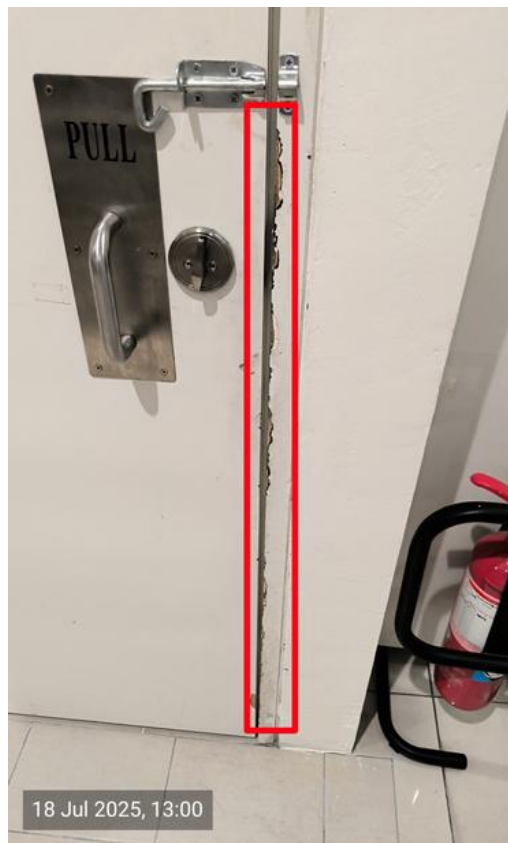
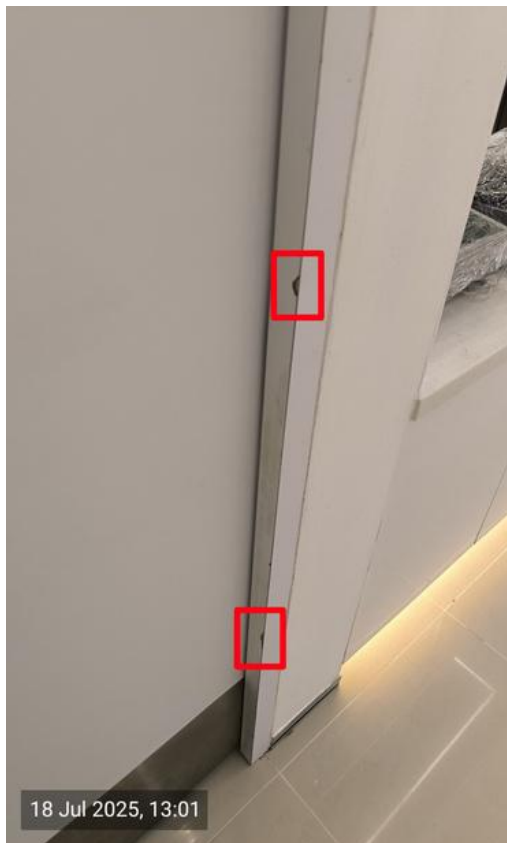
Findings	Noted chipped.
Recommendation	Kindly assist to patch up.
Status	New Findings
Findings #25	
Location	External Area - Wall

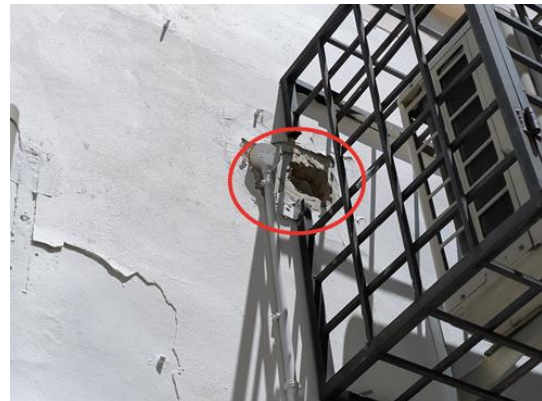
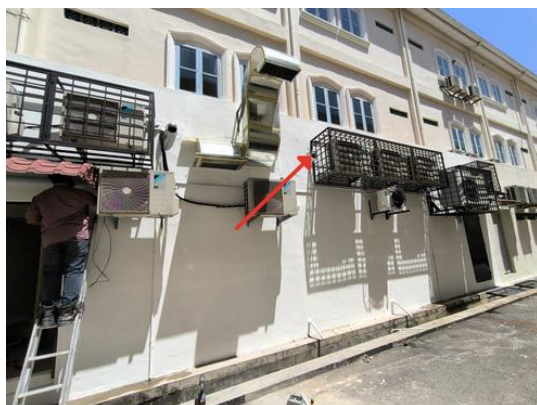
Findings	Noted with a hole.
Recommendation	Kindly assist to seal.
Status	New Findings
Findings #26	
Location	Sales Floor - Main Entrance

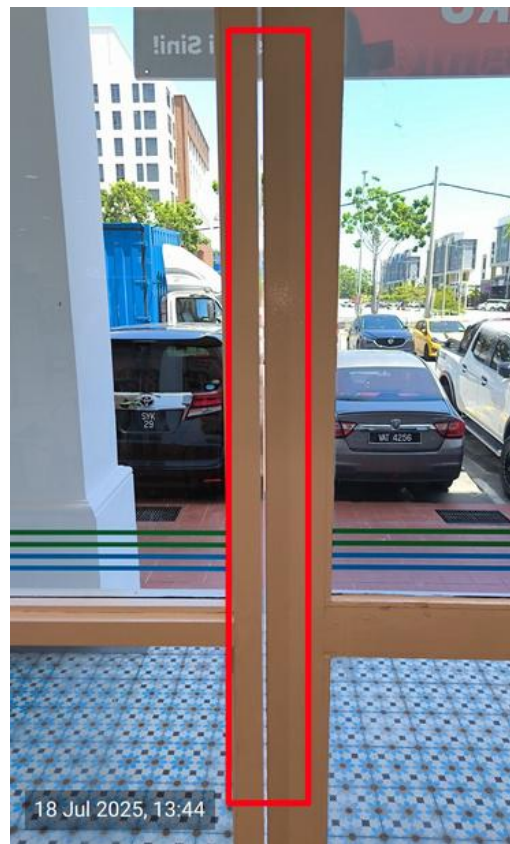
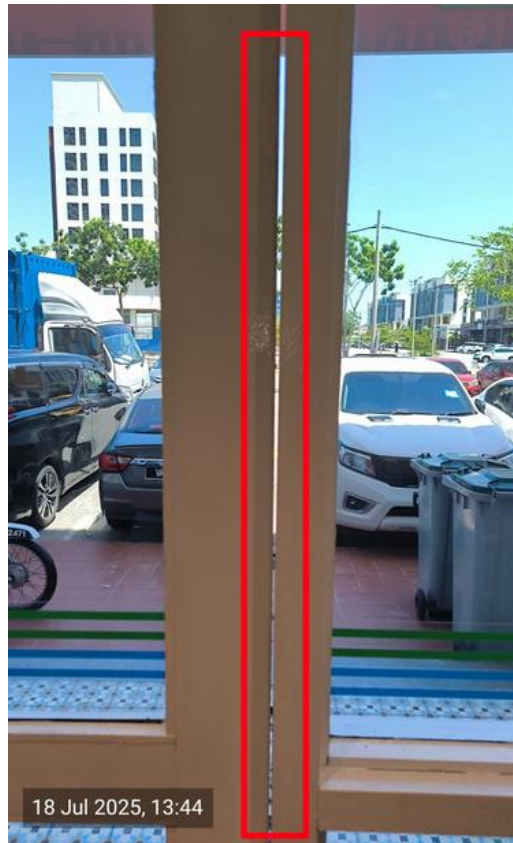
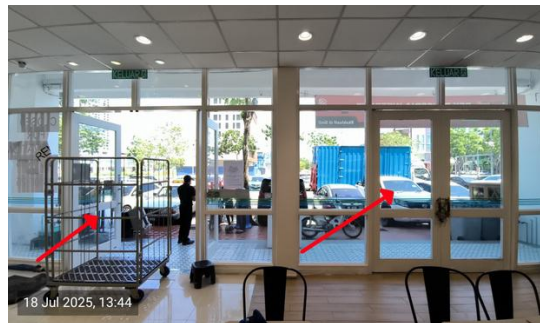
Findings	Noted with gaps.
Recommendation	Kindly assist to seal.
Status	New Findings
