## Field Biologist Site Inspection for Family Mart

FamilyMart Marang / 30 Jul 2025

Document No.	000129
Audit Title	Post-Opening Site Inspection
Site Name	FamilyMart Marang
Location	LOT 8994-B, Bangunan Komersial Marang, 21600 Marang, Terengganu, Malaysia (5.207336, 103.20646599999999)
Contractor Present	Yes
Name	Ho Kok Wai
Project PIC Present	Yes
Name	Yuziir
Inspected by	Arif Zulrushdi
Inspection Date	30.07.2025
Prepared by	Arif Zulrushdi

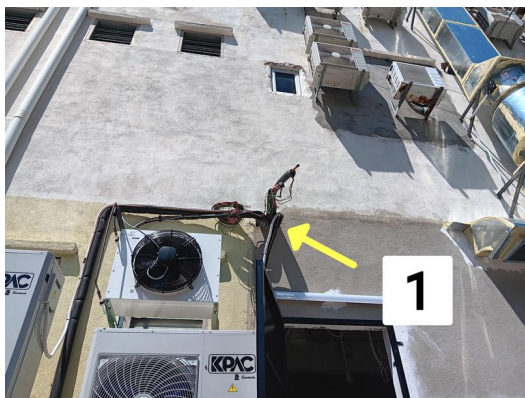
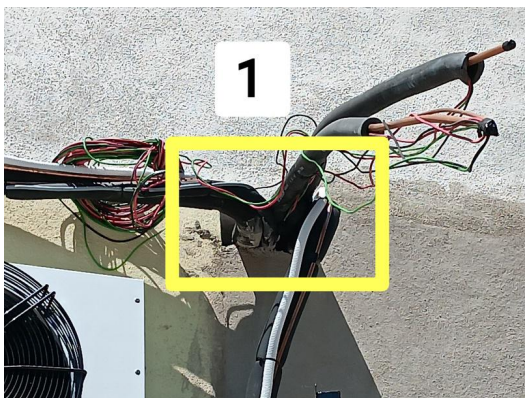
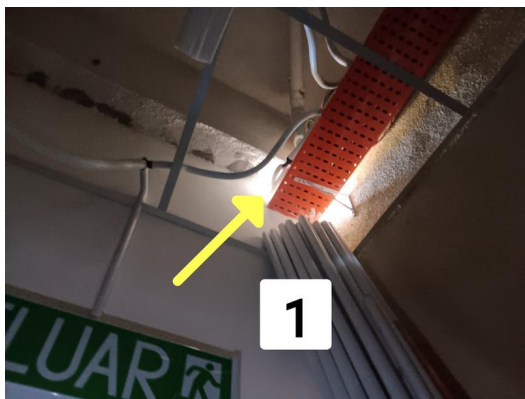
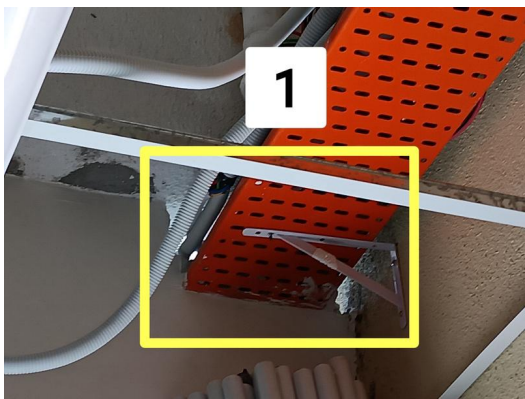
Gap around the ducting into internal area.

Please seal the gap.

Updates during 30.7.2025  
1: DONE

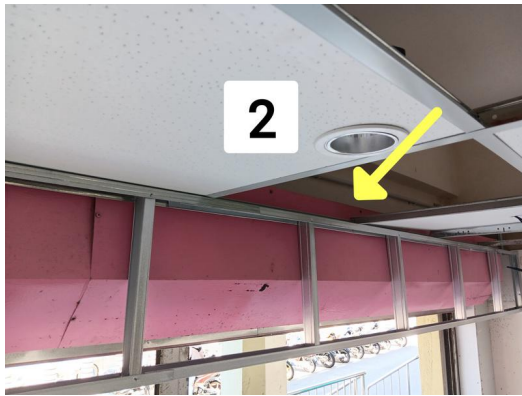
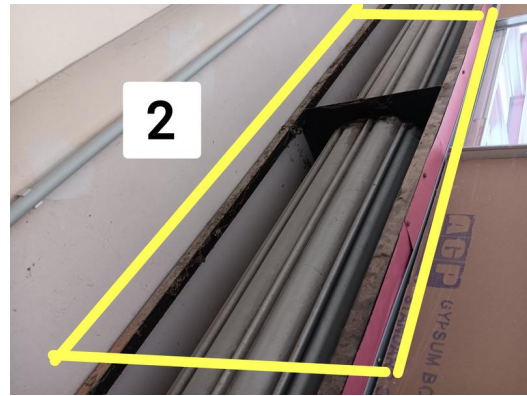
No plate on shutter roller casing installed. This may provide entry for rats.

Please close the upper shutter casing with suitable plate.

2: DONE

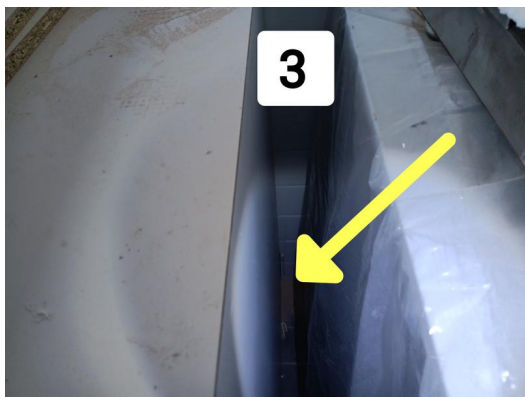
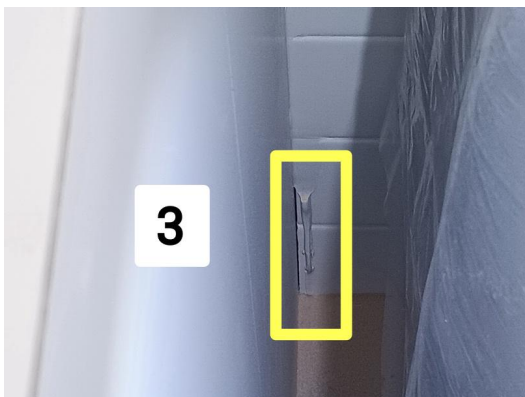
The plaster proofing is not complete and left some gaps.

Please seal the gaps completely.

Updates during 30.7.2025  
3: DONE

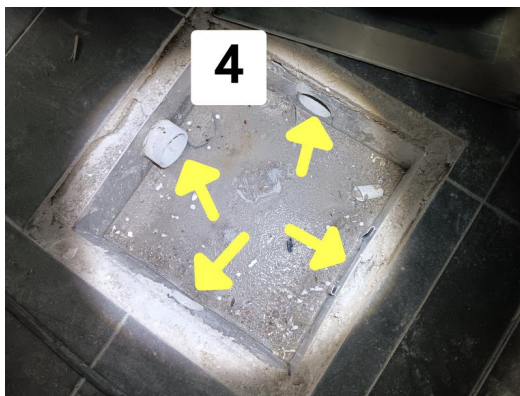
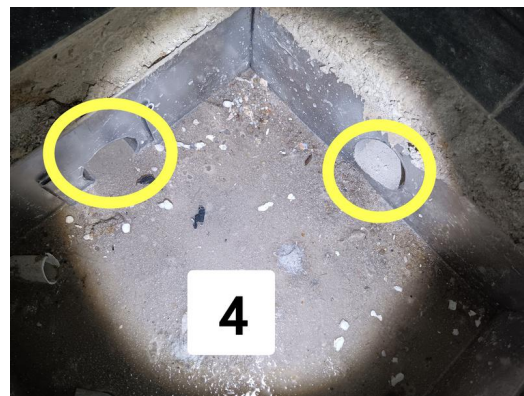
Floor trap pipes do not have metal mesh filter to prevent pest entry from outside.

Please install metal mesh filter at the pipes.

4: DONE

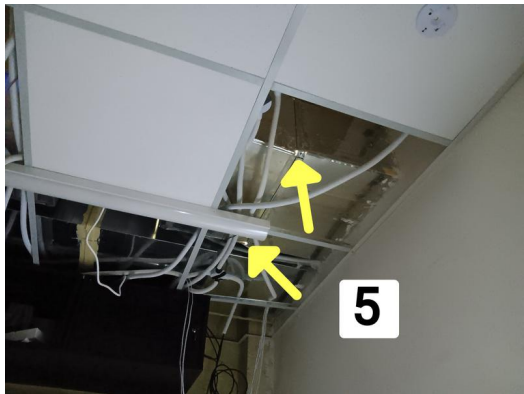
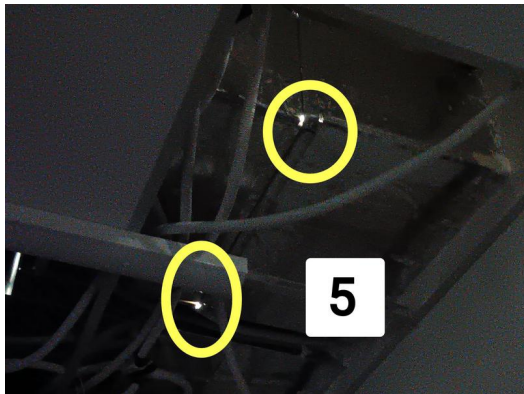
Gaps observed at the ventilator casing above manager area.

Please seal the gaps completely.

Updates during 30.7.2025  
5: DONE

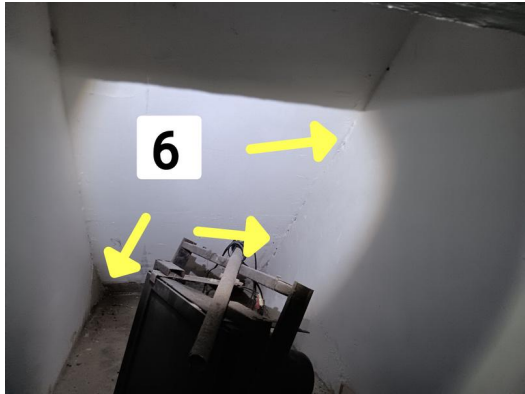
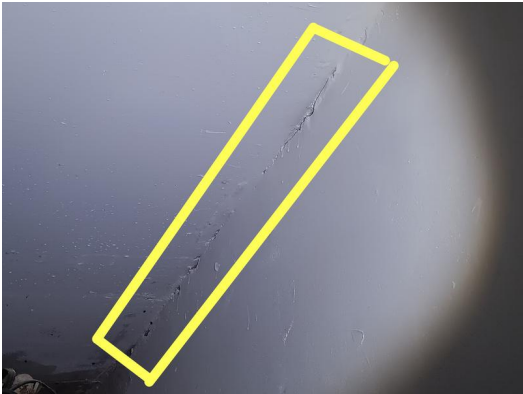
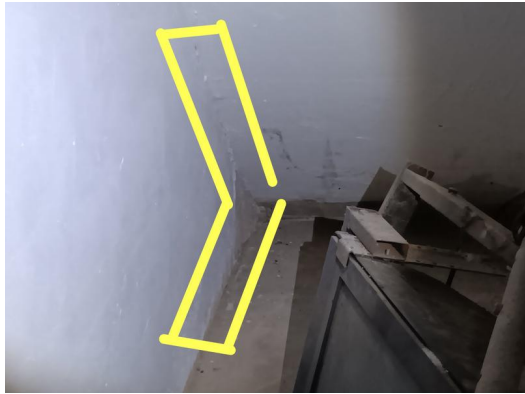
Crack and crevices at the wall edges can provide harbourage for pests.

Please seal the crack and crevices completely.

Updates during 30.7.2025  
6: DONE

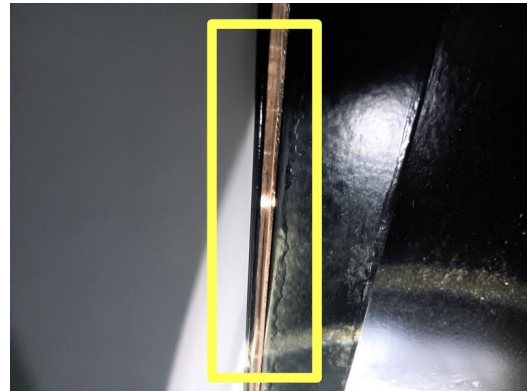
Gaps observed around the doorframe.

Please install additional door strips.

Updates during 30.7.2025  
7: DONE

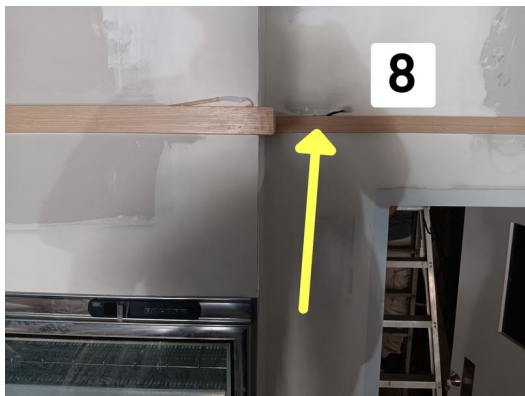
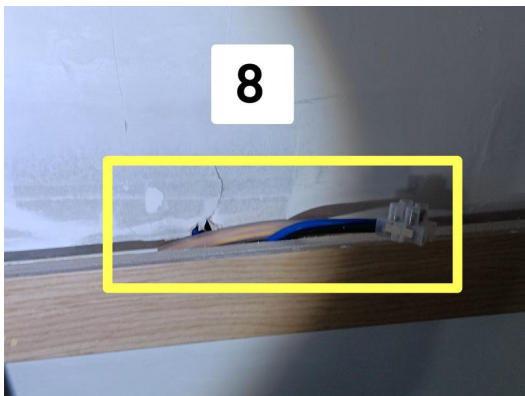
The wiring not yet complete and found with gaps at wall.

Please close the gap completely after complete wiring.

Updates during 30.7.2025  
8: DONE

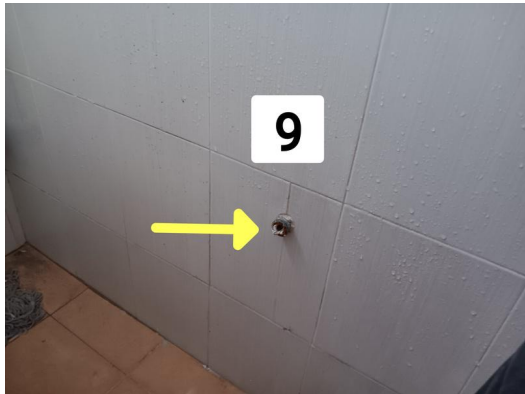
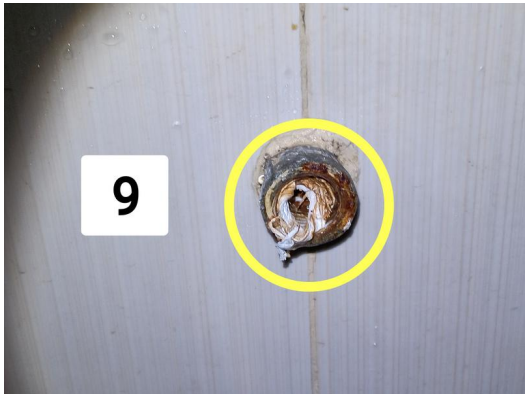
Gap found at unclosed pipe.

Please ensure no gap left after done installation.

Updates during 30.7.2025  
9: DONE

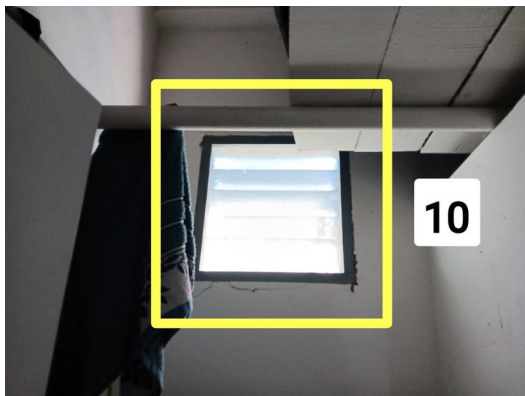
No exhaust fan installed. Toilet ventilation windows with gaps may allow pests to enter.

Please install a secure exhaust fan with ni gaps or seal the window completely.

10: DONE
