Analysis of CMOS 2 power supply problem

Apr 3 2024

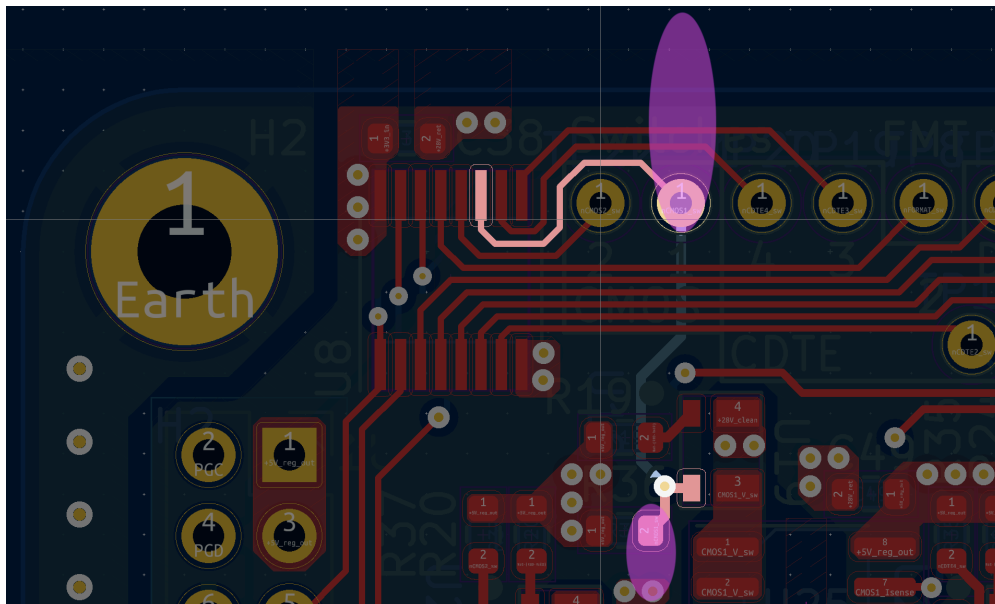
The signal nCMOS1_sw is covered in epoxy on the MAX7317 chip leg. There are two other possible short sites for this trace. The upper site would need to contact the box, either by wearing through Kapton located between the PCB and the box shelf, or via FOD at least 150 mil long, jumping the testpoint to the box.

The lower site could be caused by FOD ~70 mil long, but the placement appears quite unstable (between caps or pads of two 0603 components). I would be surprised if, e.g., a conductive fiber settled and stayed in this location.

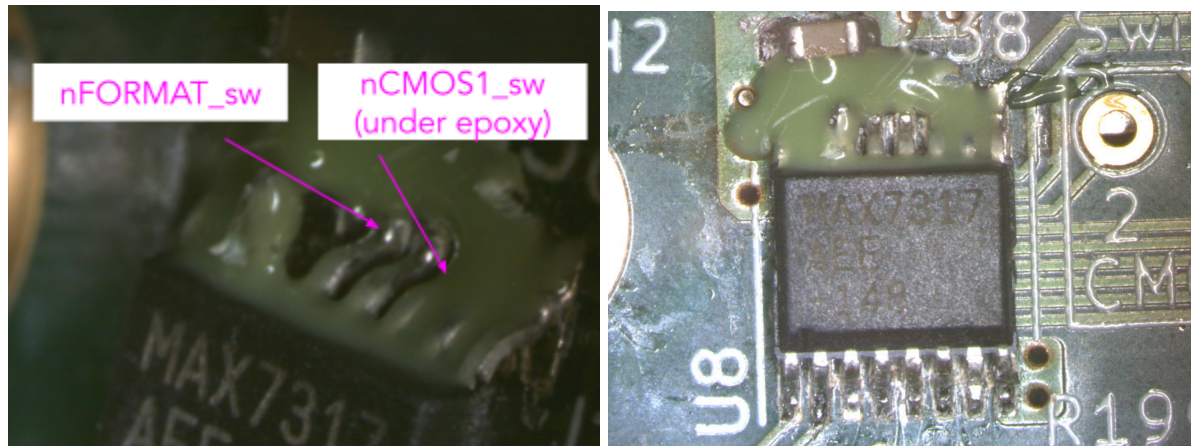
The Formatter and CMOS 2 enable pins are the two visible pins on the left photo. These were taken prior to the flight vibe test at SSL.

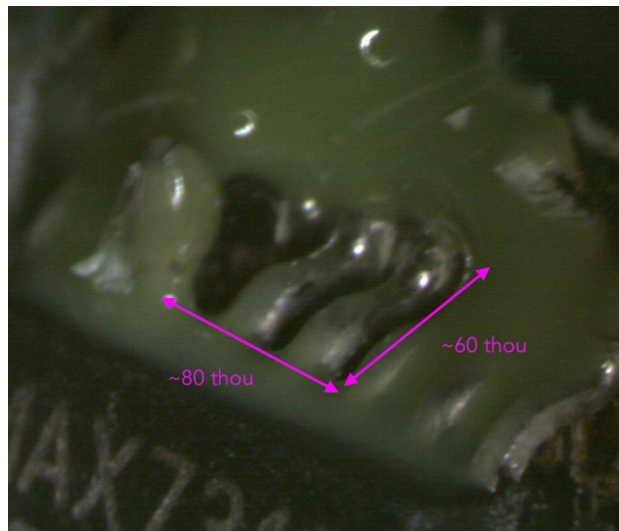
The above photo has rough dimensions of exposed area annotated. A conductive object would need to have size <80 thou, or a radius of curvature <80 thou at the point it contacts the chip in order to cause a short. And come in at the right angle, settle stably (through launch and shipment), etc.

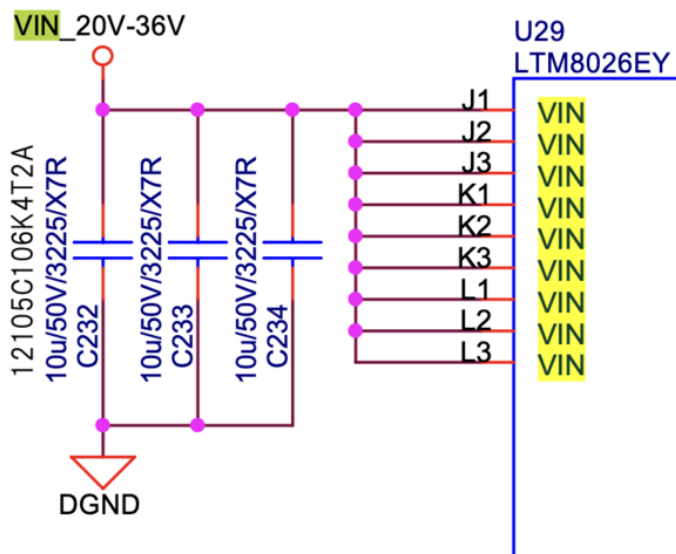
A plot of the loaded CMOS 1 (normally functioning) output indicates a rise time of ~ 1 ms. This implies $\text{inrush} < 1.5$ A for a load capacitance of ~ 60 μF , far below any absolute limits of the SSR.

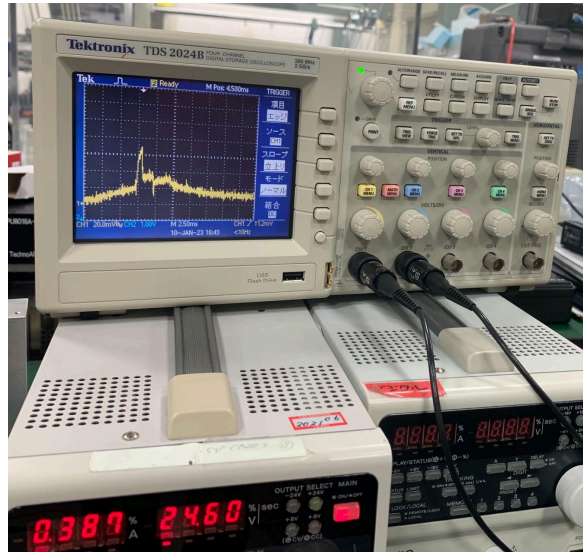
in which the voltage drop across the ballast resistor rises $\sim 60\text{ mV}$, giving a peak inrush current of 1.2 A . So it seems the design analysis is close to actual system performance.

So at first glance inrush issues *also* seem unlikely.
