Analysis of CMOS 2 power supply problem

Apr 3 2024

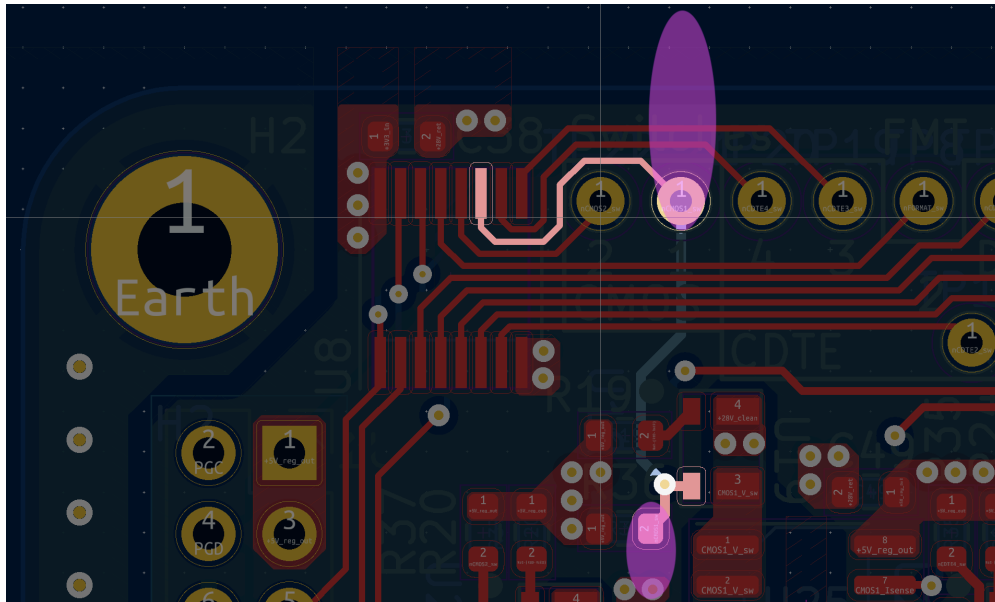
nCMOS1_sw shorts

The signal nCMOS1_sw is covered in epoxy on the MAX7317 chip leg. There are two other possible short sites for this trace. The upper site would need to contact the box, either by wearing through Kapton located between the PCB and the box shelf, or via FOD at least 150 mil long, jumping the testpoint to the box.

The lower site could be caused by FOD ~70 mil long, but the placement appears quite unstable (between caps or pads of two 0603 components). I would be surprised if, e.g., a conductive fiber settled and stayed in this location.

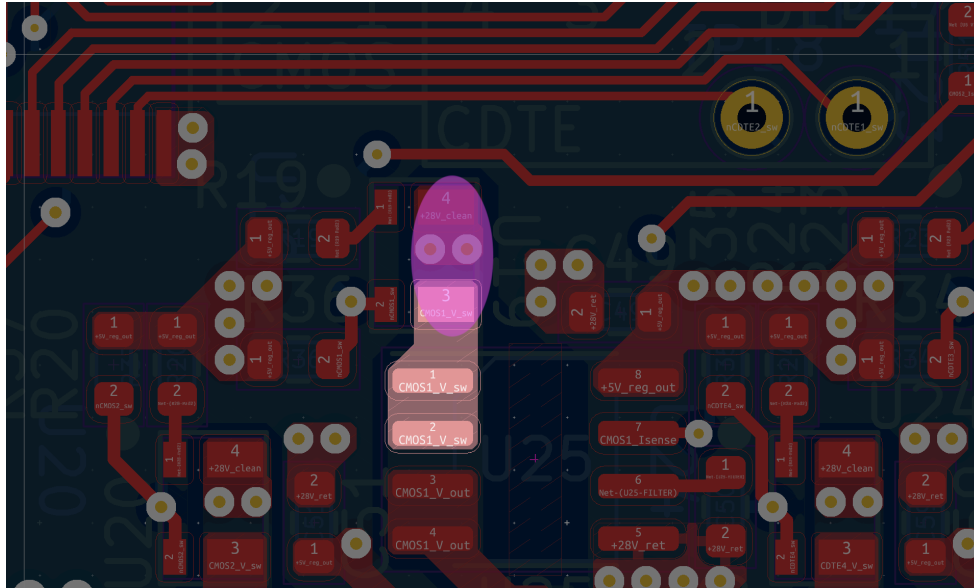
CMOS1 V_{sw} shorts

This is the power line to CMOS 2 after the [optically isolated MOSFET](#) that turns it on/off, and before it passes through a Hall effect current sensor.

One possibility is for the [opto-isolated MOSFET](#) to fail closed. I don't know what failure modes to expect from this MOSFET. I would expect significant overvoltage ($>60\text{ V}$) or overcurrent ($>3\text{ A}$) would be needed to damage the part in this way.

Another possibility is for FOD to settle alongside the MOSFET, shorting pad 4 to pad 3 (jumping $+28\text{V_clean}$ directly into CMOS1_V_sw). This is directly in the current path to CMOS 2, so we would need FOD that forms a stable connection carrying $\sim 0.4\text{ A}$, 28 V . That sounds unlikely to me.

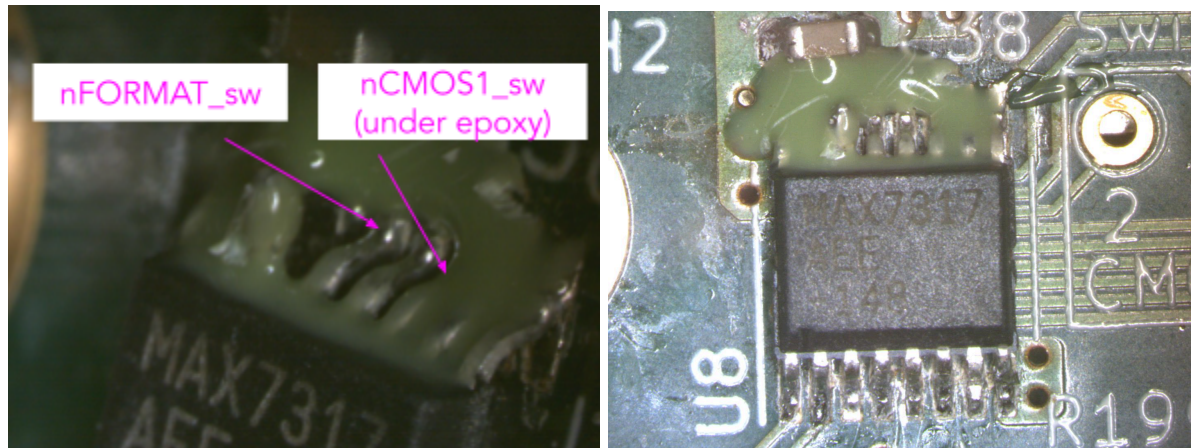
Board photos

The Formatter and CMOS 2 enable pins are the two visible pins on the left photo. These were taken prior to the flight vibe test at SSL.

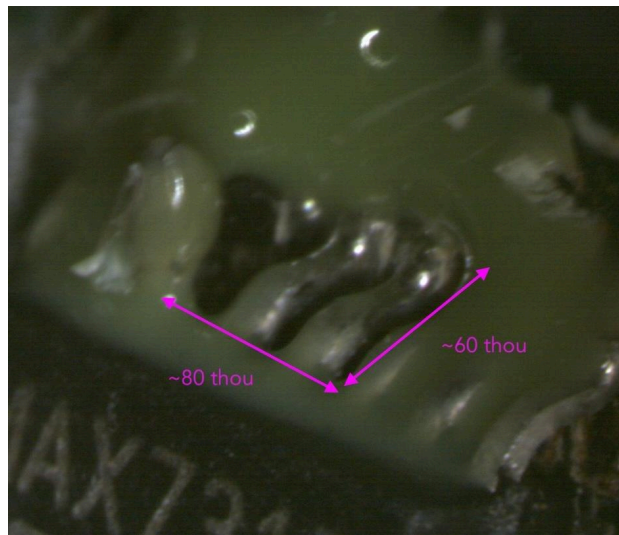
The above photo has rough dimensions of exposed area annotated. A conductive object would need to have size <80 thou, or a radius of curvature <80 thou at the point it contacts the chip in order to cause a short. And come in at the right angle, settle stably (through launch and shipment), etc.

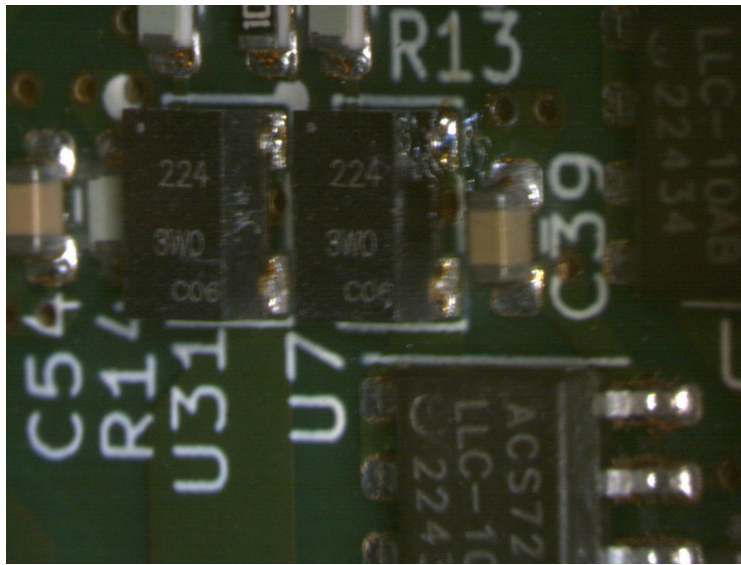
- From board photos, the -31WR variant has cap markings 224 / 3W0 / C06:

- From the [datasheet](#), the marking "3W0" is consistent with the -31WR variant.
- Here is the 28 V side of the board:

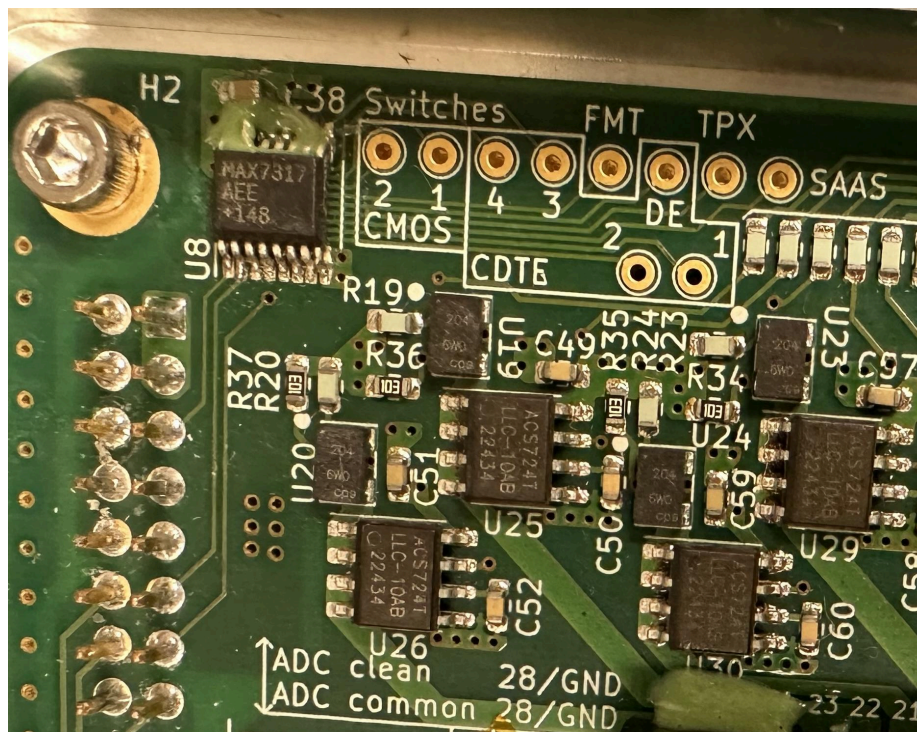
- Looks like the cap is marked something like 204 / 6W0 / C09
- From the [datasheet](#), the marking "6W0" is consistent with the -61WR variant.
- So we don't have the wrong MOSFET in place.

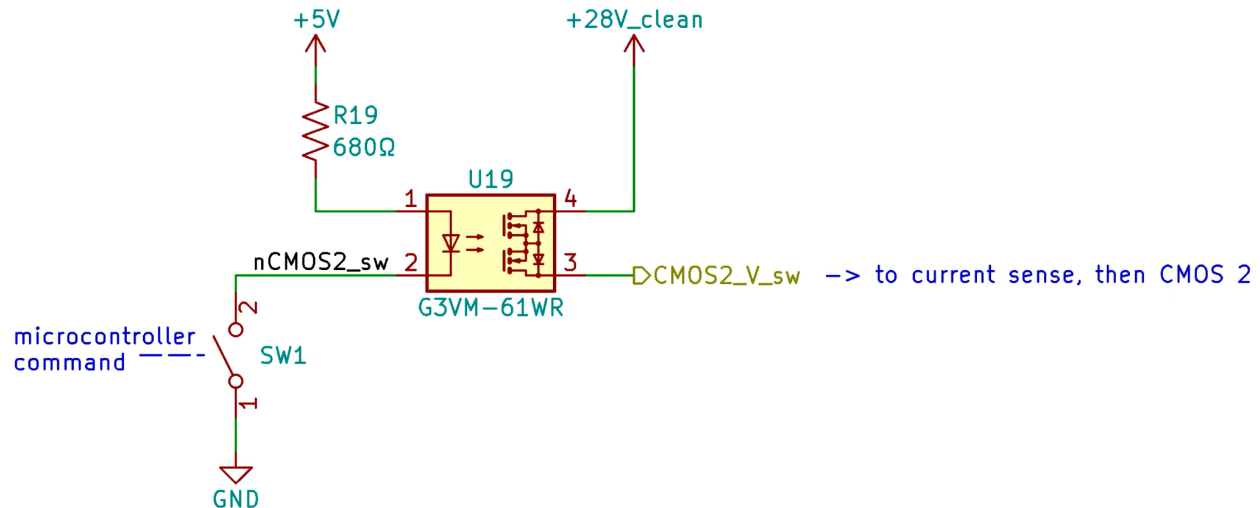
For the CMOS 2 switch, the G3VM-61WR variant is used instead, but the ballast resistor is the same. The current through the LED is

Using the measured value of the 5 V line (5.35 V) and an LED forward voltage of 1.22 V (from the datasheet), the current is 6 mA. This is larger than the minimum turn-on current of the LED, and much smaller than the maximum allowable current through the LED (30 mA).

Looking up this forward current value in the Omron the [precautions](#) plots, they expect an operating life above 10^7 hours for a 0.1% component failure rate (1 in 1000 parts fail).

So we are well within the design range for the LED. With board in-hand, check ballast resistor value.
