# **DPS-64 card interference with MCE(4S/4M)**

Prepared By: Stephen Fu

# BBRx IRN Test on Jambu

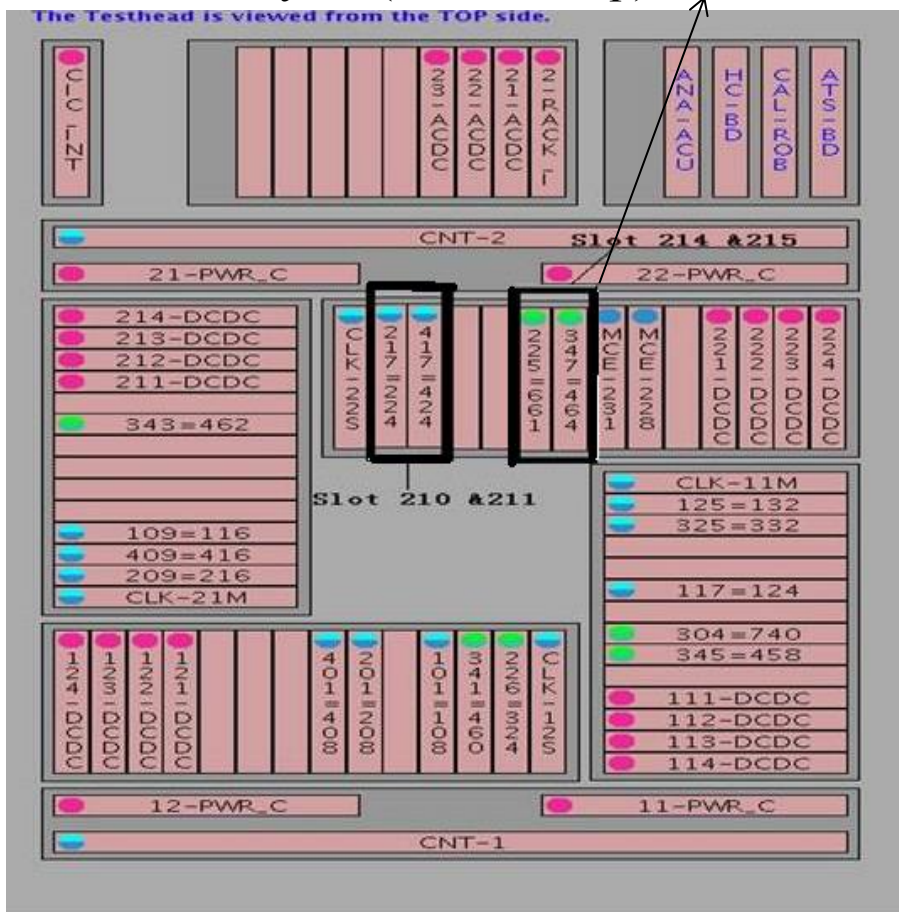
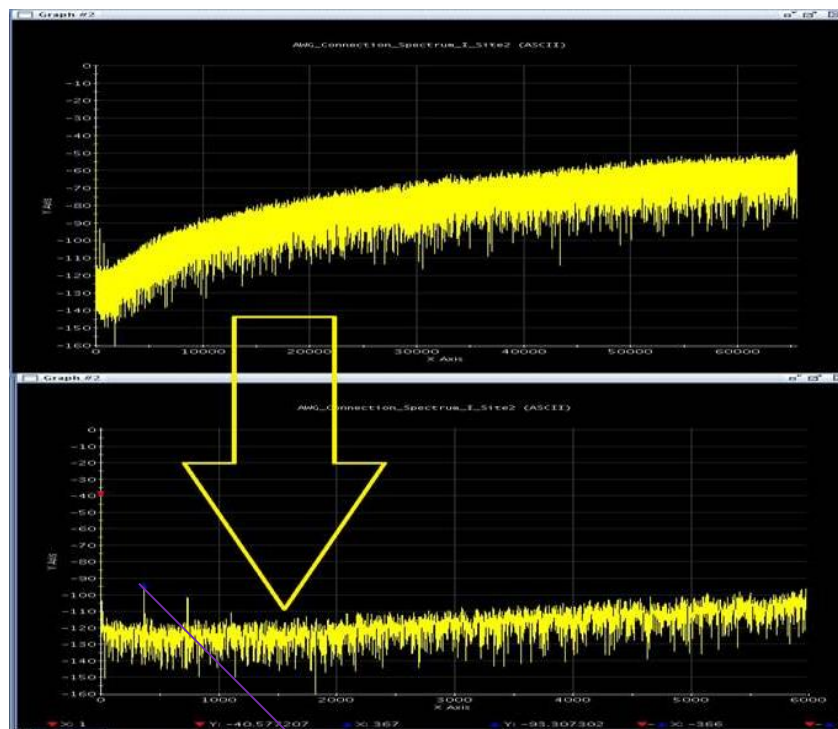
Tester head layout (before Swap): DPS64 is closed to MCE

This suspicious tone(107.6KHz) will cause the following IRN test failure.

1	1	AN_BBRX_GSMSEIRNMMBW2K110K_0_Q6	301052100	AN_BBRX_GSMSEIRNMMBW2K110K_0_Q6_ADC0_IRN_I	@	Pass	***	59.0253 uV	***
1	1	AN_BBRX_GSMSEIRNMMBW2K110K_0_Q6	301052200	AN_BBRX_GSMSEIRNMMBW2K110K_0_Q6_ADC0_IRN_Q	@	Pass	***	61.2933 uV	***
1	1	AN_BBRX_GSMSEIRNMMBW2K110K_0_Q6	301052300	AN_BBRX_GSMSEIRNMMBW2K110K_0_Q6_ADC0_ORN_I	@	Pass	***	58.1606 uV	***
1	1	AN_BBRX_GSMSEIRNMMBW2K110K_0_Q6	301052500	AN_BBRX_GSMSEIRNMMBW2K110K_0_Q6_ADC0_ORN_Q	@	Pass	***	60.2523 uV	***
1	1	AN_BBRX_GSMSEIRNMMBW2K110K_0_Q6	301052400	AN_BBRX_GSMSEIRNMMBW2K110K_0_Q6_ADC0_ORN_IPJQ	@	Fail	***	1.00000 59.2157	***

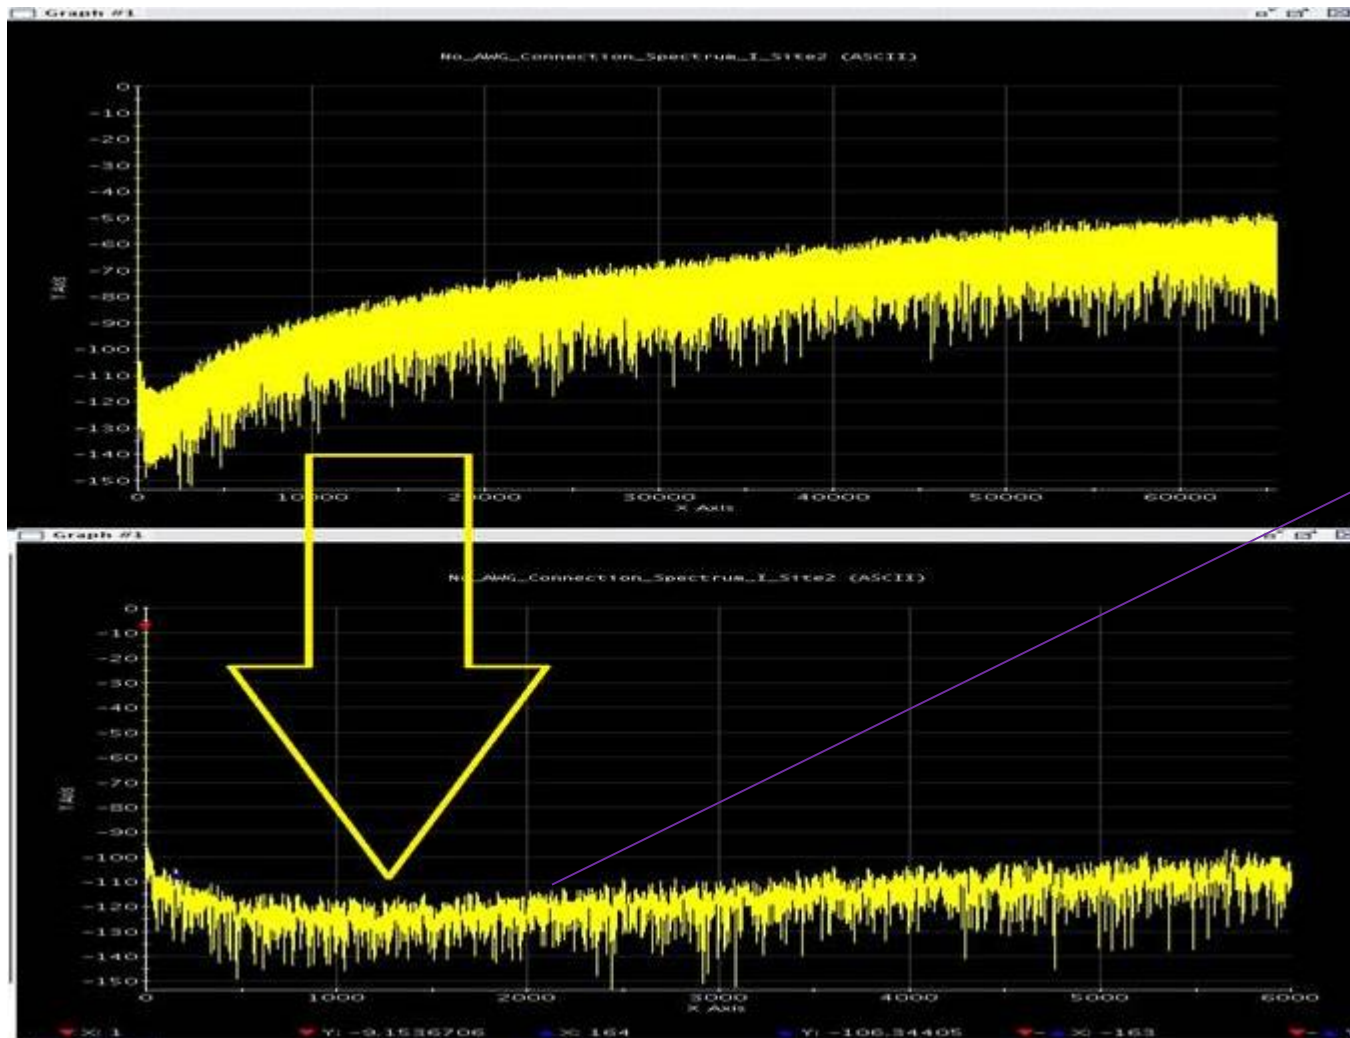
To make sure that the suspicious tone is from AWG, try to disconnect AWG sourcing, and didn't observed the tone.

The noise floor is relatively higher as the input is floating, but can't see the tone anymore.

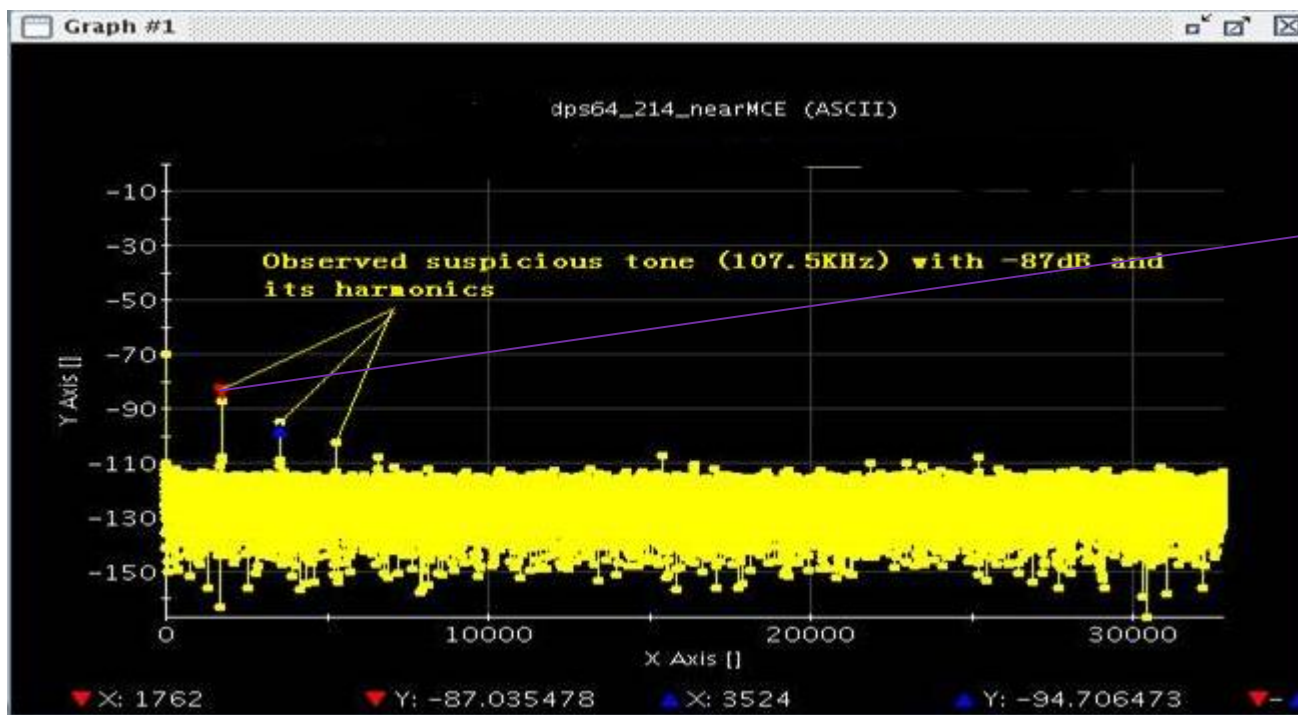
Without device, still can capture the suspicious tone and its harmonics.

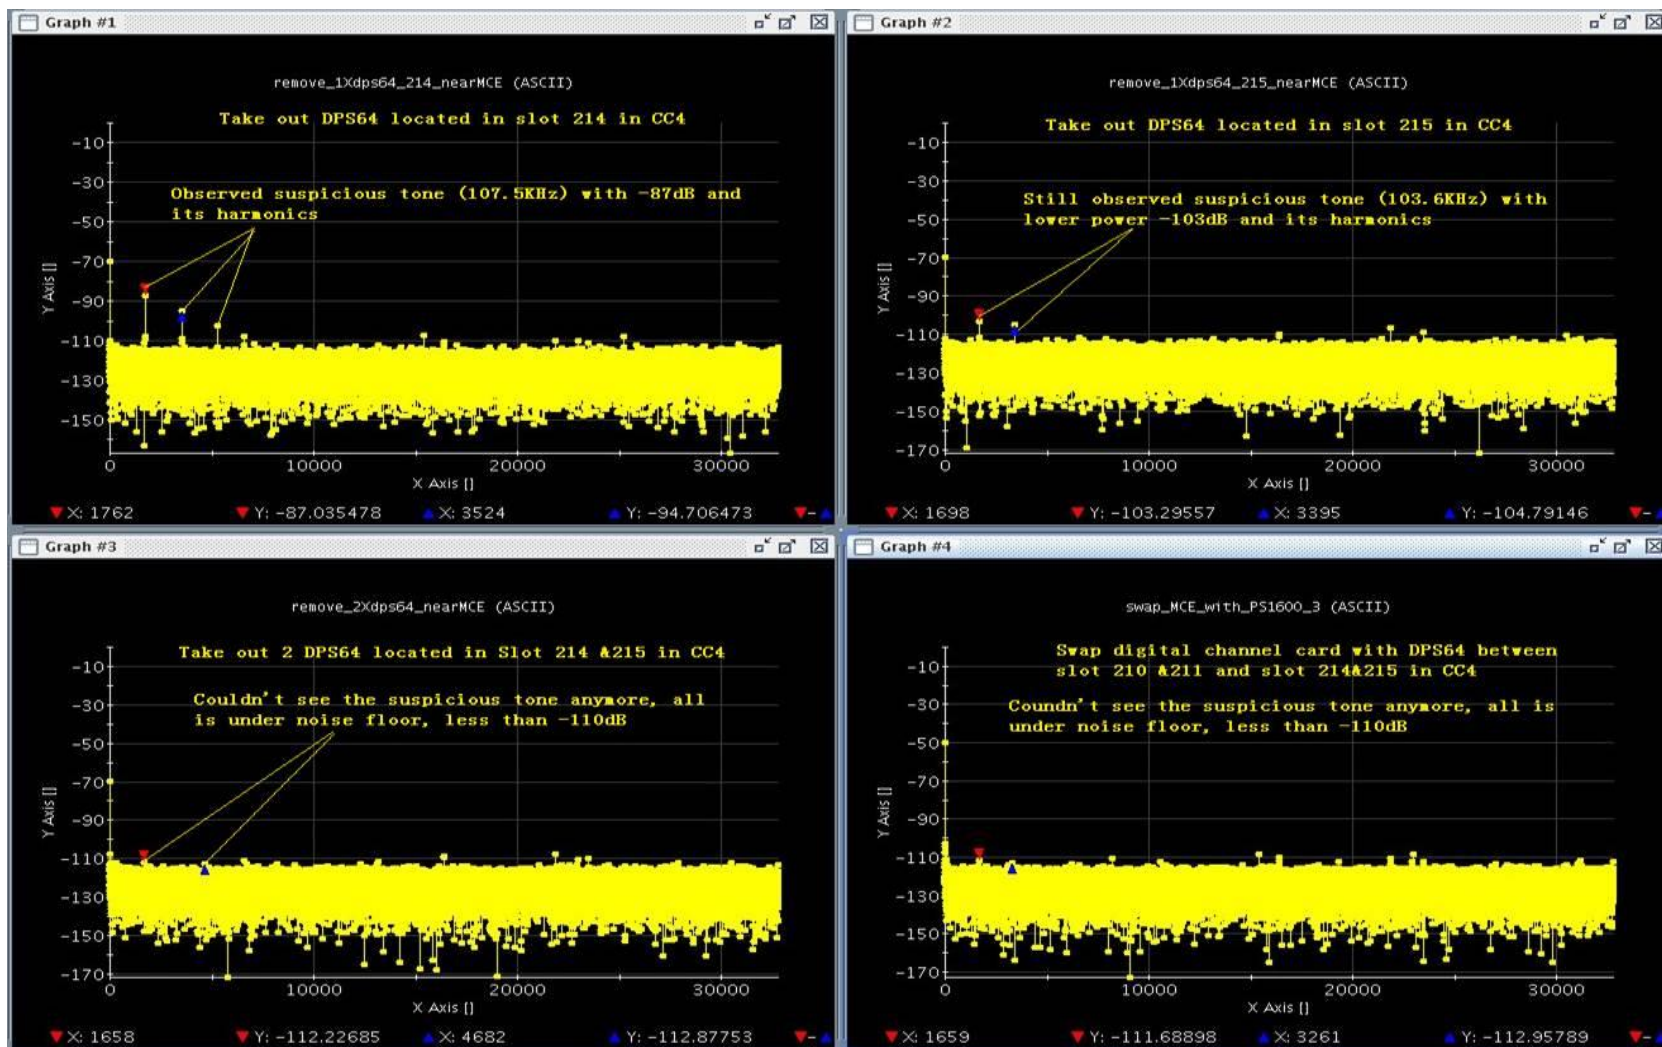
Try to isolate the root cause of this suspicious tone. Capture the waveform spectrum when changing DPS64 location.( Using loopback test program)

1	1	AN_BBRX_GSMSEIRNMMBW2K110K_0_Q6	301052100	AN_BBRX_GSMSEIRNMMBW2K110K_0_Q6_ADC0_IRN_I_0	Pass	***	28.3959 uV	***	
1	1	AN_BBRX_GSMSEIRNMMBW2K110K_0_Q6	301052200	AN_BBRX_GSMSEIRNMMBW2K110K_0_Q6_ADC0_IRN_Q_0	Pass	***	28.8254 uV	***	
1	1	AN_BBRX_GSMSEIRNMMBW2K110K_0_Q6	301052300	AN_BBRX_GSMSEIRNMMBW2K110K_0_Q6_ADC0_ORN_I_0	Pass	***	28.0462 uV	***	
1	1	AN_BBRX_GSMSEIRNMMBW2K110K_0_Q6	301052500	AN_BBRX_GSMSEIRNMMBW2K110K_0_Q6_ADC0_ORN_Q_0	Pass	***	28.3998 uV	***	
1	1	AN_BBRX_GSMSEIRNMMBW2K110K_0_Q6	301052400	AN_BBRX_GSMSEIRNMMBW2K110K_0_Q6_ADC0_ORN_IPJQ_0	Pass	1.00000	28.2235 uV	40.0000

Four systems: Mabololo(SG), Arena3(SG), Yuzu(SG), Brut(SD)  
(the DPS boards and MCE are separate in tester head)  
IRN test is passing, Couldn't observe the suspicious tone.

Three systems: Jambu(SG), Zandra(SD), Harpo(SD)  
(the DPS board is close to MCE in tester head)  
IRN test is failing on Jambu and Zandra, Can capture the suspicious tone .  
Need to verify it on Harpo.

CR has been filed to address this issue for R&D to isolate the root cause.  
[\[SOTrack\] \(QCOM-794\) DPS-64 card interference with MCE](#)
