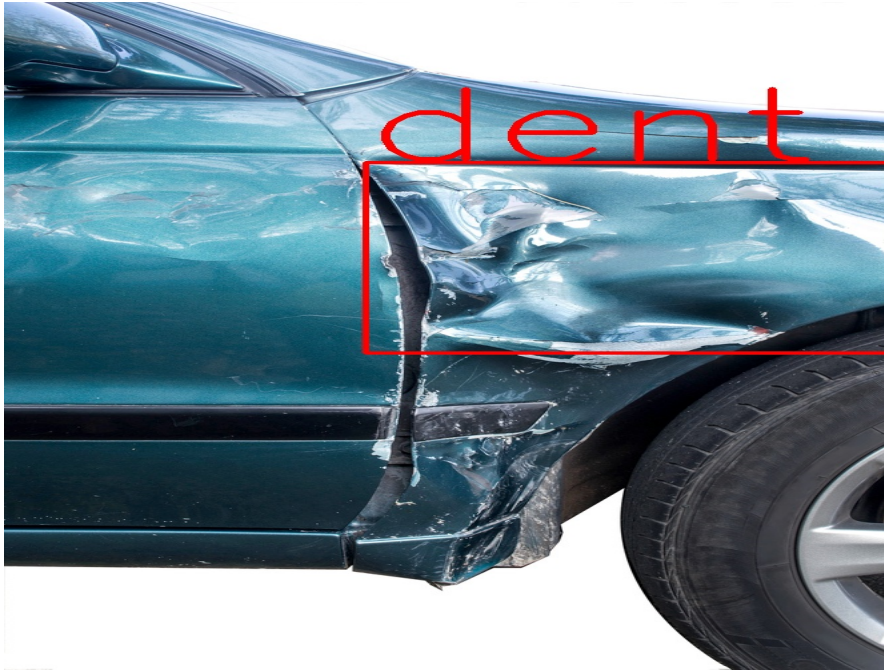
The vehicle was partially visible from the side angle, and an initial assessment was conducted based on the provided information.

- Dent detected on the left side of the vehicle (Confidence: 0.83)
- No other damage was observed

- Severity level: 3 (Moderate)

- Further inspection is required to assess the extent of the damage
- It is recommended to inspect the vehicle's body panels and frame for any additional damage
- A detailed repair estimate should be provided once the assessment is complete

- The vehicle should be towed to a secure location for further inspection and assessment
- It is recommended to use a flatbed tow truck to prevent further damage to the vehicle

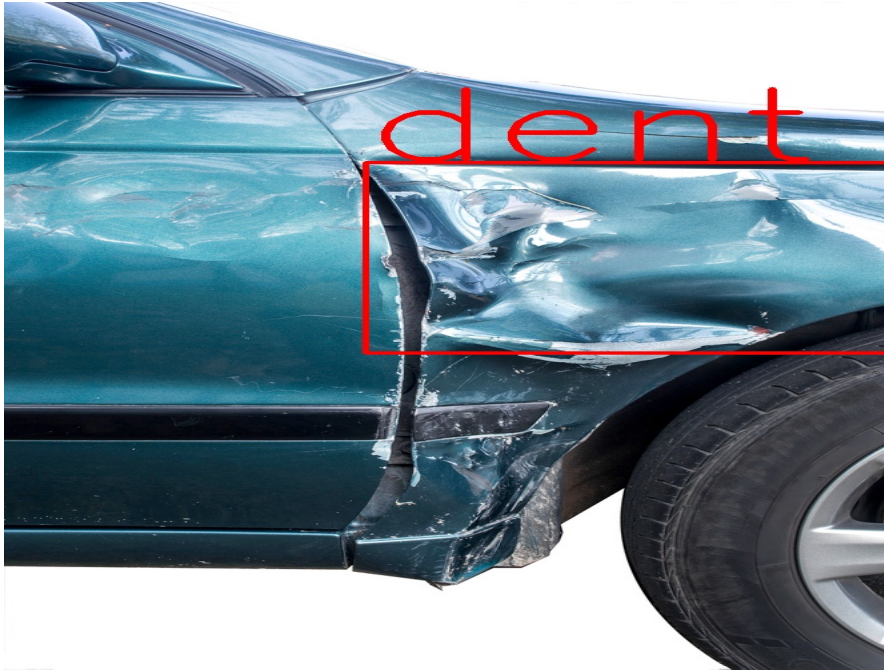
I have some additional information regarding the vehicle. The vehicle was involved in an accident with another vehicle and was driven to the location where it was inspected. The driver of the vehicle reported that the vehicle was struck on the left side by another vehicle.

The vehicle was partially visible from the side angle, and an initial assessment was conducted based on the provided information.

- A thorough examination of the vehicle's underside and frame should be conducted during the towing process
