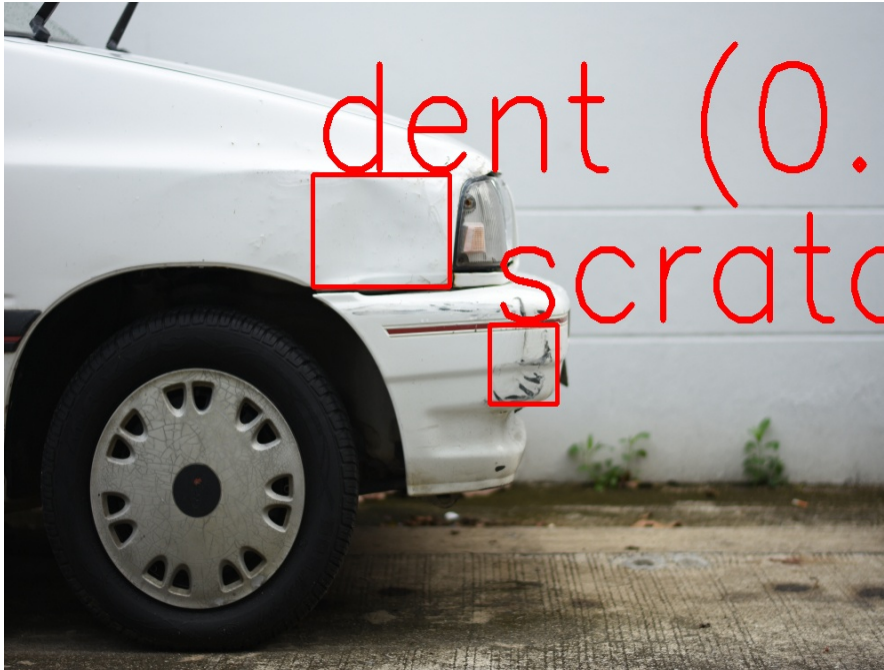
- Description: a white car, shown partially from the side angle, displaying 2 scratches and crack.
- License Plate: No plate detected
- No additional vehicle data found.

- 1. Dent detected on the left side:
 - a. Location: left side
 - b. Size: N/A
 - c. Depth: N/A
 - d. Material: N/A
 - e. Description: dent detected with a confidence level of 0.74
- 2. Scratch detected on the right side:
 - a. Location: right side
 - b. Size: N/A
 - c. Description: scratch detected with a confidence level of 0.29

- The severity level of the damage is currently unknown due to the lack of information

- The vehicle requires a detailed inspection by a qualified mechanic to determine the extent of the damage and necessary repairs.

- The vehicle requires towing to a secure location for further assessment and repair.

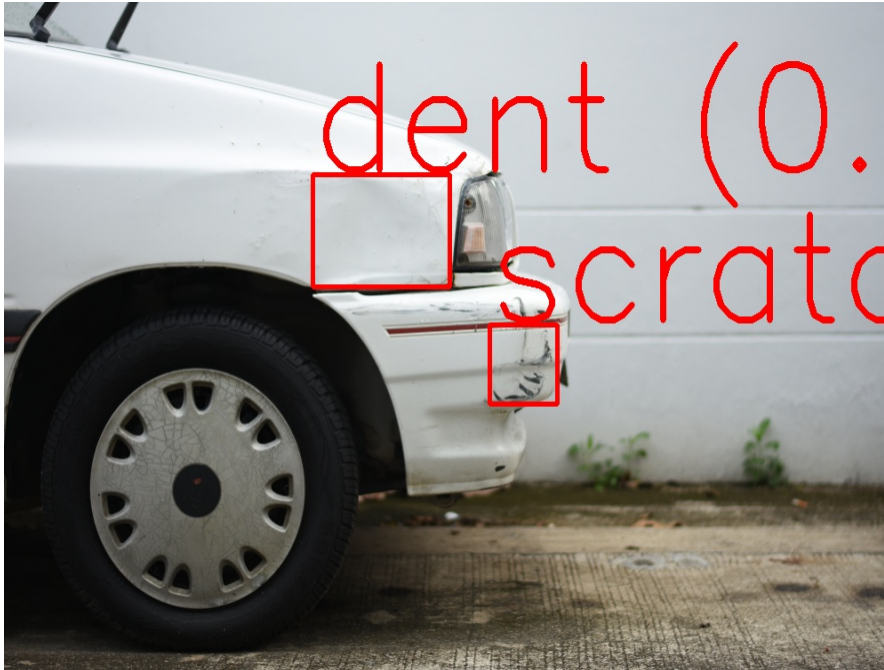
- Description: a white car, shown partially from the side angle, displaying 2 scratches and a crack.
- License Plate: No plate detected
- No additional vehicle data found.

- 1. Dent detected on the left side:
 - a. Location: left side
 - b. Size: N/A
 - c. Depth: N/A
 - d. Material
