November 14, 2008

Volume 16, Issue 19

A FOCUS ON SAFETY

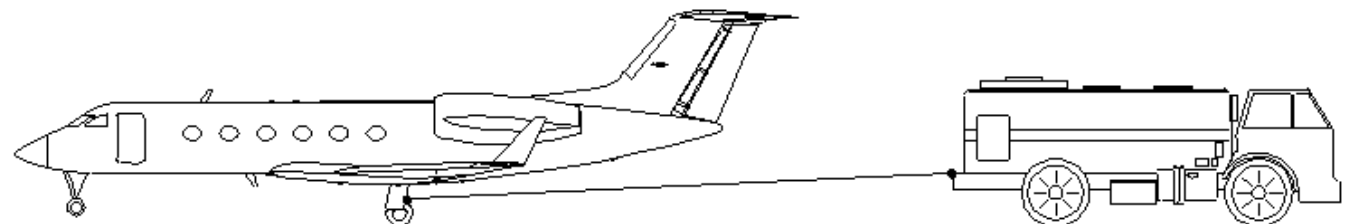
**BONDING (ACCEPTABLE)**

The Gulfstream Ground Handling and Servicing Handbooks, and Aircraft Maintenance Manuals have removed the grounding requirement and call only for bonding the fuel source to the aircraft during any type of fueling or defueling operation.

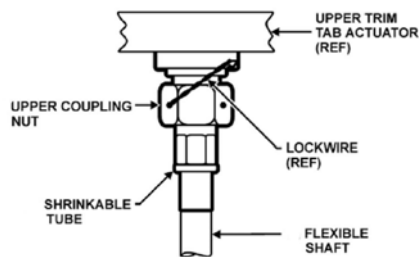
**Flexible Shaft Upper End Sealing
ASTRA/SPX/G100**

Rudder Trim installations on the Astra through G200 aircraft are susceptible to water ingress into the trim actuator housings. This has resulted in failure either as a result of corrosion and/or freezing in flight.

The shrinkable tubing, part number ATUM-19/6-0, called out in each of the installations is a specialized Raychem product. ATUM tubing is radiation-cross linked, heat-shrinkable, and adhesive-lined to provide environmental sealing in a wide variety of applications. The internal adhesive coating, when heated, melts and flows to form a positive environmental seal. The coating adheres to the outer tubing and the surface below, creating an excellent barrier to moisture penetration.

Ensuring this procedure is properly accomplished will reduce the probability of premature failure.

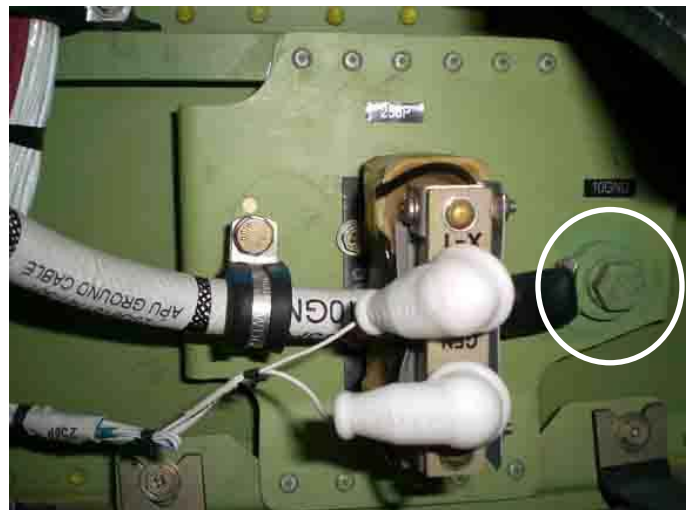
10GND LOCATION

Several G150 aircraft have reported “GEN LOAD UNBALANCE” status messages. In some cases, the aircraft starts out with all generator currents reading the same and the APU generator current slowly decreases to zero.

A team from Dallas troubleshooted the problem to a poor ground for the APU generator return cable at 10GND (see graphic). The plate to which the ground is mounted was found to be poorly bonded to the aircraft structure. When the plate was tapped, the APU generator current indication in the cockpit would jump.

To correct the issue, technicians removed the rivets, burnished the two mating surfaces, and reinstalled the plate. Electrical bonding practices in this area have been reviewed with production personnel to ensure proper ground performance on future aircraft.

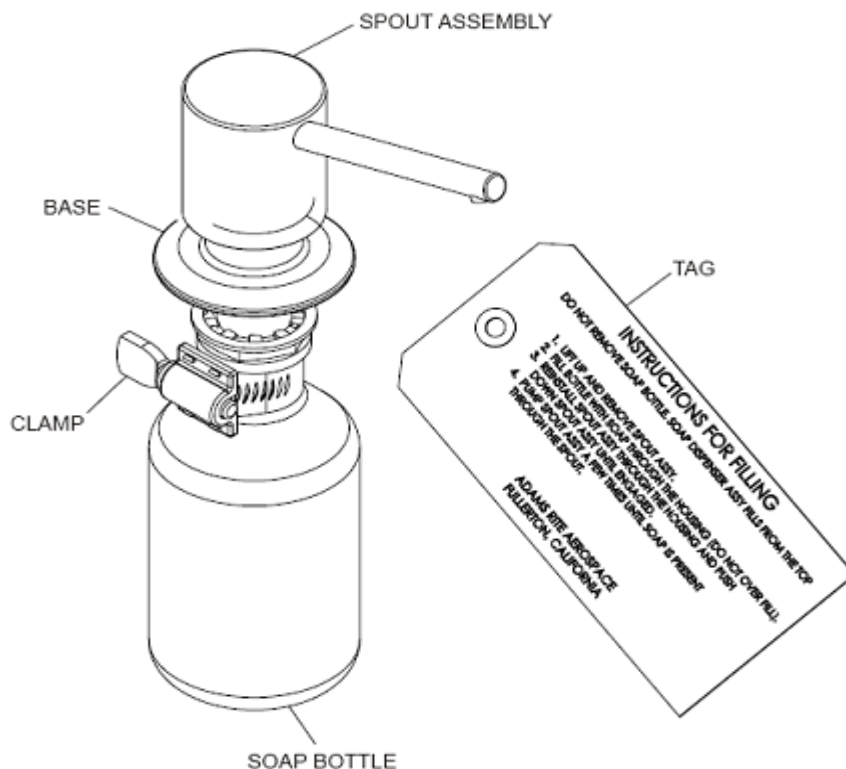
Adams Rite Soap Dispenser

Several operators have commented about soap leaking out of their aircraft's forward and aft lavatory soap dispensers, Adams Rite Aerospace Soap Dispenser Assembly part number AR9116-DXXX. This generally occurs only on high-altitude, long-range flights.

All incidents were narrowed down to servicing of the soap dispenser. The filling instructions in the Adams Rite Component Maintenance Manual (CMM) state: Fill the bottle with soap through housing. Do not overfill.

The bottle capacity is listed at 5 oz. In the fault isolation section of the CMM, one of the remedies for a bottle that does not dispense soap is to fill bottle to capacity. However, when filled in this manner, the bottle will leak soap due to pressurization at high altitude. The manual is not clear in exactly how much soap should be used and indicates "full" and "fill to capacity" as the reference marks to go by.

Based on service experience, it is recommended to fill the soap bottles no more than three quarters full, or 3.5 to 4.0 oz. This will prevent soap from oozing from the assembly on long, high-altitude flights. When serviced in this manner, no problems have been noted. This information will be added to the next revision of the Completion Center Maintenance Handbook (CCMH).

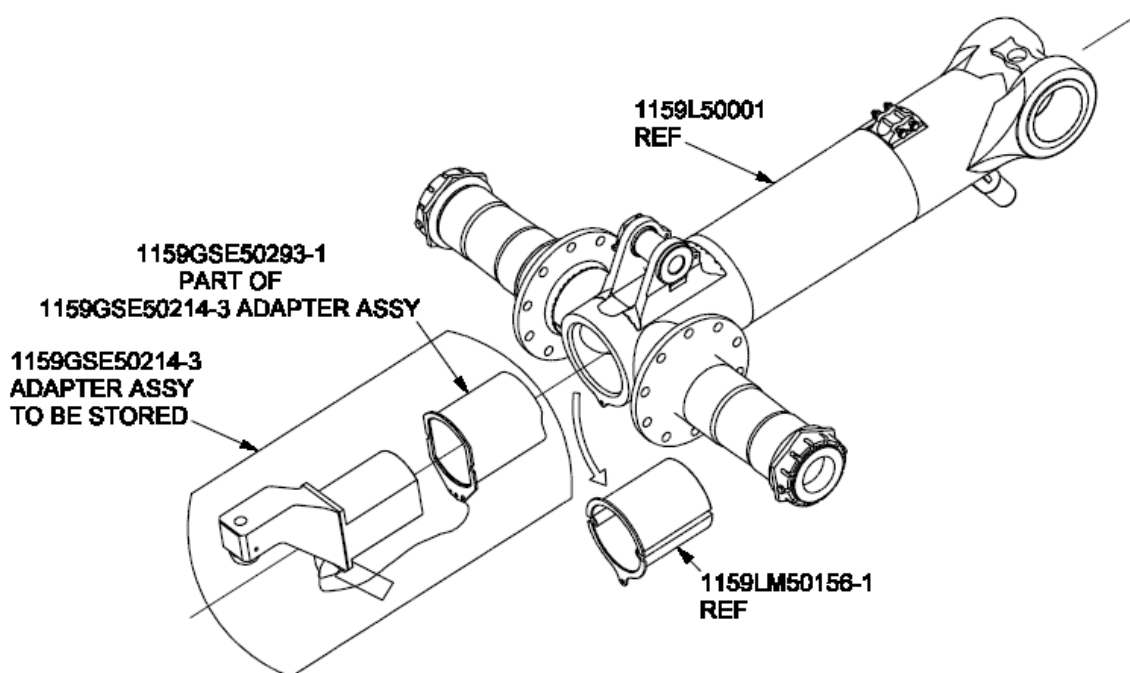
Drawing excerpt from ASC 155 Figure 1

Recently, a GV operator jacked the aircraft without the proper jack pad adapter and damaged the main landing gear (MLG) axle. As a result, we are publishing this reminder of the importance of using the correct adapter when jacking the aircraft.

The latest style jack pad adapter was installed by Aircraft Service Change (ASC) 155 for aircraft 501-619 and is a production standard from aircraft 620 and subsequent. This modification removes the existing MLG axle bushings, P/N 1159LM50156-1, and installs a Foreign Object Debris (FOD) cap at each MLG axle jack point, which helps to minimize the possibility of corrosion in the lower MLG axle. Additionally, this modification changes the jack pad adapter assembly to a new part number, 1159GSE50214-3.
