Project: **Design/Engineering Services –
BPCPC Mechanical System
Upgrade**

RE: **Addenda #1**
of Pages: **26**

1.0 Background

2.0 Existing Conditions and Site Observations

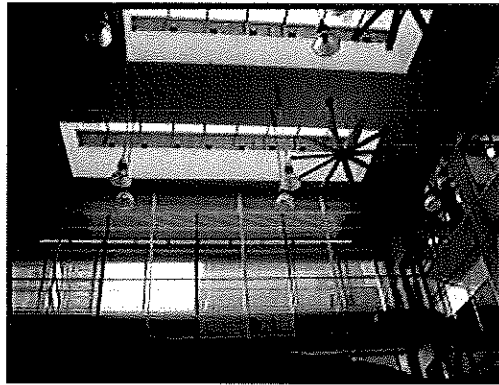
Photo 12. Proposed location for new chillers

Our recommendation is to install four (4) x 18 ton, packaged air-cooled Multistack chiller units. The proposed location of these chillers would be located in a new 4th floor Mechanical Equipment Room located above the open atrium area on the 4th Floor, below the skylight, and adjacent to the existing 4th floor catwalk (Photo 12). Other locations may be proposed by the BPCPC but would require floor space inside the building in a location accessible to the outside for fresh air/exhaust air.

This location was selected because it allows ready access to the exterior to provide condenser cooling air and exhaust air. Intake air louvers would need to be located in place of the storefront windows along the Second Place side of the building. The estimated size of the louvers are approximately 120 sq ft. of new louver area for intake air. These new louvers would be installed so that air can be ducted into the new Mechanical Equipment Room, with ductwork running through the existing 4th floor catwalk space. In order to provide exhaust air from the new chillers, we propose to utilize the existing skylight with a louvered exhaust opening. Modifications to the skylight and roof will be required. New piping will be run from the new chiller units to the existing chilled water main piping on the 2nd floor. New chilled water pumps will need to be provided to circulate water to all existing air handling units, and fan coil units. New electric power wiring and equipment will be required, and revisions to the building control sequence of operation will be required to incorporate the new equipment. In addition, further investigation into the adequacy of the building electric service will be needed during the design phase. It is recommended to engage in metering of the electric service to confirm the load on the existing electric distribution.
