# ***ROAD SAFETY AUDIT***

## **ROUTE 3 BEDFORD-BILLERICA- CHELMSFORD**

### **MAJOR HIGHWAY MEDIAN CROSS-OVER CRASHES**

**Final Report**

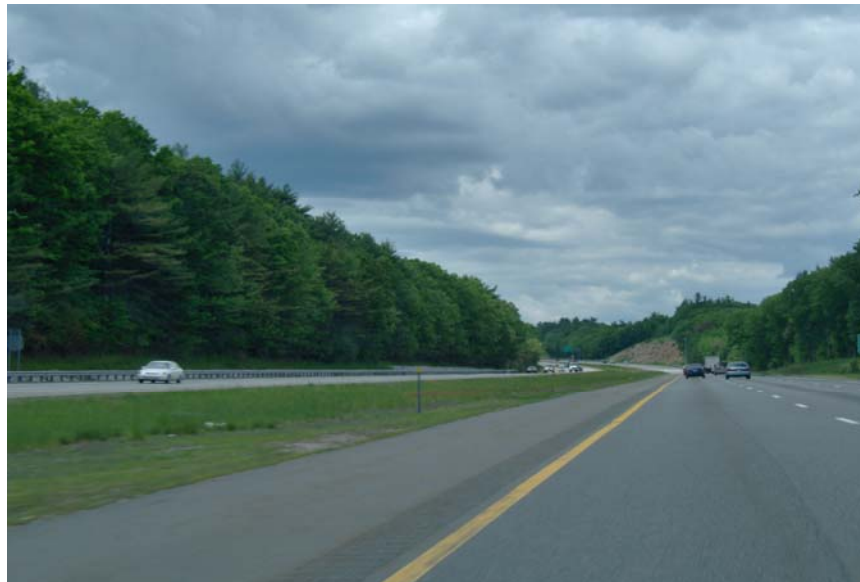
**Figure 2 - Route 3 in Northbound direction – wide inside shoulder with rumble strip in place.**

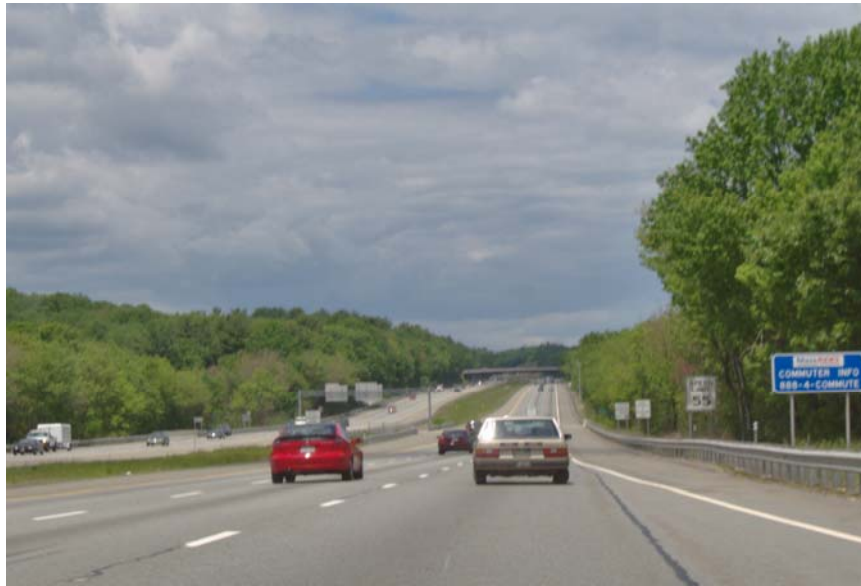
**Figure 3 - Northbound at Interchange 26 on-ramp.**

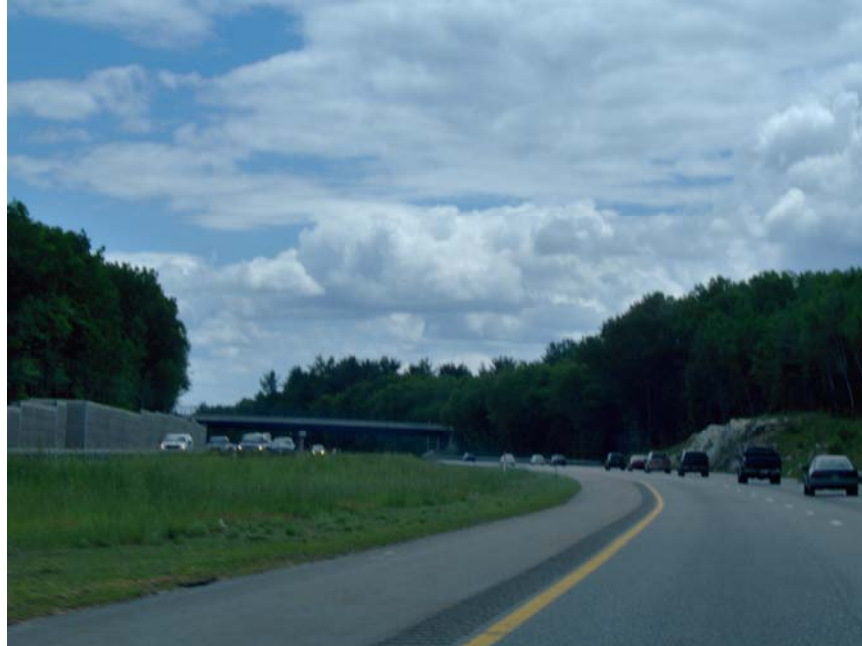
**Figure 4 - Route 3 Southbound south of Interchange 27 – horizontal curve and elevation difference between directions at this location.**

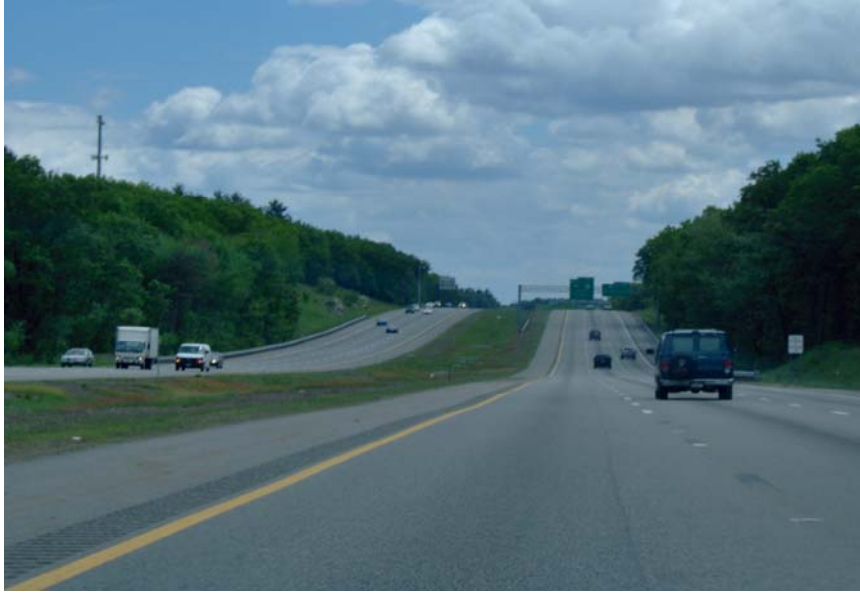
**Figure 5 - Section south of Interchange 26 – typical median section.**

- Slope of the median is 6:1 or flatter and is highly crossable,
- There is no barrier in median,
- The median (edgeline to edgeline) is currently 76± feet in width,
- When the highway is widened in the future as anticipated, the median width will be 52 feet,
- The high volumes (>100,000 on average weekday), and
- The “comfortable” design results in high speeds (32% > 70 mph) and large speed differential currently exists with the 55 mph posted speed.

Based on the analysis of the data, the field drive-thru and discussion of the conditions by the RSA team members, it is suggested that a median barrier be installed along the length of the study route. This will represent approximately six (6) miles of barrier to be installed. The RSA team discussed the potential difficulty installing a median barrier due to the fiber optic cable run that exists and this must be a consideration. The selection of the barrier type is briefly discussed in the next section.

First and foremost, the RSA team is recommending the installation of a median barrier. Based on costs, future highway widening plans, aesthetics and available recovery zone, it was further recommended that the median barrier be a cable type barrier. With an approximate open median area of 6 miles, the costs for installing a cable barrier in all the open areas is estimated to be \$870,000. This is based on the per mile cost of \$144,000. With regard to the cable barrier, it should be placed as far from the pavement edge as feasible, possibly near the center of the median. Implementation will need to also

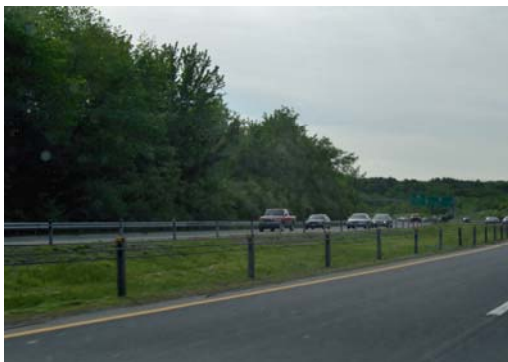
**3 Cable CASS System on Route 213**

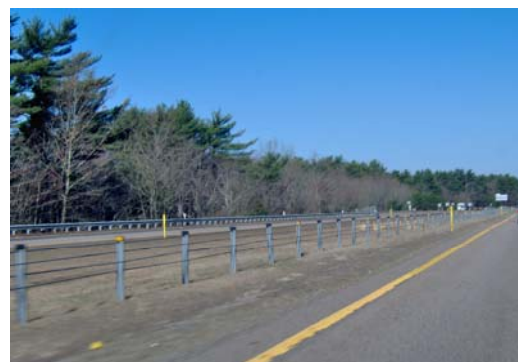
**4 – Rope Brifen System on I-495**
