ISEC2076 - ASSIGNMENT 1

CPTED Physical Security Assessment

Site Name	TD Canada Trust Branch	Location	5236 St. Margaret's Bay Rd Upper Tantallon, Nova Scotia B3Z 0P4
Site Manager	Jeremy Zwicker	Contact Details	902-826-3106 ext. 250 jeremy.zwicker@td.com
Security Manager	Joe Public	Contact Details	999-999-9999 ext. 999 joe.public@securityjoe.com

Description of site: Stand-alone single story brick building currently housing a branch of a Canadian bank in a rural community.

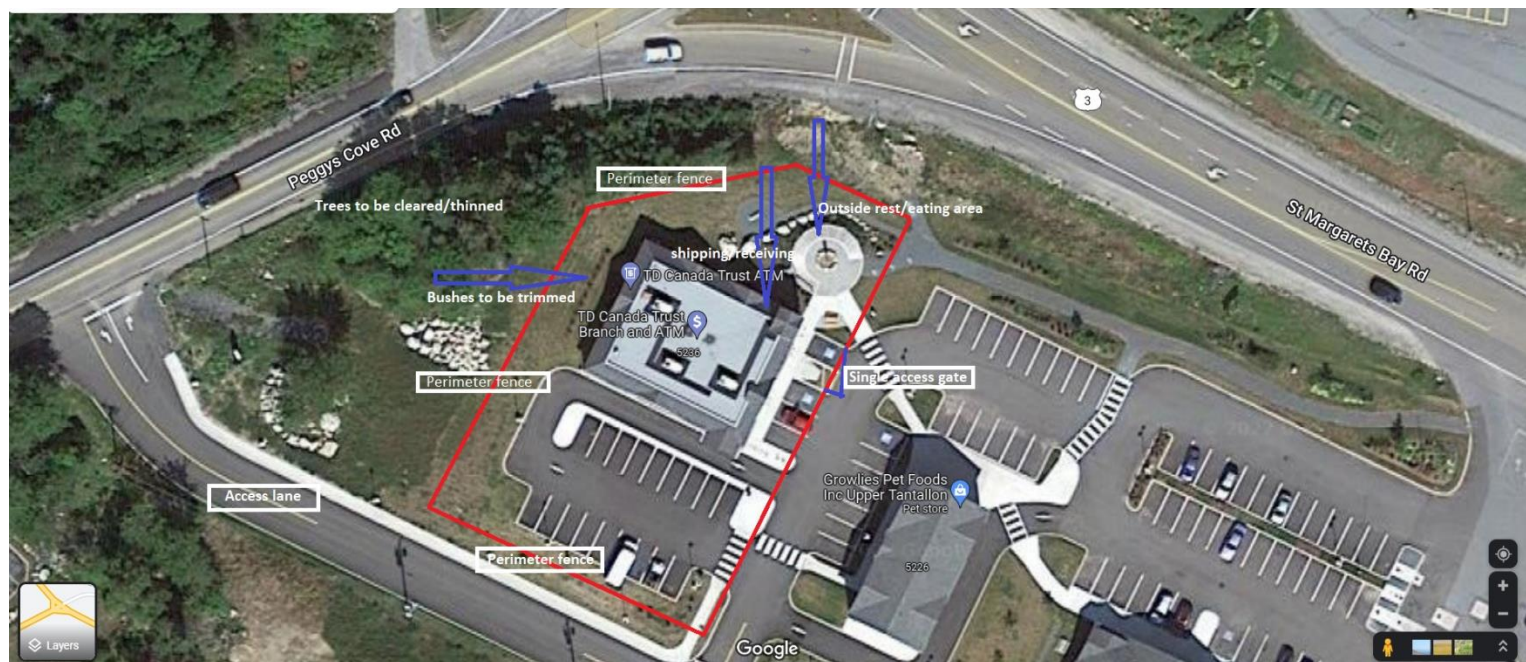
Aerial view of site with suggested security upgrades

Vulnerability:	Lack of security fencing around perimeter of site to strictly control and monitor pedestrian and vehicle access and egress
Solution:	1. Security Fencing Install security fencing around the entirety of the perimeter of the property. This fencing should be between 6 and 8 feet tall with 3 strands of barbed wire on the top with a monitored single access gate
Solution:	2. Single Access Gate Gate to have CCTV camera surveillance as well as digital swipe access card to open
Solution:	3. Clear Security Zone Create and maintain a cleared zone on the outside of this outermost security fence visible by CCTV cameras (see landscape)

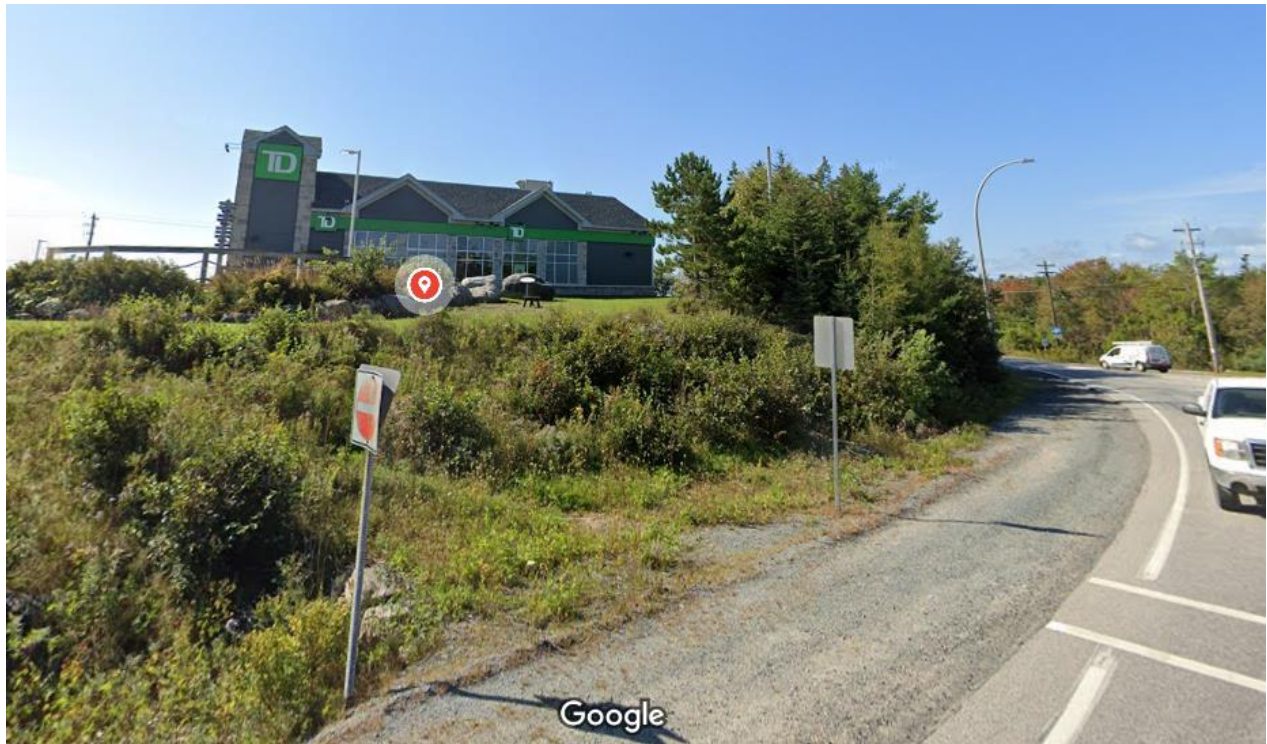
Image of dense tree growth impeding visibility from road

Vulnerability:	Dense and overgrown tree coverage along west side of site reducing visibility from busy main road along property boundary
Solution:	Thin the density of trees to increase observability as well as remove low tree branches to 8 feet from the ground
Vulnerability:	Several tall and overgrown bushes between site perimeter and back emergency door reducing visibility of security zone around building.
Solution:	Removal or trim bushes and maintain at 36 inches
Other:	No visible vandalism or garbage
Recommended:	Renew landscape/property maintenance contract with current providers

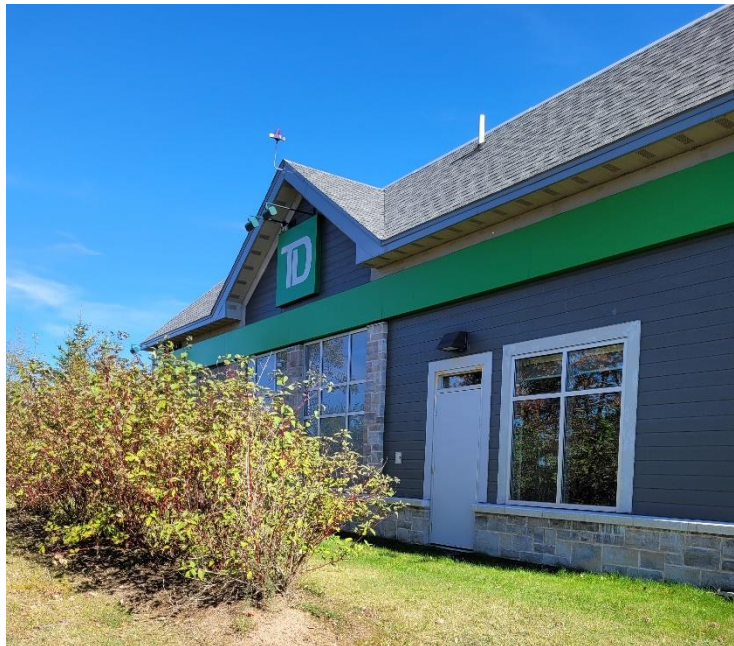
Image of overgrown bushes on west side (back) of building

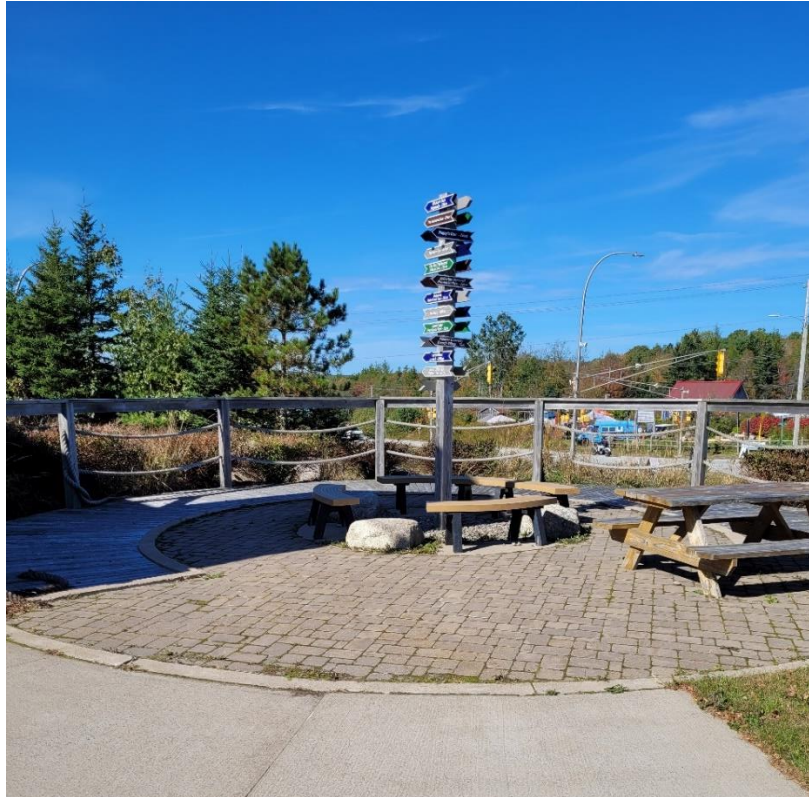
Image of rest/seating area located outside the northeast corner of building

Situated near the northeast corner of the building, there is a dedicated outdoor rest area with seating as well as a picnic table. This area casually surrounded by a wood and rope barrier and is intended for public enjoyment and utilization. It provides a clear unobstructed view of the St. Margarets Bay Road as well as the northern side of the building and property, and a partial view of the front entrance and front parking area. There are two sidewalks leading to this area, one extending from the front of the building, and one from the front of the neighbouring business and the paved parking lot. In addition, there is also a groomed walking path from the St. Margarets Bay Rd. to the rest area.

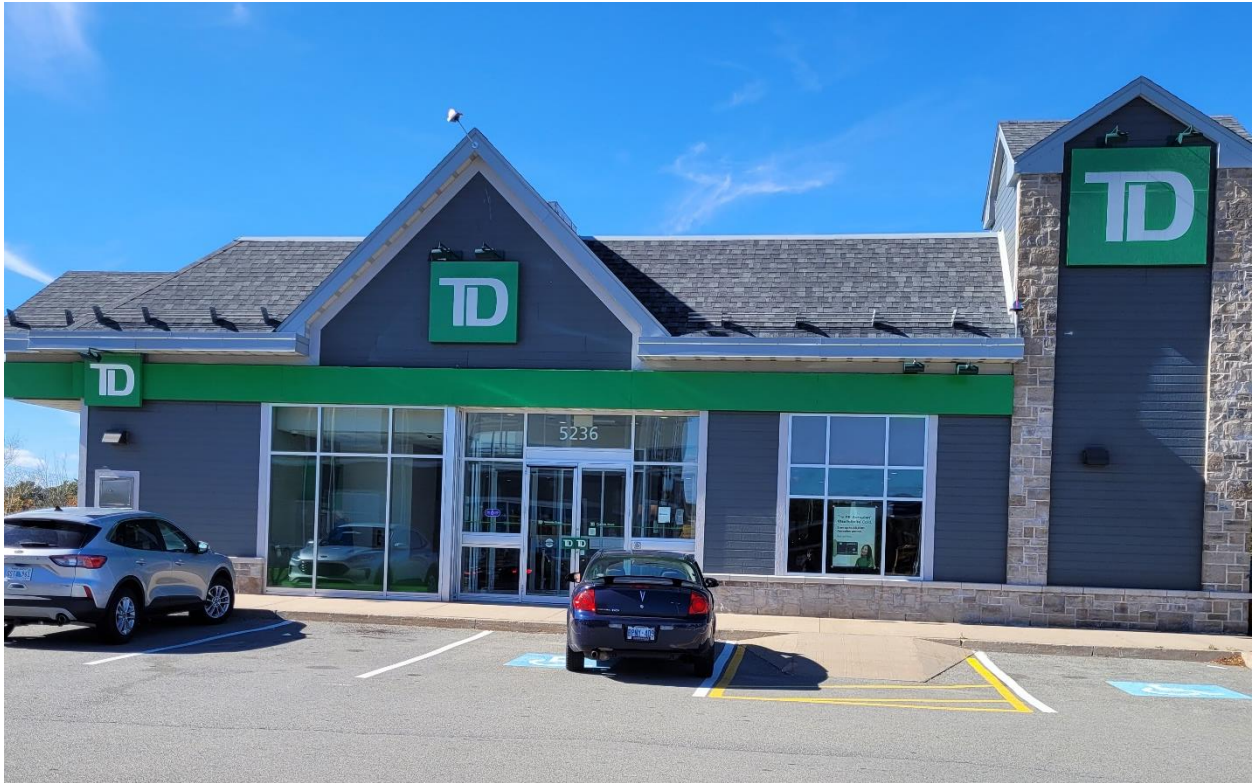
Image of front of building

Vulnerability: Glass and steel frame front-entrance door

Vulnerability: No barrier for authentication or authorization control at building entrance

Vulnerability: No warning signs posted (e.g., no trespassing or restricted area)

Vulnerability: Large glass windows to the left of main entrance door with only elevated walkway between front of building parking area

Solution: **Door replacement**
Solid steel front-entrance door

Solution: **Access Controls**

1. Digital security swipe card or biometric authentication and authorization to gain entry

2. Turnstile access control integrated with surveillance (CCTV and entrance security staff) will also aid to reduce tailgating

3. Security personnel stationed inside entrance

4. Visitor registration, escorting and ID badge, as per visitor policy, required and enforced for every visitor and contractor

Solution: Post warning signs in conspicuous locations

Solution: Install concrete bollards between front parking spaces and large windows to reduce the likelihood of a vehicle breaking through the glass windows

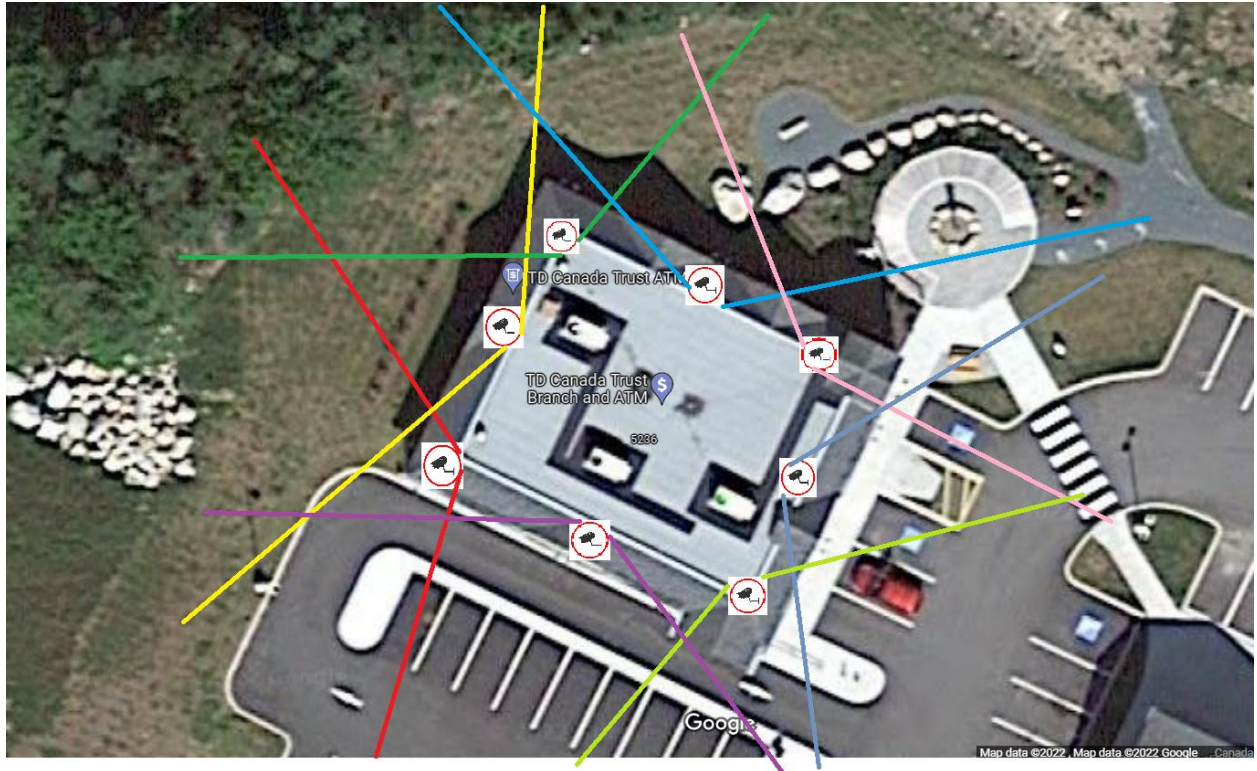
Image of suggested CCTV camera placement on exterior

Vulnerability:	No exterior surveillance cameras installed on building or property
Solution:	<ol style="list-style-type: none">1. Position digital CCTV cameras to cover the entirety of the perimeter of the building ensuring no blind spots2. Position digital CCTV camera at security fence gate to monitor both access and egress of the site3. Surveillance feeds should be monitored live 24 hours/day, 7 days/week by on site security personnel in secured location inside building to allow for immediate response4. Feed should be recorded off site and retained for a minimum of 31 days5. Post CCTV signs where clearly visible to anyone approaching site, including fence and gate, as well as any monitored interior areas

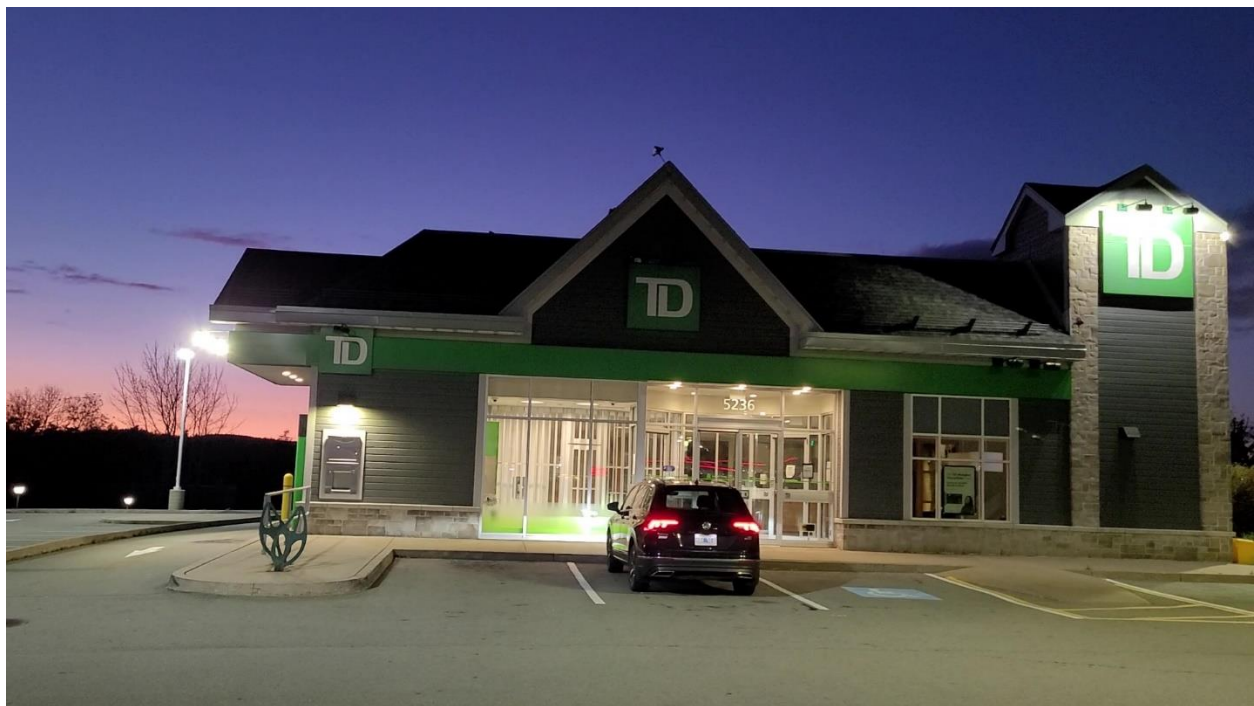
Image of evening lighting on east side (front) of building

It was noted that the existing installed lighting on the north, south and west sides of the building were not being utilized. The east side (front) was appropriately lit, as was the parking area. The access lane located along the south/southwest was observed to have adequate illumination as well.

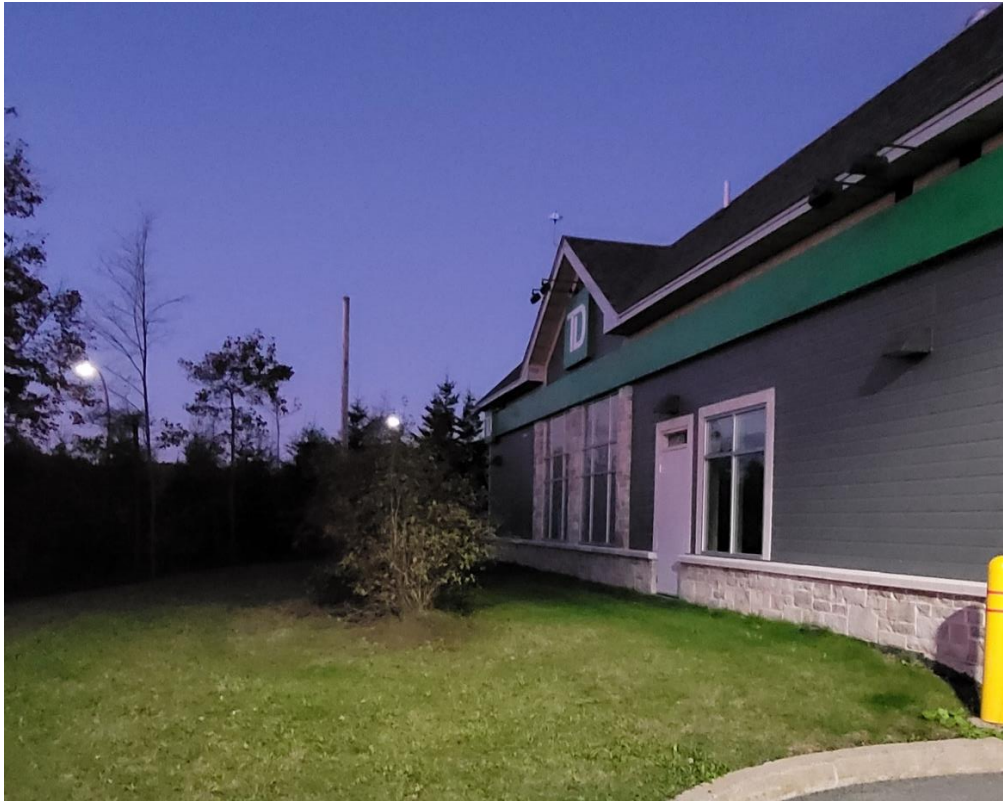
Image of evening lighting on west side (back) of building. Current lighting not in use.

- Vulnerability:** North, west, and south sides of building are not adequately lit for deterring or detecting unlawful activity. It was observed that lighting has been installed, but not in use
- Solution:**
1. Install lighting where coverage is inadequate for protection zones
 2. Assure placement of security lighting to be in such a position as to not result in silhouetting security personnel or create a glare which may be exploited
 3. Confirm currently installed lighting is in use during times of low natural light
 4. Protect lighting wiring from tampering or interference with security measures such as locking the electric meter box
 5. Ensure lighting remains in use during power outages or interruptions with a back-up power supply.

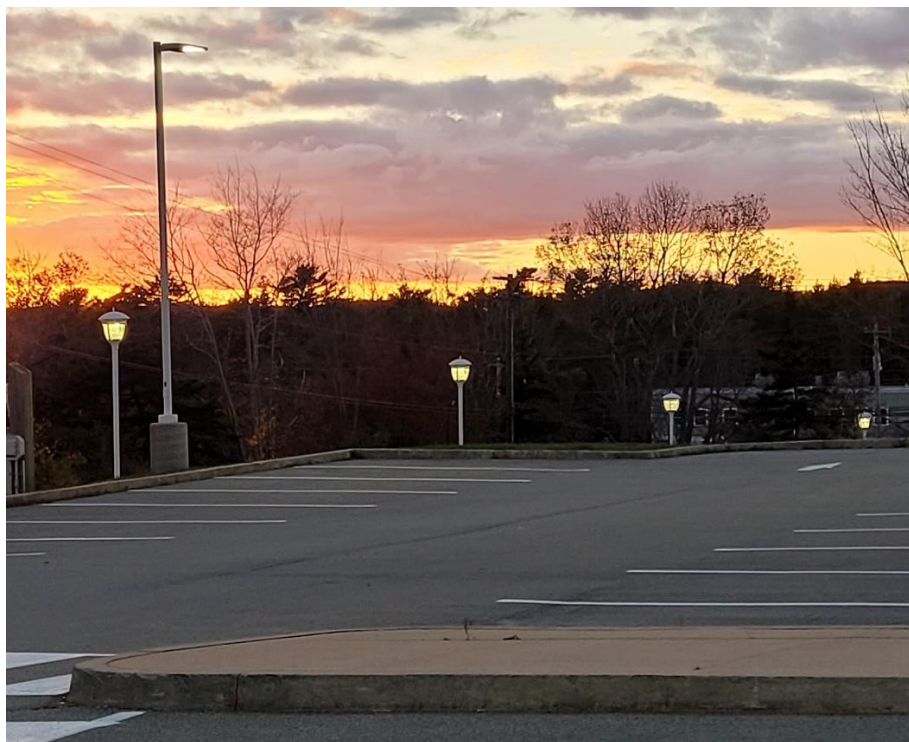
Image of lighting on access lane and south side parking
