AWR1843 DeviceSilicon Errata

Silicon Revision 1.0

This document describes the known exceptions to the functional and performance specifications to TI CMOS Radar Devices (AWR1843).

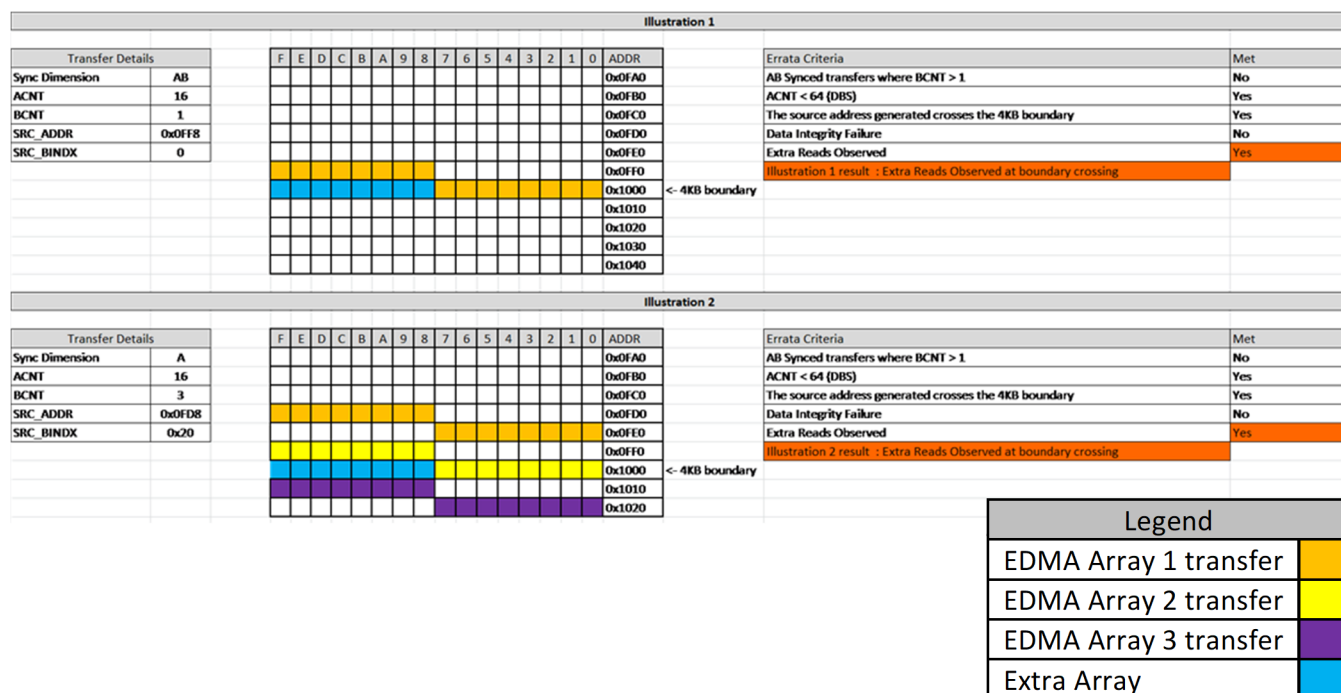
Figure 6-1. Scenario ID #3 – Extra Reads

For each extra read in **Scenario ID #3** for which [Condition \[1\]](#) is applicable, each index i above that satisfies the condition results in extra read from starting address SRC_ADDR + (i + 1) * SRCBIDX and of length equal to the distance from the start address to the boundary [that is, 0x1000 – X(i)]. Note: length < ACNT.

For **Scenario ID #3, Scenario ID #4, and Scenario ID #5– EXTRA READS**, another workaround besides avoiding the 4-KB boundary cross conditions, is to ensure that buffers involved in this kind of transfer are positioned so that extra reads stay within the physical memory boundaries. If the extra reads go to Reserved space or space blocked by the Memory Protection Unit (MPU), the TPTC generates a bus error interrupt to the processor.

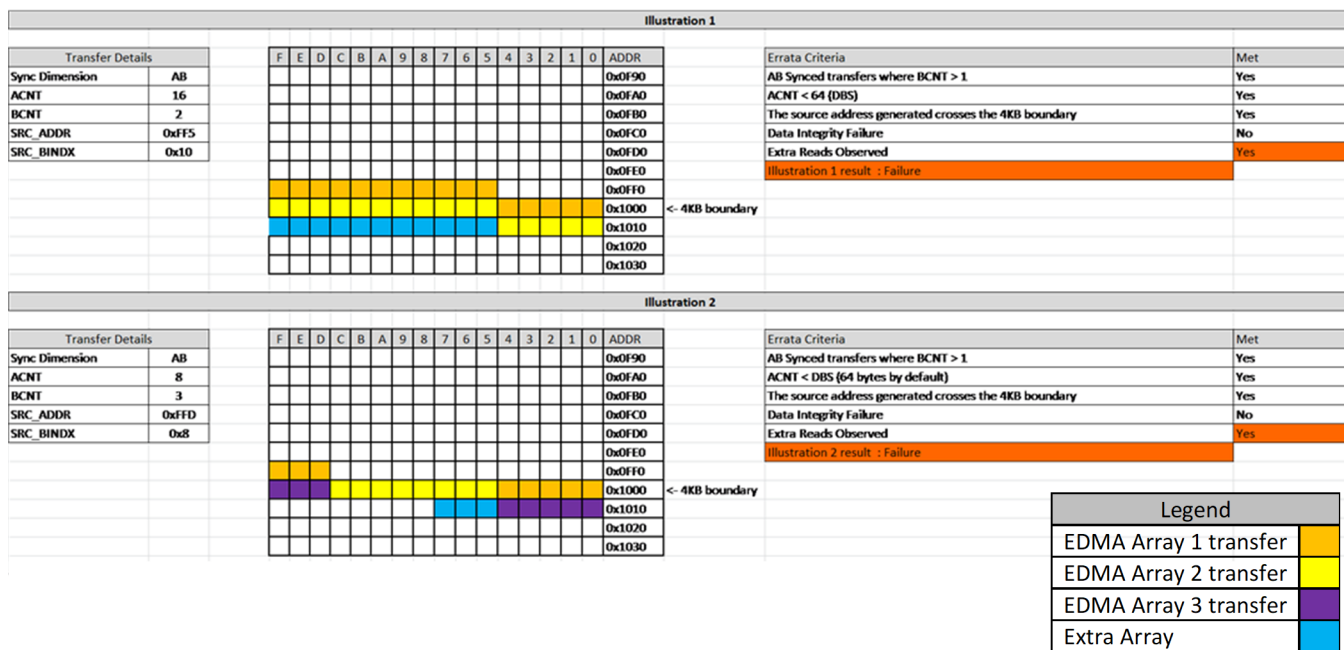
Figure 6-2. Scenario ID #4 – Extra Reads

For each extra read **Scenario ID #4** in for which [Condition \[1\]](#) is applicable, there is an extra read from starting address SRC + BCNT * ACNT (=SRCBIDX) of length equal to the distance of the start address to the boundary [that is, length is 0x1000 – X(i)], where i is the index of one and only 4-KB boundary crossing condition. Note: length < ACNT.

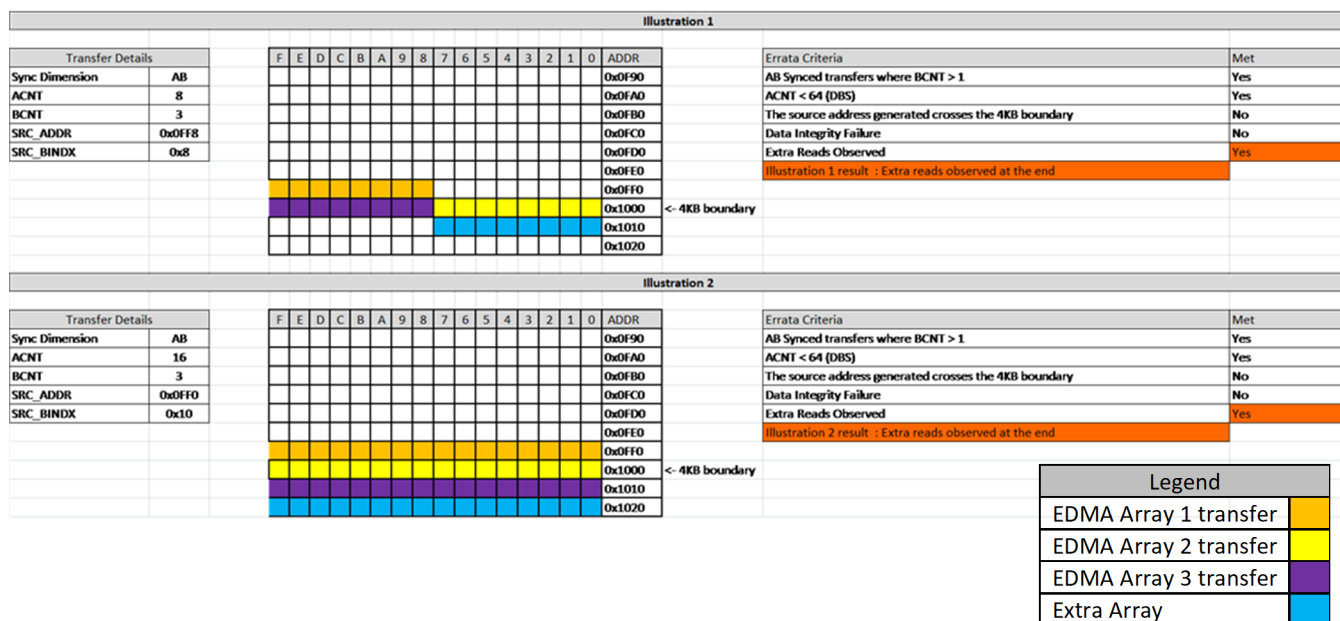
Figure 6-3. Scenario ID #5 – Extra Reads

For the extra read **Scenario ID #5** in for which [Condition \[2\]](#) is applicable, there is an extra read from starting address SRC + BCNT * ACNT (=SRCBIDX) of length equal to the distance of the start address and is of length ACNT.

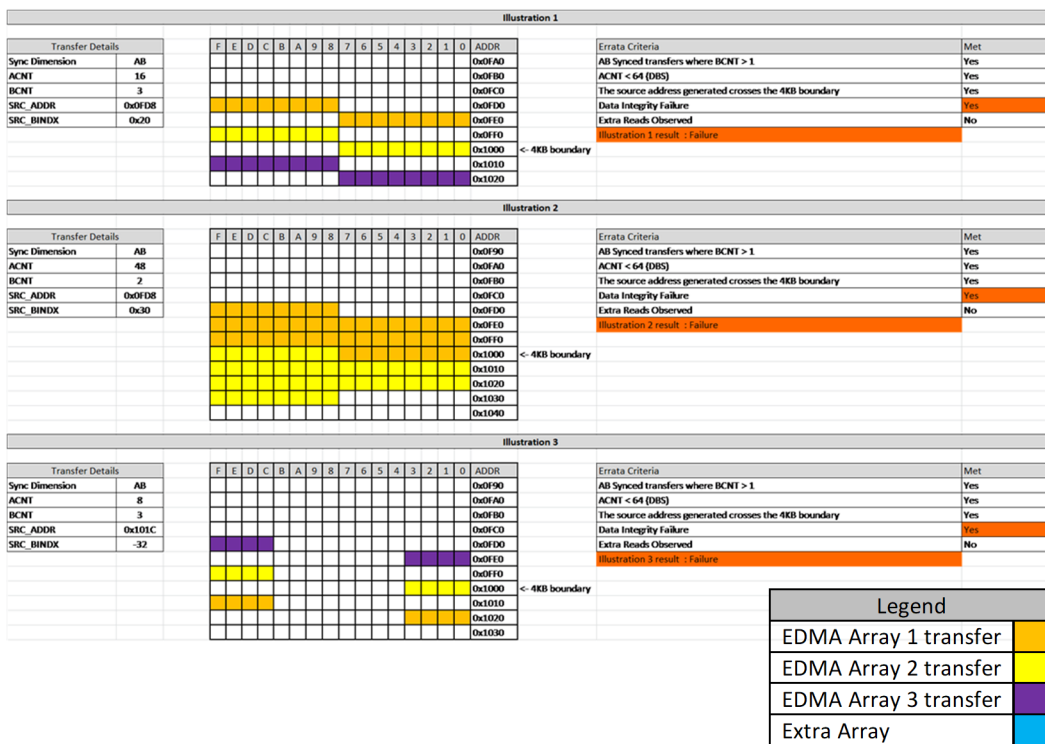
Figure 6-4. Scenario ID #1 – Data Integrity Failure

Certain scenarios can lead to an incorrect read, hang, or data integrity issues in the EDMA TPTC block. [Table 6-1](#) shows the various scenarios and the resulting effects of each scenario.

Workaround(s): **Workaround #1 - ALL SCENARIO IDs (see Table 6-1)**

Prevent one or more of the conditions necessary for the problematic scenarios to happen.
