ADA Curb Ramp New Construction Inspection Form (Perpendicular)

NW 309th Ave

24952.54

NW Timeric Dr

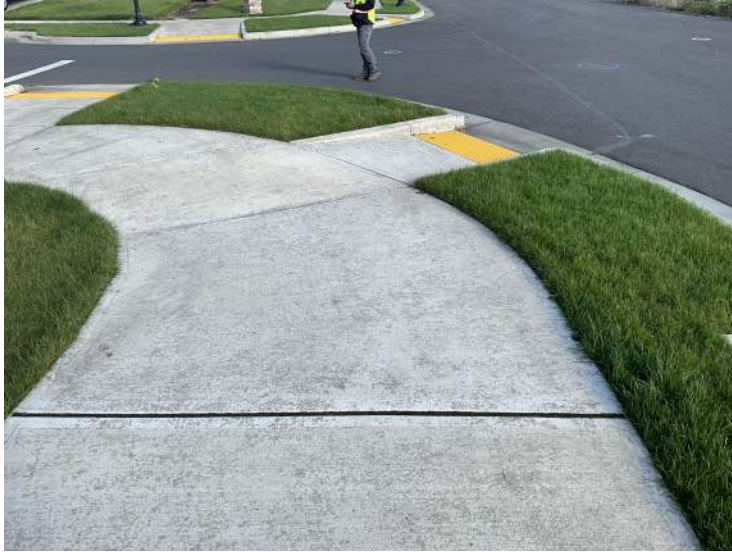
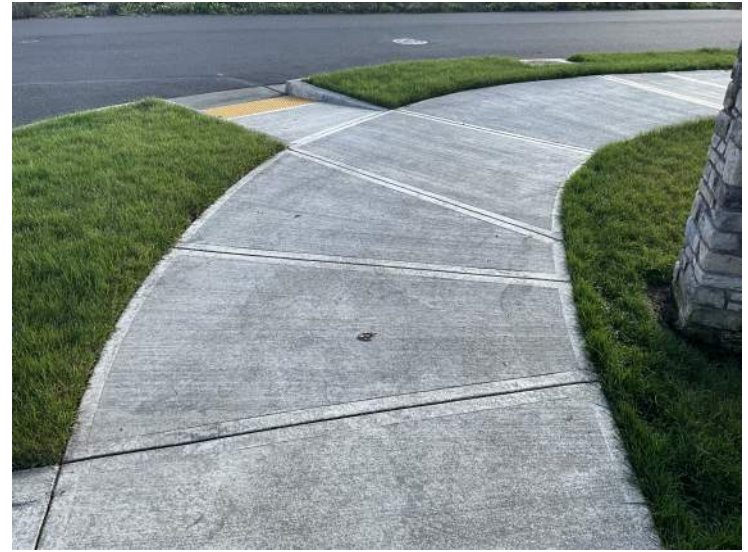
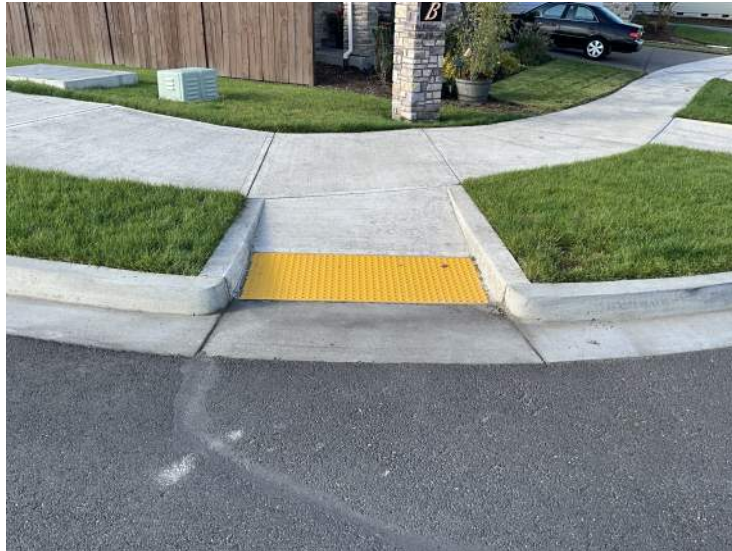
ADA Curb Ramp Images

Slope X

> 2.0%

☒

Slope Y

2.1

Failure, poor craftsmanship, warped turn space
