Chinese Journal of Aeronautics

# Data-driven reliability analysis of Boeing 787 Dreamliner

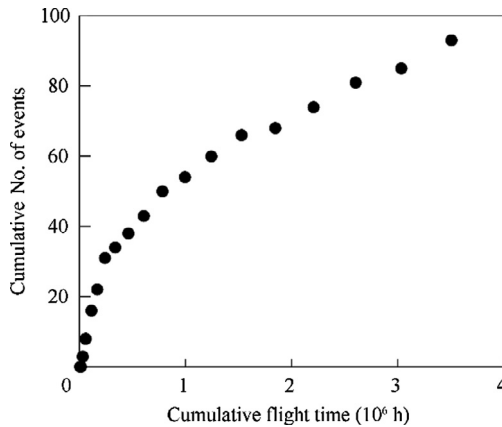
Fig. 1 is a time-cumulative event plot of event data from Table A1 and A2 and other databases mentioned above. We note that the slope of the plot decreases with increasing time. This is indicative of increasing reliability. The Duane plot in Fig. 2 shows the trend of cumulative Mean Time Between Failures (MTBF) over the flight hours. It can be seen that there is a sharp inflection point at around 115000–160000 hours, which corresponds to the period in the first quarter of 2013. The approximately straight line after the inflection point suggests that the data are consistent with an NHPP (Non-Homogeneous Poisson Process) power law model, which allows us to model the reliability growth using the Crow-AMSAA model.<sup>22</sup>

**Fig. 1** Number of flight time hours vs. failure events of the 787 aircraft.

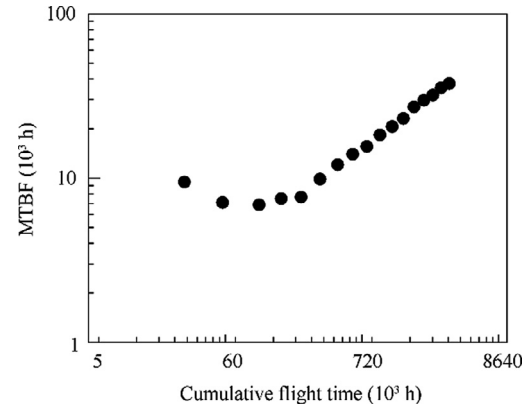
**Fig. 2** Duane plot of flight time vs. cumulative mean time between failures (MTBF).

The value of  $\beta$  of 0.7 ( $< 1$ ) in Table 2 suggests a decrease in failure rate over time and is indicative of reliability growth. Examining Fig. 2, it can be seen that the reliability of the 787 aircraft (as measured by the MTBF) was deteriorating until the grounding and started improving after the aircraft returned to service (fourth data point). Other parameter estimates such as DMTBF (demonstrated or instantaneous mean time between failures) and DFI (Demonstrated or instantaneous Failure Intensity) are also reported. Their positive values follow from the corrective actions taken by Boeing during the aircraft grounding period, as well as due to a somewhat natural reduction of those problems that typically emerge during the initial stages of the aircraft operation.
